NUMBER: 08-004-15 REV. A

FLASH: Battery Electric Vehicle, Multiple System Enhancements

2013 - 2015 (FF) Fiat 500e

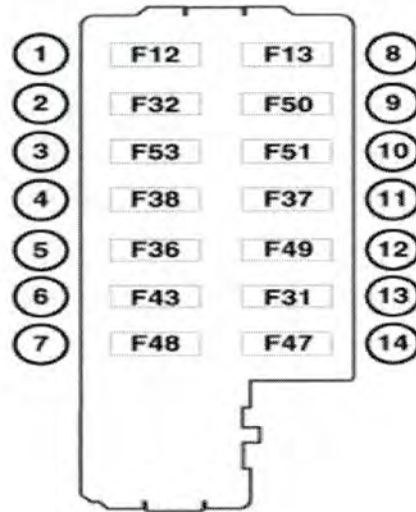
Fig. 1 Interior Fuse Panel Located By The Left Kick Panel.

NOTE: Sometimes when updating the software on these modules, the CTM may stop communicating and/or U11F6-00 is set as an active fault. Pulling the fuse for the CTM will regain communication with that module and change U11F6-00 to a stored DTC.

15. Is U11F6-00 set as an active fault?
 - a. Yes >>> Proceed to Step #16.
 - b. No >>> Proceed to Step #18.
16. Turn off the ignition and pull fuse F36 for 10 seconds. It is located in the interior fuse panel, which is part of the BCM, see (Fig. 1).
17. Turn the ignition back on and check if U11F6-00 is now set as a stored fault?
 - a. Yes >>> Proceed to Step #16.
 - b. No >>> This bulletin has been completed. Perform normal diagnostic, Follow TechConnect > U11F6-00-LOST COMMUNICATION WITH CONVERGENCE TELEMATICS MODULE.
18. Clear any DTCs that may have been set in other modules due to reprogramming. The wiTECH application will automatically present all DTCs after the flash and allow the tech to clear them.

13. Is U11F6-00 set as an active fault?
 - a. Yes >>> Proceed to Step #14.
 - b. No >>> Proceed to Step #16.
14. Turn off the ignition and pull fuse F36 for 10 seconds. It is located in the interior fuse panel, which is part of the BCM, see (Fig. 1).

Remove fuse F36 .
