NUMBER: 08-004-15 REV. B

SB-10057936-7326

FLASH: Battery Electric Vehicle, Multiple System Enhancements

2013 - 2015 (FF) Fiat 500e

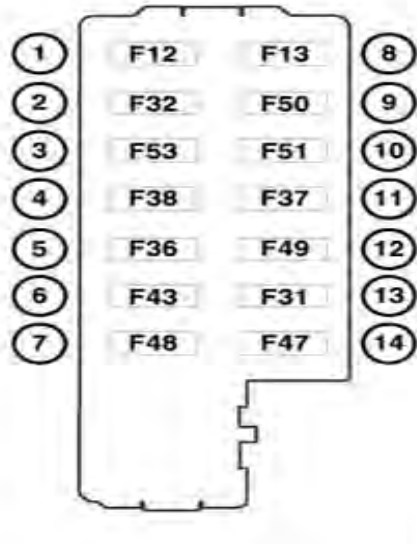
Fig. 1 Interior Fuse Panel Located By The Left Kick Panel.

NOTE: Sometimes when updating the software on these modules, the CTM may stop communicating and/or U11F6-00 is set as an active fault. Pulling the fuse for the CTM will regain communication with that module and change U11F6-00 to a stored DTC.

15. Is U11F6-00 set as an active fault?
 - a. Yes >>> Proceed to [Step #16](#).
 - b. No >>> Proceed to [Step #18](#).
16. Turn off the ignition and pull fuse F36 for 10 seconds. It is located in the interior fuse panel, which is part of the BCM, see ([Fig. 1](#)).
17. Turn the ignition back on and check if U11F6-00 is now set as a stored fault?
 - a. Yes >>> Proceed to [Step #17](#).
 - b. No >>> This bulletin has been completed. Perform normal diagnostic, Follow TechConnect > U11F6-00-LOST COMMUNICATION WITH CONVERGENCE TELEMATICS MODULE.
18. Clear any DTCs that may have been set in other modules due to reprogramming. The wiTECH application will automatically present all DTCs after the flash and allow the tech to clear them.

13. Is U11F6-00 set as an active fault?
 - a. Yes >>> Proceed to [Step #14](#).
 - b. No >>> Proceed to [Step #17](#).
14. Turn off the ignition and pull fuse F36 for 10 seconds. It is located in the interior fuse panel, which is part of the BCM, see ([Fig. 1](#)).

Remove fuse F36 .
