Bulletin No.: 14301 Date: March 2015

SUBJECT: Special Coverage Adjustment – Inadequate Clearance of Fuel Fill Pipe Clamp

to Brake Lines

MODELS: 2011-2014 Chevrolet Express

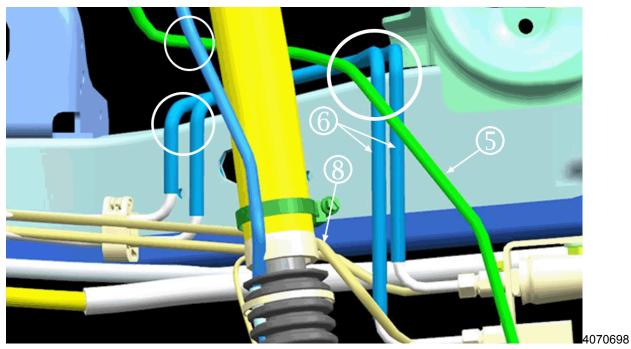
The illustration shows the brake line routing on the inboard side of the frame near the left wheel opening. Inspect the new brake lines (6) for frame contact in the areas that are circled in the illustration. Also ensure the right rear brake line (5) is NOT contacting the new brake line (5) in the circled areas of the illustration as well. The old brake line routing (8) is shown to display the differences between the two brake line designs.

- 10.5 Inspect the brake line routing on the inboard side of the frame near the rear left wheel opening. The brake lines should NOT contact the frame and should NOT have a stressed or tight fitment over the frame.
- 10.6 Install the brake line mounting clips in the production positions.
- 10.7 Ensure the brake lines are secured by the mounting clips in the production routing positions.
- 10.8 Tighten the rear jounce hose and crossover pipe mounting bracket bolt.
