Service Bulletin

SPECIAL COVERAGE

SUBJECT: Special Coverage Adjustment – Loss of Steering Due to Water Intrusion (Steering Gear Umbrella Seal Missing)

**MODELS: 2004-2005 Chevrolet Malibu, Malibu Maxx
2005 Pontiac G6**

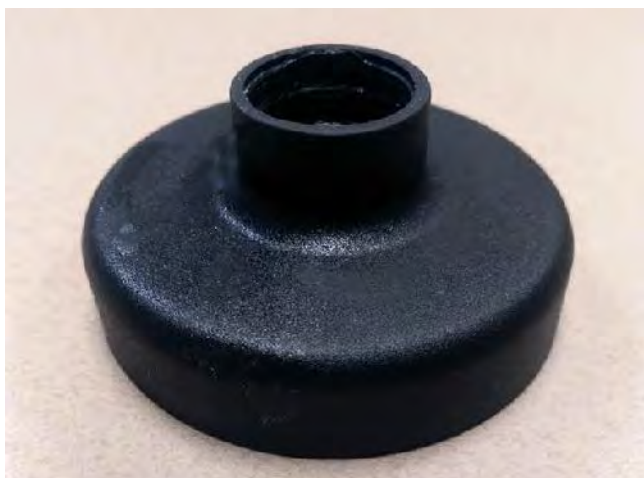
3984319

Use the following steps to inspect the steering gear input shaft for the presence of an “Umbrella Seal”. If no seal is installed, it will be necessary to replace the steering gear.

1. Raise and support the vehicle. Refer to *Lifting and Jacking the Vehicle* in SI.
2. Inspect the input shaft area of the steering gear and determine if the seal is installed.

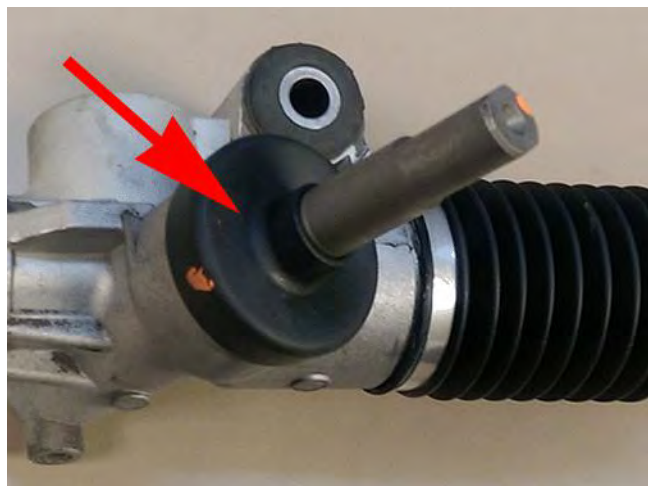
3984329

- If the seal **is** installed, no further action is required. Inform the customer that any additional diagnosis and repairs are not covered under this special coverage.

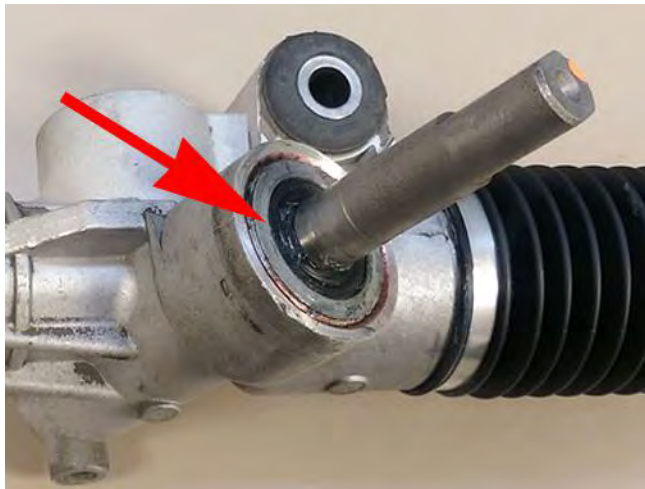
3984334

- If the seal is **not** installed, proceed to the *Steering Gear Replacement* section below.

If the vehicle does not have the seal installed, replace the steering gear assembly. Refer to *Steering Gear Replacement* in SI.
