# Service Bulletin

**SUBJECT: Special Coverage Adjustment – Transmission Clutch Wave Plate**

**MODELS:** 2007-2009 Buick Enclave  
 2008-2009 Chevrolet Equinox, Malibu  
 2009 Chevrolet Traverse  
 2007-2009 GMC Acadia  
 2007-2009 Pontiac G6  
 2008-2009 Pontiac Torrent  
 2007-2009 Saturn AURA, OUTLOOK  
 2008-2009 Saturn VUE  
 Equipped with FWD or AWD and 6-Spd Automatic Transmission  
 (RPO MH2, MH4, MH6, or MY9)

**This bulletin is being revised to add the 2008-2009 Saturn VUE, add transmission RPO codes, and update the Warranty Transaction information section. Please discontinue use, and discard all copies of Special Coverage Recall 14404.**

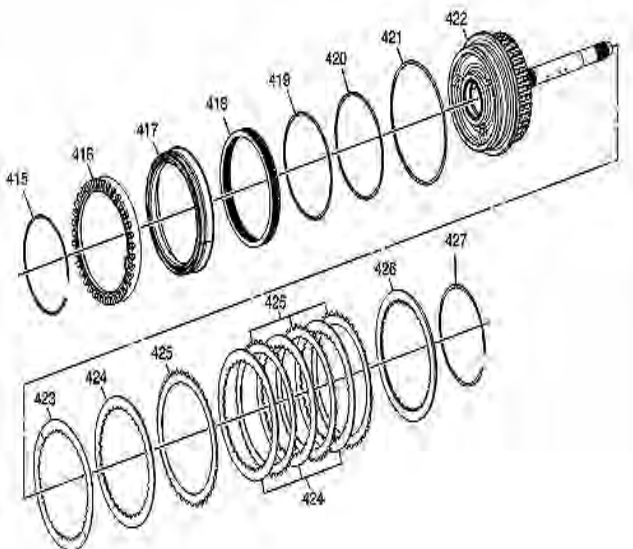
2584818

**Note:** Debris generated by the condition must be cleaned from the entire transmission and the pump fluid filter (201) and the control solenoid filter plate (16) must be replaced. Failure to separate the case halves, disassemble the transmission, clean the debris and replace the pump fluid filter (201) and the control solenoid filter plate (16) could lead to repeat transmission damage and repairs.

A broken 35R wave plate can generate varying amounts of debris inside the transmission. In most cases this debris has not passed through the pump fluid filter (201) potentially damaging the pump, valve bodies or torque converter. This debris can be cleaned and the transmission successfully repaired.

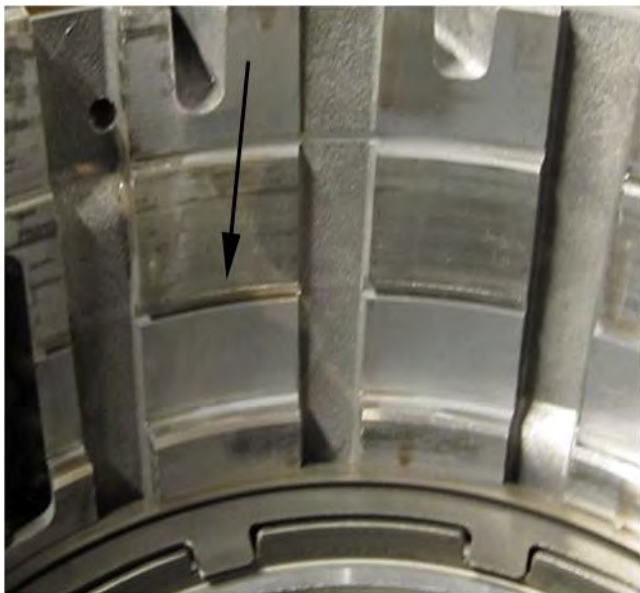
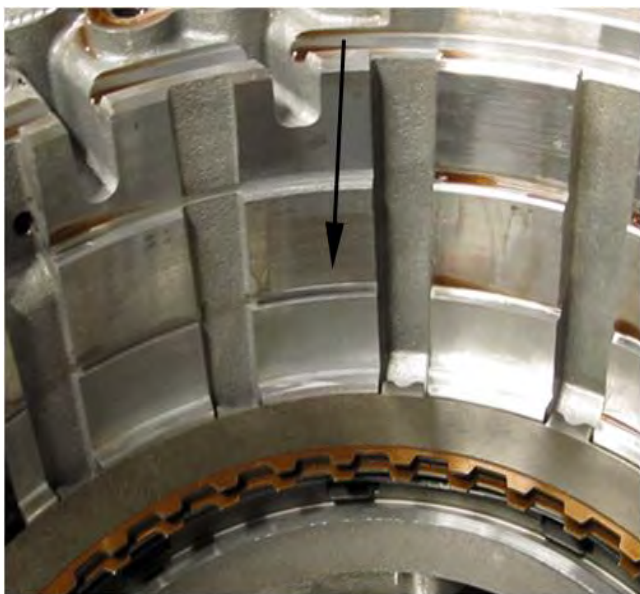
1. Remove the case cover assembly (35). Inspect the case cover for damage. This part is serviced and can be replaced if it is damaged.
2. Remove the 35R/456 clutch housing assembly (422) and inspect it for a broken 35R wave plate (423).
3. Inspect the case (21) for damage caused by a broken wave plate as shown below.

- The snap ring groove, which is well below the 3-5-R wave plate area, is unlikely to be damaged. It should still be checked to verify the snap ring is fully seated and to be securely retained.

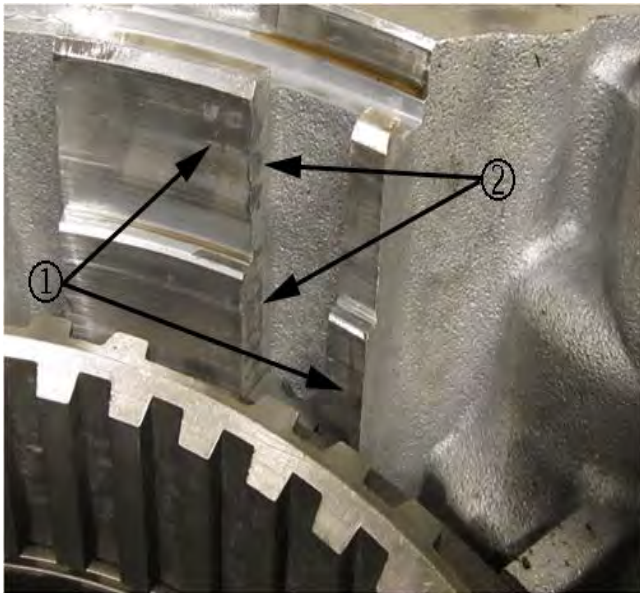
2753503

- Peening or wear of the face or edge of the case lugs that engage the steel clutch plates is normal and not cause for transmission replacement.

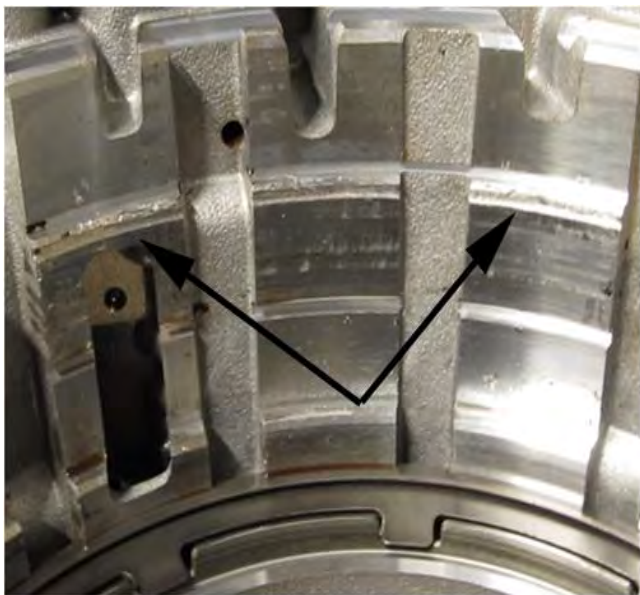
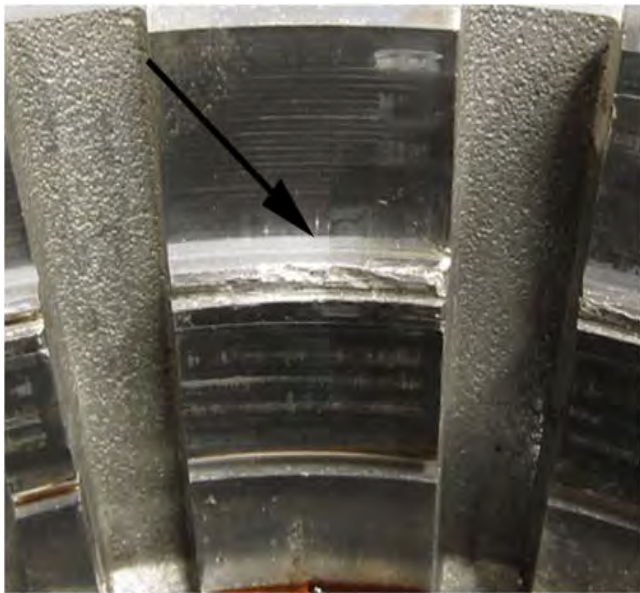
- Some degradation of the shelf for the 2-6 backing plate is acceptable as long as the plate can lie flat. A raised burr that prevents this can be removed using a de-burring tool, file or some other abrasive.

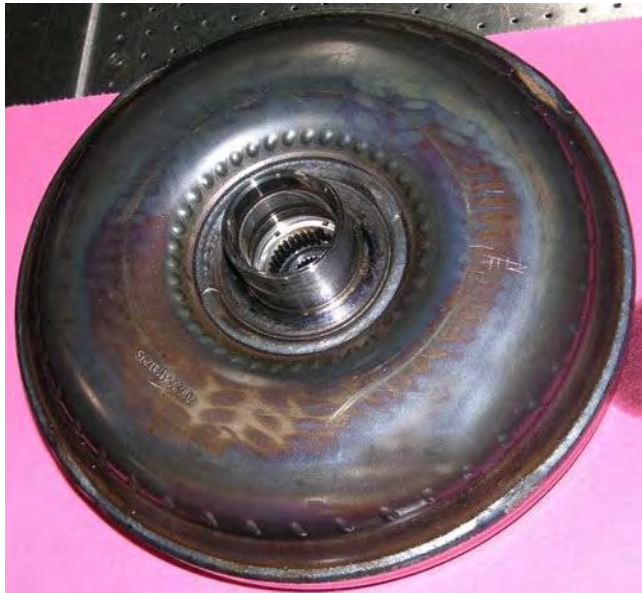
2739303

**Note:** The manufacturing process of the torque converter can cause the hub side to appear blue or darker in color while the lug side is a natural metal color. If the torque converter appearance is like this and no other reason is observed per the SI procedure for torque converter diagnosis, then the torque converter does not need to be replaced.

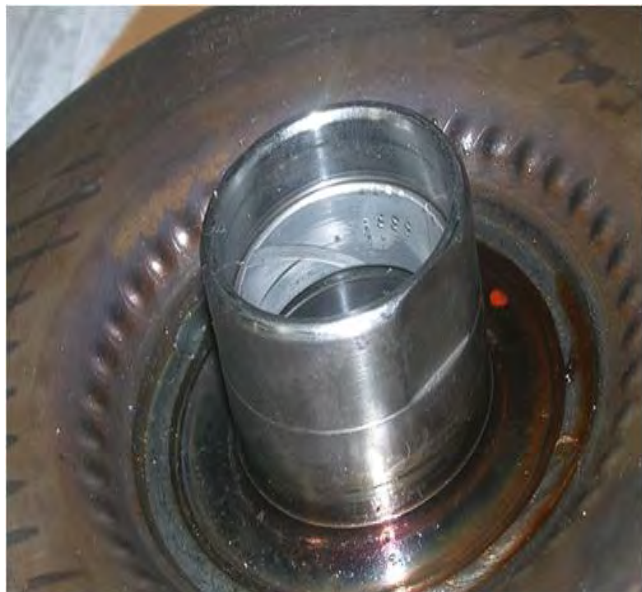
2753510

Marks such as these on the torque converter bushing are not a reason to replace the torque converter. They usually occur during removal of the transmission from the vehicle or removal/installation of the torque converter on the transmission and are caused by the bushing contacting the front differential transfer drive gear support (208) or the 3-5-R housing (422).

Also the marks are below the surface of the bushing and will not interfere with proper operation, however if there is a raised burr it can be removed with a de-burring tool or other abrasive.

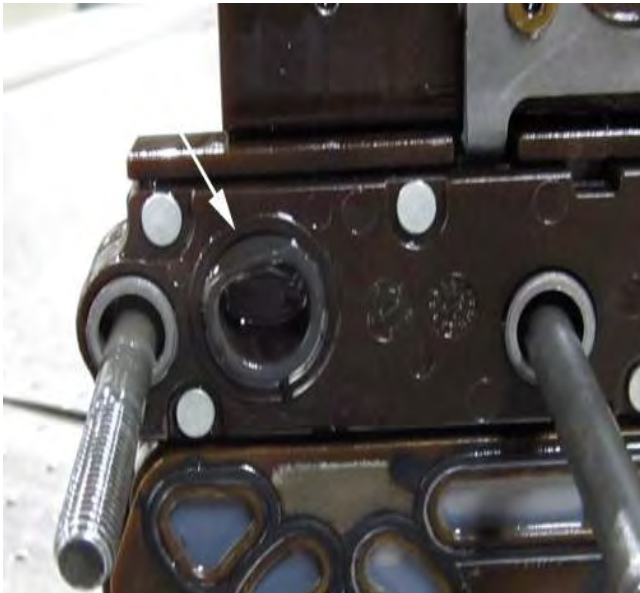
2850322

6. Inspect the control solenoid (w/body and TCM) valve assembly (TEHCM) (15) pressure switches. The O-ring seals may be deformed but if they are attached, as shown above, the TEHCM should not be replaced; it should be reused. Deformed seals do not affect switch performance.

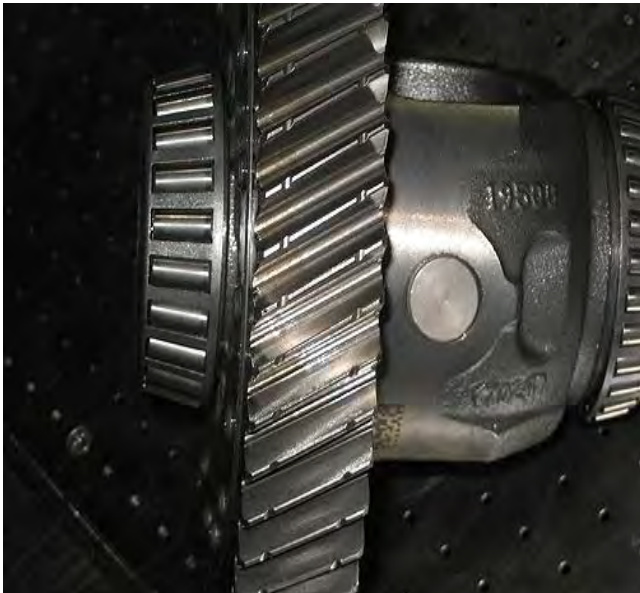
2584822

**Note:** The front differential carrier assembly (31) teeth are marked with notches to identify gear ratio (see picture above). Do not confuse these marks with tooth damage. Do not replace the gear for this condition.
