Service Bulletin

SUBJECT: Service Update for Inventory and Customer Vehicles
Parking Brake Cable
Expires with Base Warranty

MODELS: 2013-2014 Buick Encore

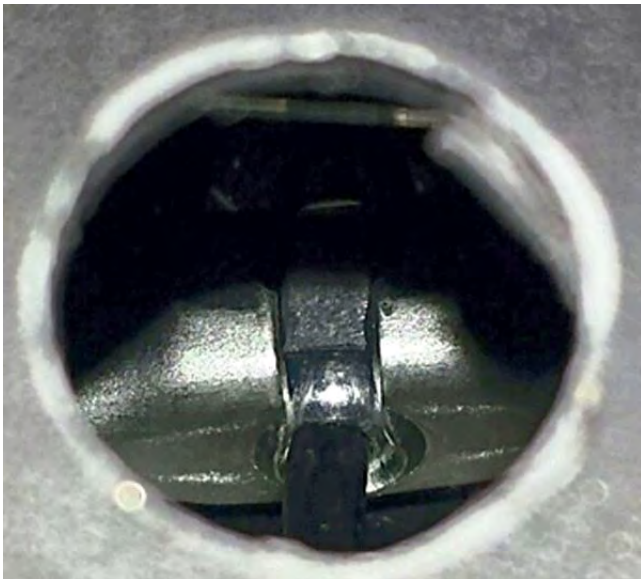
4089232

Cable ferrule end is fully seated in the equalizer slot.

- If the cable ferrule is fully seated in the equalizer slot, no further action is required. Install the rubber pad in the storage area of the front floor console and close the storage area lid.

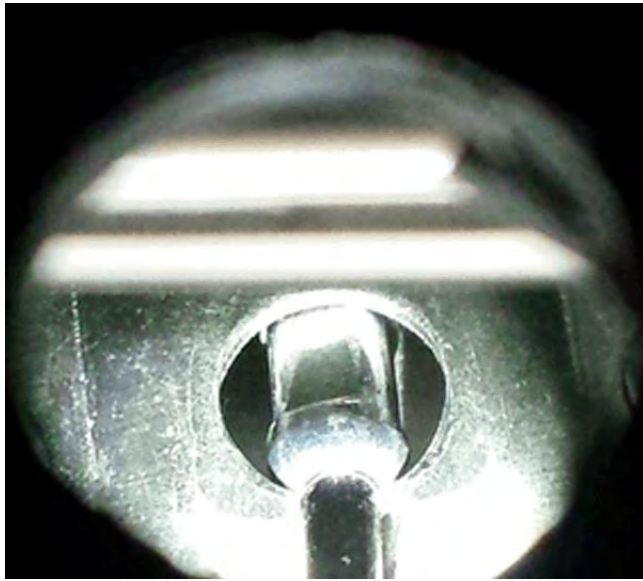
Cable ferrule end is NOT seated down in the equalizer slot.

- If the cable ferrule is NOT fully seated in the equalizer slot, proceed to step 10.
