Service Bulletin

SUBJECT: Service Update for Inventory and Customer Vehicles
Body Harness Contact with Park Brake Bracket
Expires with Base Warranty

MODELS: 2014-2015 Chevrolet Silverado
2014-2015 GMC Sierra

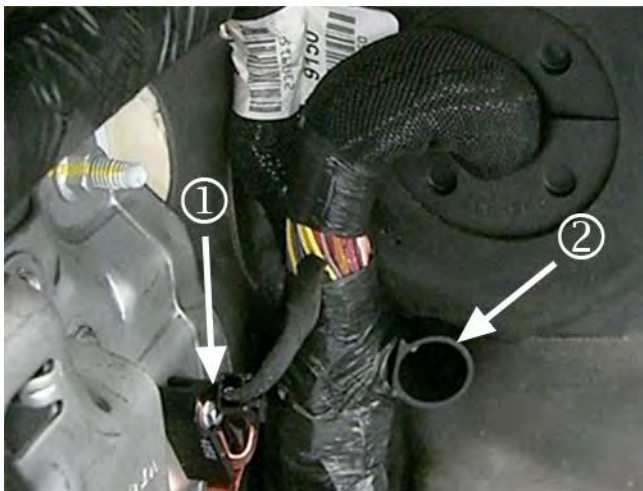
4109182

Note: The graphic above was taken with the junction block removed **for illustration purposes only**. Complete junction block removal is NOT necessary.

4. To gain slack on the harness, disconnect the park brake light warning switch terminal (1) and detach the harness retainer (2) from the body stud.
