# Service Bulletin

Bulletin No.: PI1442

**Subject:** Intermittent Engine Stall and/or Crank/No Start with No DTCs

**Models:** 2013-2014 Chevrolet Spark

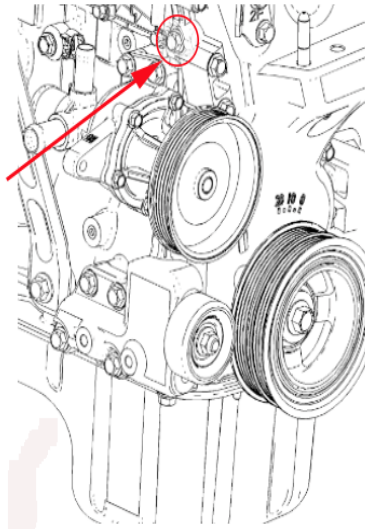
4110954

This condition may be caused by the ignition coil ground G107 bolt being too long causing the bolt to bottom out before generating the proper torque specification, creating a poor contact on the ground wire, circuit 150 (black).

2. Remove the G107 bolt.

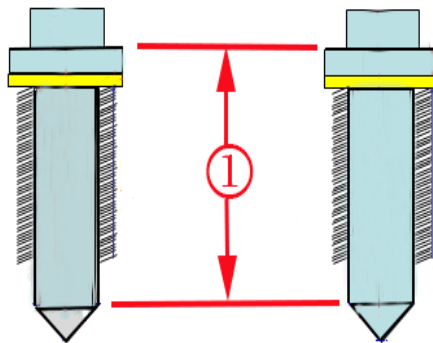
4110962

3. Measure the length (1) of the bolt as illustrated above.
  - The correct length is approximately 16.4 mm (0.65 in).
  - The incorrect length is approximately 20.8 mm (0.82 in).
4. If the bolt is the correct length, inspect the bolt and ground wire for possible cause of the engine stalling and/or crank with a no start condition. If no root cause was found, reinstall the original bolt and continue diagnoses. Skip to step 6. Refer to SI for further diagnostics.
5. If the bolt is the incorrect length, replace the bolt with a shorter bolt, P/N 11561025.
6. Reinstall G107 bolt.
7. Reinstall the radiator surge tank.
8. Verify the condition as been corrected.

The bolt may feel and look properly torqued but if the conditions above exist, inspect the ignition ground G107 bolt for the proper length. If incorrect length, replace the bolt with a shorter bolt, P/N 11561025.
