## Service Bulletin

Bulletin No.: PIT5374B

**Subject:** Headlight Performance (BCM Calibration and Bulbs)

**Models:** 2015 GMC Sierra  
2014 GMC Sierra 1500

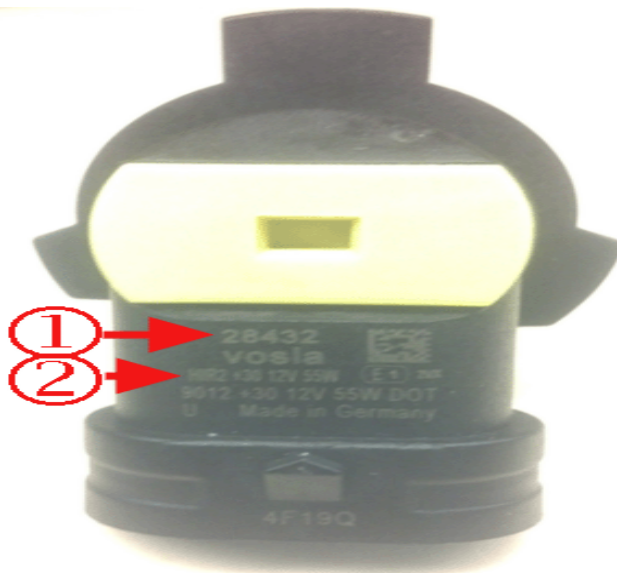
1. 28432
2. HIR2+30

1. For vehicles built before 12/23/14 at Flint Assembly (11th Vin Digit "F"), 1/13/15 at Silao Assembly (11th Vin Digit "G") or 1/16/15 at Ft. Wayne Assembly (11th Vin Digit "Z"), reprogram the BCM with the latest calibration available in TIS2WEB starting on 1/12/2015. The new BCM calibration will increase the voltage to the headlight bulbs in both the low beam and high beam selections. All vehicle build after the above dates already have the new BCM calibrations and the BCM reprogramming does NOT need to be done.
2. Replace both headlight bulbs with updated bulb part number 23342527. IMPORTANT: Verify the correct bulb is being installed by confirming the following markings on the bulb:

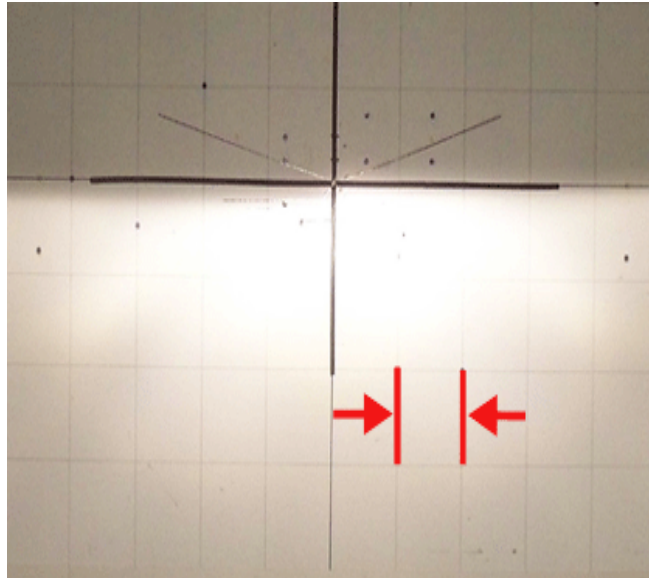
4092519

**Important:** When installing the new headlight bulbs, do not touch the glass and pay close attention that the bulbs are fully seated into the headlight housing. If the bulb is not properly installed it can lead to an incorrect light pattern. A beam pattern photo with a properly installed bulb is shown below. This photo is of a GMC Sierra Low beam pattern (1 Lamp with opposite lamp blocked) on wall/aiming screen at 25 ft (7.62 m). Each block division is approximately 10.5" (26.67cm)

3. After bulb replacement, perform Headlamp Aiming procedure (see below)

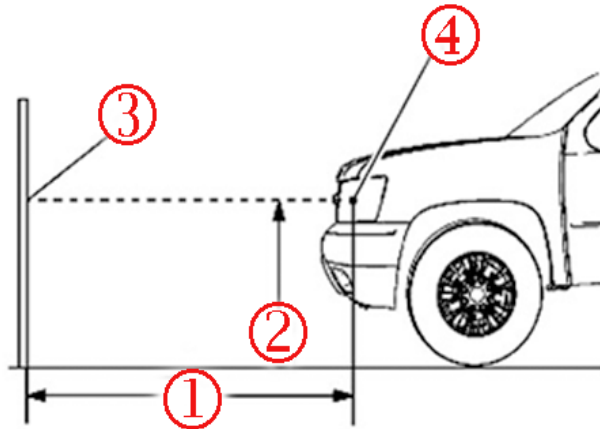
4092121

1. 25 ft (7.62 m)
  2. Height of Horizontal Aiming Line on screen
  3. Aiming Screen or Wall
  4. Reference mark (small circle) on headlamp lens
9. Turn the headlamps ON.
  10. Block the light from projecting onto the screen from the passenger side headlamp. This will allow the cutoff ("top" of the beam pattern) in the beam pattern from the driver's side to be more pronounced for easier aim verification.

8. At the screen, measure from the floor and place the horizontal tape at the measured height. This establishes the Horizontal Aiming Line.

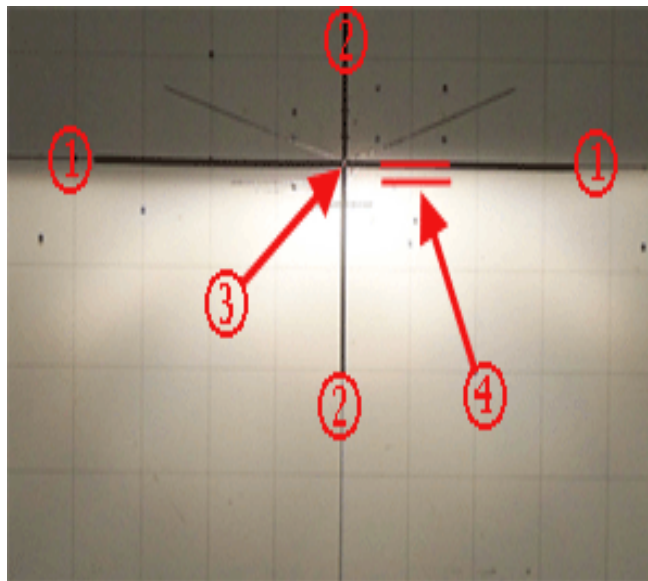
4092365

**Note:** GMC Sierra Low beam pattern (1 Lamp) on wall/aiming screen at 25 ft (7.62 m)

1. Horizontal Aiming Line
2. Reference line only, Not needed for proper aiming
3. Step in beam pattern
4. Top of beam pattern (cutoff line) positioned at the horizontal aiming line +0 / -0.75" (-19mm)

13. Adjust the vertical headlamp aim adjustment screw until the cutoff (top of the beam pattern) on the right side of the beam pattern step is set between the Horizontal Aim Line and 0.75 (19mm) inches below.
14. Repeat the aiming procedure for the passenger's side headlamp while blocking the light from projecting onto the screen from the driver's side headlamp.
