# Service Bulletin

Bulletin No.: PIT5391

**Subject:** No Crank or Start Then Immediate Stall (Inspect Circuit 5199 Under Driver Sill Plate)

**Models:** 2015 Cadillac Escalade Models  
 2014 Chevrolet Silverado 1500  
 2015 Chevrolet Silverado, Suburban, Tahoe  
 2014 GMC Sierra 1500  
 2015 GMC Sierra, Yukon Models

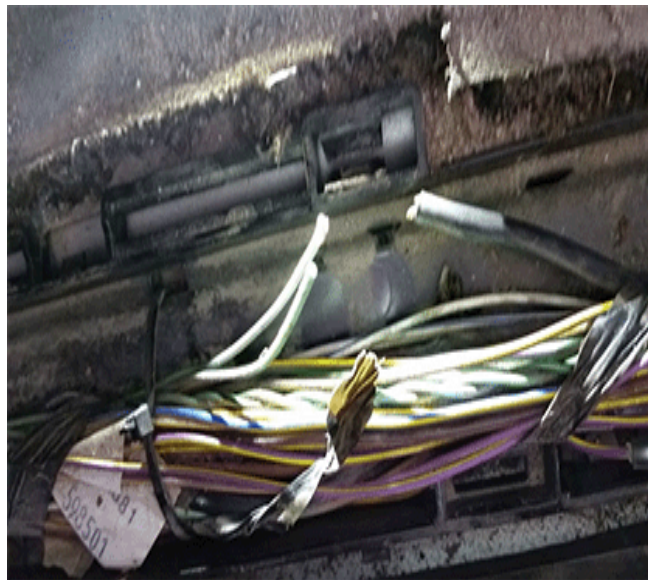
4109559

This concern could be caused by the KR73 Ignition Run Relay, located in the UBEC, not turning on due to an open or high resistance in circuit 5199 under the driver's sill plate, as shown below.

Inspect the wiring under the driver's sill plate and repair any damaged/corroded circuits using the appropriate SI wiring repair document.
