MIN – 15101

ProStar® with Cummins® ISX – Front Crossmember Bolt

ProStar® with Cummins® ISX 15L

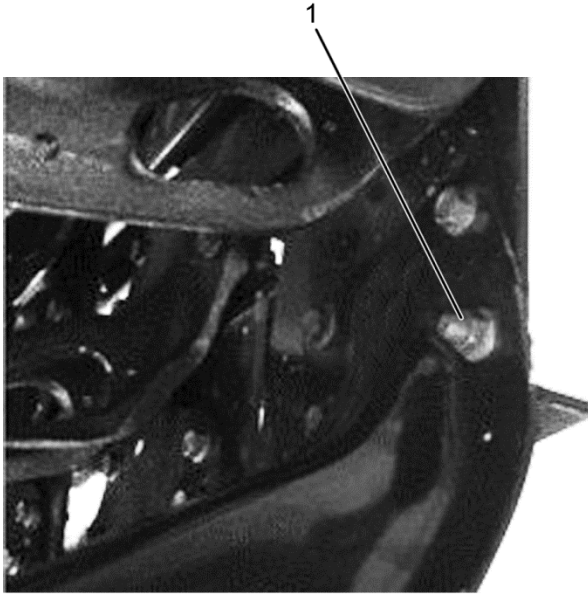
Figure 1. Incorrect Front Crossmember Position.

Certain ProStar® vehicles equipped with Cummins ISX 15L engines were built with the front left frame crossmember bolt installed in the wrong direction. This condition could cause damage to the transmission cooler lines as a result of rubbing against the bolt.

1. Crossmember bolt

- If crossmember bolt (Figure 1, Item 1) is installed in reversed position; remove, invert and reinstall in correct position. Using torque wrench, tighten bolt to 81 lb-ft (110 N·m).
- If crossmember bolt is shown installed in correct position, proceed to Step 6.

5. Verify transmission cooler lines are not rubbing against bolt. If a rubbing condition is still present, reroute cooler lines to prevent hard contact.
