**NUMBER:** 18-053-15**GROUP:** Vehicle Performance**DATE:** June 25, 2015

Malfunction Indicator Lamp (MIL) Illumination P0344 - Camshaft Position Sensor Intermittent

2012 - 2015 (JK)

Jeep Wrangler (RHD)

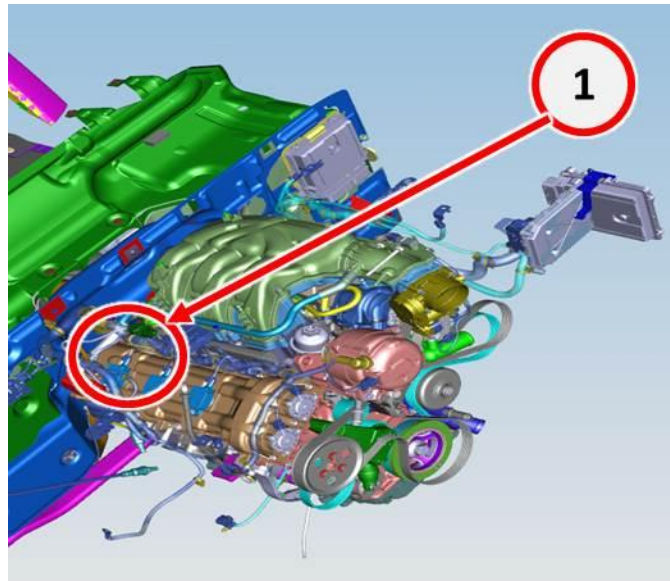
Fig. 1 Underhood Engine View

1 - Engine harness repair location

1. Remove the engine cover.
2. Locate the engine wire harness tower clip on the right side of the engine near the camshaft position sensor. See (Fig. 1).

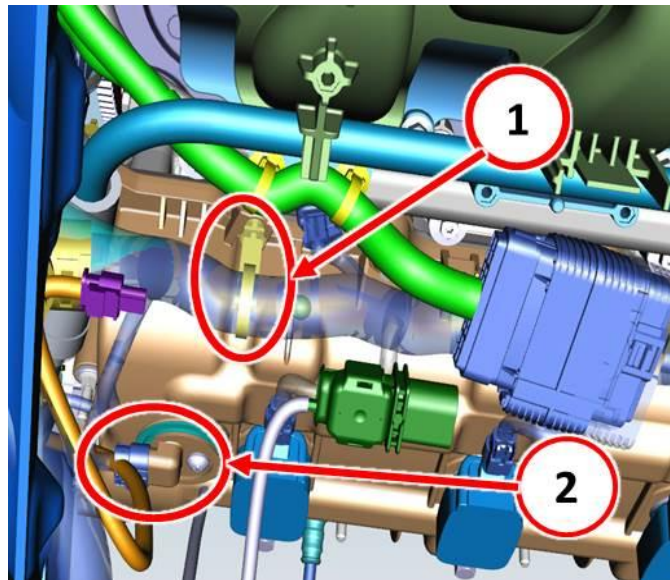
Fig. 2 Engine Wire Harness

1 - Engine harness tower clip

2 - Camshaft Position Sensor (CMP)

3. Remove the existing wire harness tower clip and install P/N 68289129AA tower clip in the same location on the wire harness. See (Fig. 2). Engage the tower clip to the cylinder head cover. The new tower clip should be a tighter fit to the cylinder head cover than the removed clip.

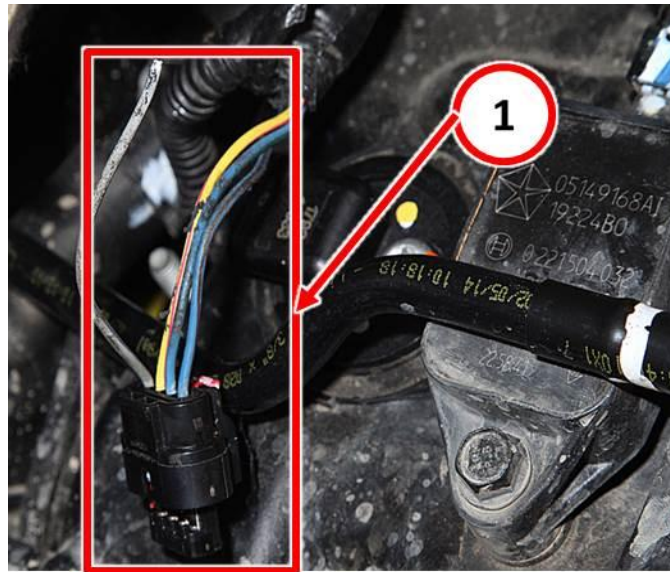
Fig. 3 CMP Sensor Connector

1 - CMP wire harness damage

- 4. Repair any damaged wiring to the CMP harness near the connector. See (Fig. 3). Refer to detailed repair instructions in DealerConnect/TechConnect Service Information Section 29 - Non-DTC Diagnostics> Circuit Testing Procedures> Standard Procedure> WIRE SPLICING.
