SERVICE BULLETIN

Classification:	Reference:	Date:
EC14-002c	NTB14-009c	June 17, 2015

2014 VERSA NOTE; MIL ON WITH DTC P059F STORED

APPLIED VEHICLE: 2014 Versa NOTE (E12)

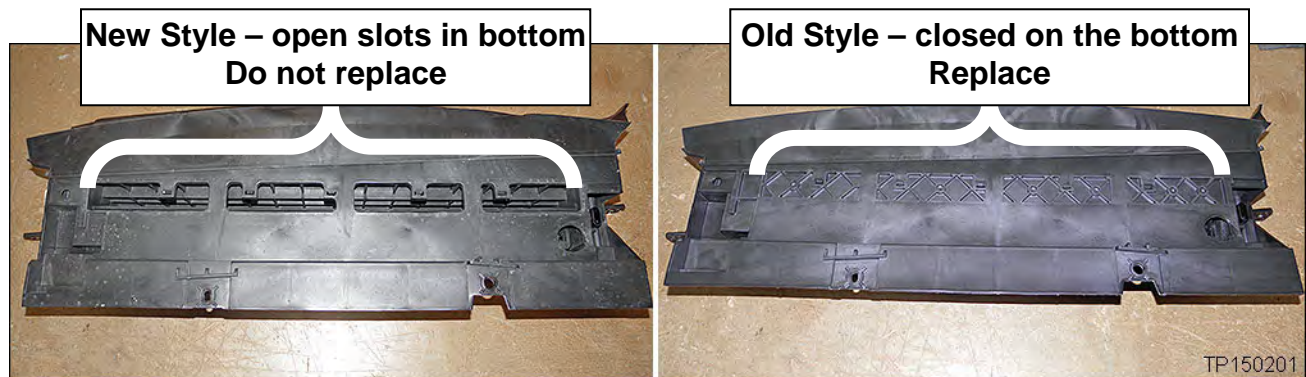
Figure 8

NOTE: If the front undercover is removed from the vehicle, the bottom of the shutter is visible. You can see if the bottom is closed or if it has open slots.

- Refer to the **FLOWCHART** on page 2 for shutter replacement applicability.
 - Replace the shutter only if OP code **CX23AA** or **CX24AA** has **not** been performed on this vehicle.
 - Check Service COMM; if either one of the above OP codes has already been performed, the new style shutter is already installed on the vehicle.
