SB-10058055-2170

FORD:

2014-2015 Fusion

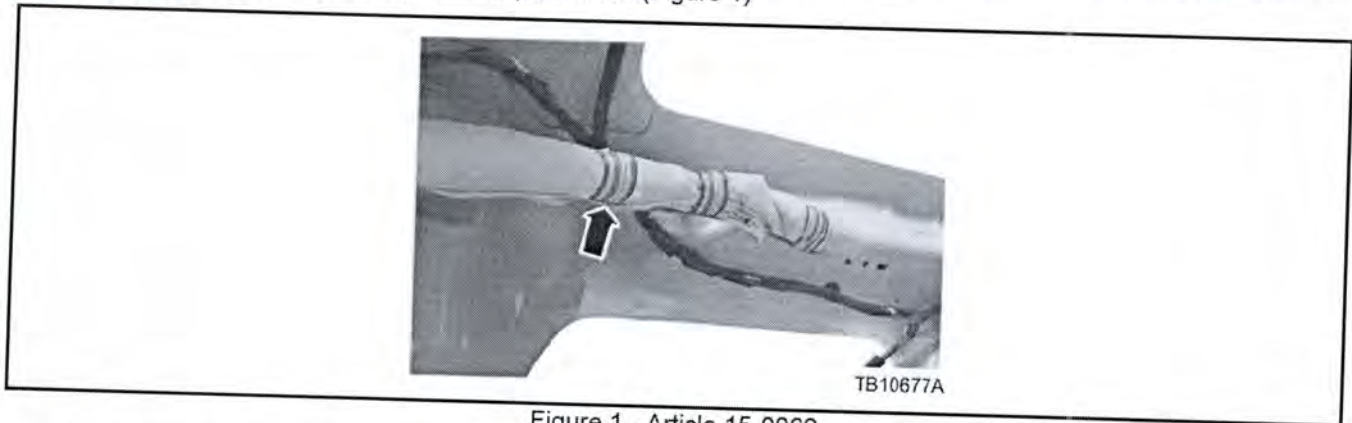
Figure 1 - Article 15-0069

1. Does the first position of the vehicle identification number (VIN) start with a number 1? Refer to Workshop Manual (WSM), Section 100-01.
 - a. Yes - proceed to Step 2.
 - b. No - the vehicle was not built at Flat Rock assembly plant, refer to WSM, Section 501-05 for normal diagnosis.
2. Remove the headliner, refer to WSM, Section 501-05.
3. Without using a cutting tool, hand tear and remove the striped or bar coded piece of tape identified on both the driver and passenger side curtain air bag in the C pillar area. (Figure 1)

- a. When removing the tape it is expected and acceptable for some of the backing or back side of the tape to remain on the curtain air bag. Do not use any chemicals or tools and attempt to remove the backing that remains.
4. Install a new headliner along with updated upper A, B and C pillars which are included in the trim panel kit. Refer to WSM, Section 501-05.
 - a. The original D-pillar trim panel can be reinstalled with a new 2-stage retention clip on each pillar.
5. For 2014 Fusion vehicles install the overhead console attachment kit to the overhead console prior to installing the original overhead console in the new headliner.
