SB-10058061-8838

LINCOLN:

2013-2015 MKS, MKT

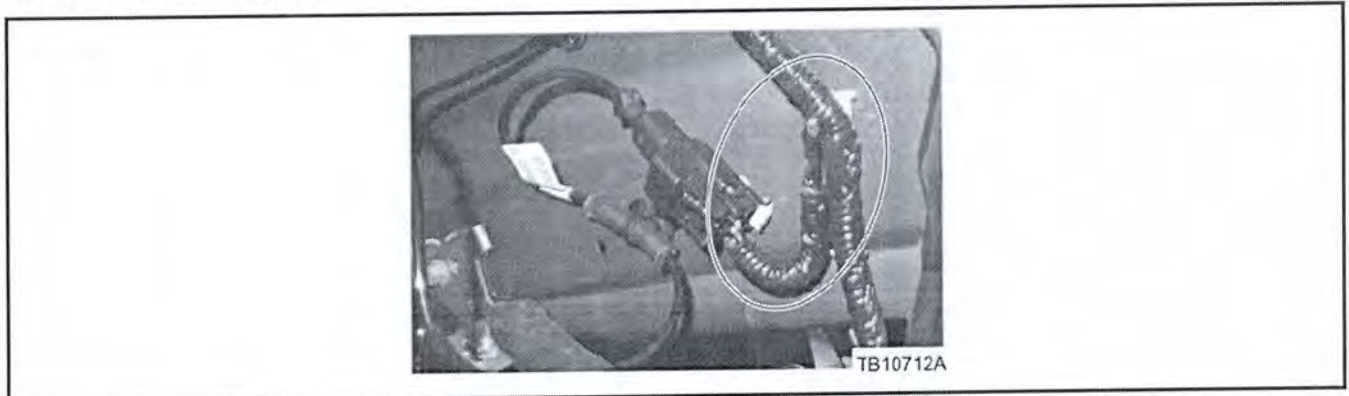
Figure 1 - Article 15-0075

1. Raise vehicle on a hoist, refer to Workshop Manual (WSM), Section 100-02.
2. Remove the front right and front left side wheel and tire per the WSM, Section 204-04.
3. Disconnect connector C1668 on the left front strut assembly and C1669 on the right front strut assembly.
4. Remove the tape and plastic convolute around the take out to connector C1668 and C1669 and the main wire harness, approximately 5.0 cm (2.0") in each direction from the take out. (Figures 1 and 2)

5. Inspect for wire damage to the main harness for any broken or exposed copper under the wire insulation.

6. Isolate any chafed/corroded wiring and replace connector (main harness 14290 side only) C1668 and C1669 with a new pigtail connector. Refer to the wiring repair kit instructions included in the pigtail kit. (Figure 1 and 2)
7. Wrap the main harness wiring 5.0 cm (2") in both directions from the take out and wrap the entire wiring of the new pigtail connectors with Coroplast™ electrical wire harness tape or equivalent. (Figure 1 and 2)
 - a. Normal electrical tape does not have the anti-abrasion properties required to protect the wiring.
8. Replace the original convolute and cover with standard electrical tape.
9. Reconnect connectors C1668 and C1669.
 - a. For MKT make sure the connector take out is routed behind the main wiring harness. (Figure 1)
10. Reinstall the right and left wheel and tire per WSM, Section 204-04.
11. Lower the vehicle.
12. Retrieve and clear any DTCs.
