SB-10058074-1829**FORD:**

2015 Edge

2015 MKC

TSB 15-0084 (Continued)

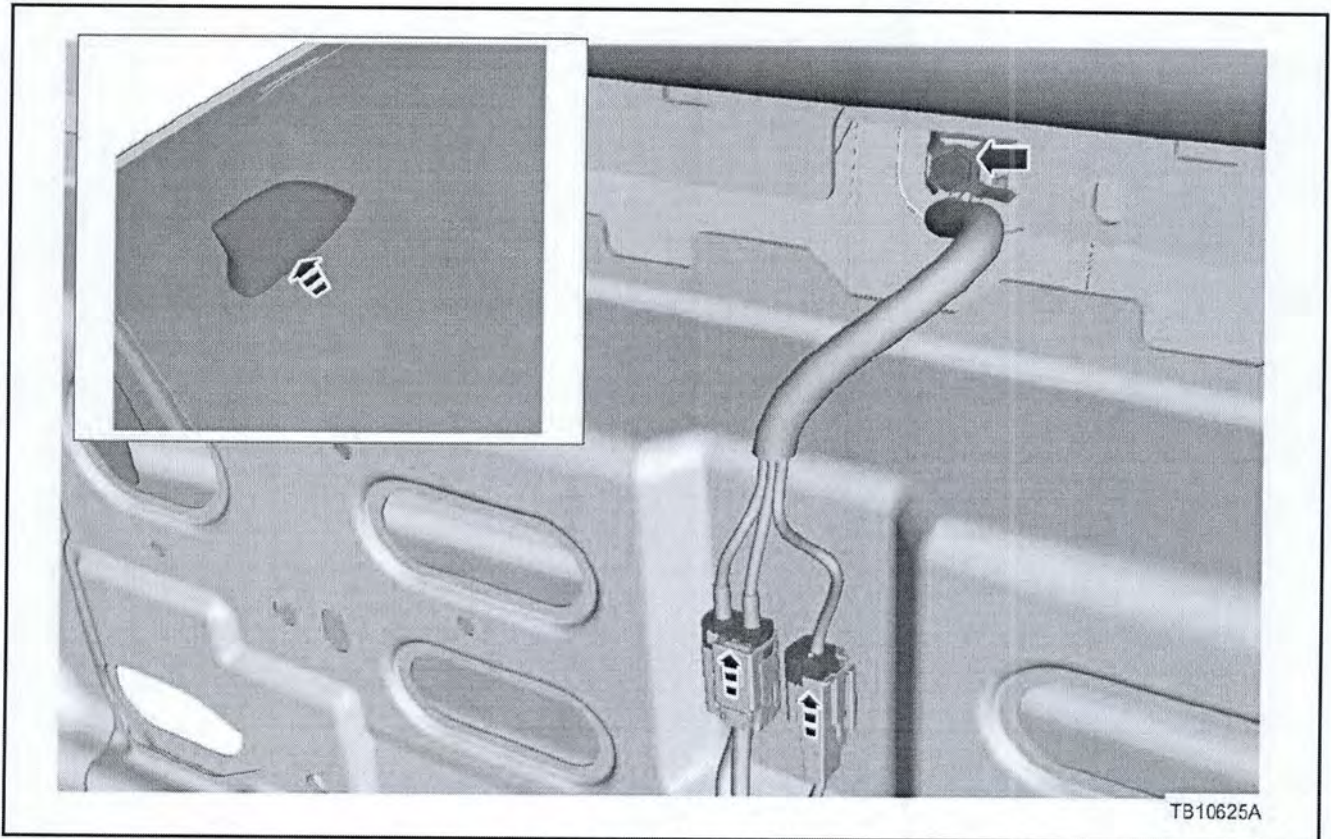
Figure 1 - Article 15-0084

Some 2015 MKC and Edge vehicles equipped with Sirius satellite radio may exhibit an intermittent concern where the audio cuts out and the radio displays a No Signal message while driving in open sky conditions in certain locations in your area. This may be due to interference with cellular phone tower signals.

- a. Remove the retainer and audio unit antenna and harness through the roof opening. (Figure 1)

- b. The new audio unit antenna must be painted to the vehicle color before installing.
 c. Tighten the bolt to 7 Nm (62 lb-in.).
 7. To install, reverse the removal procedure.
