## SB-10058083-7590

**FORD:**

2014-2015 Transit Connect

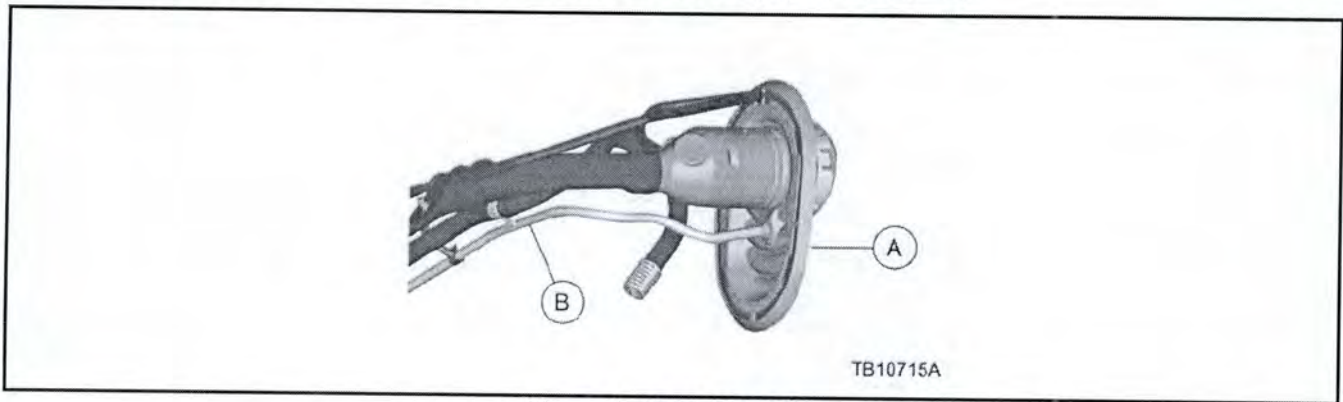
Figure 1 - Article 15-0087

Some 2014-2015 Transit Connect vehicles built on or before 10/17/2014 may exhibit a fuel odor inside the cabin after refueling. This may be due to a distorted fuel tank filler pipe gasket and missing fuel tank filler pipe drain tube.

1. Remove the fuel tank filler pipe. Refer to Workshop Manual (WSM), Section 310-01.
2. Replace the filler pipe gasket and add a fuel filler pipe drain tube. (Figure 1A and 1B)
