Michael A. Berardi
Director
Service Engineering Operations
Ford Customer Service Division

July 20, 2015

SUBJECT: **Customer Satisfaction Program 15B04 - Supplement #1**
Certain 2013 and 2014 Model Year C-MAX Hybrid Electric Vehicles (HEV)
12 Volt Battery Test and Module Software Update

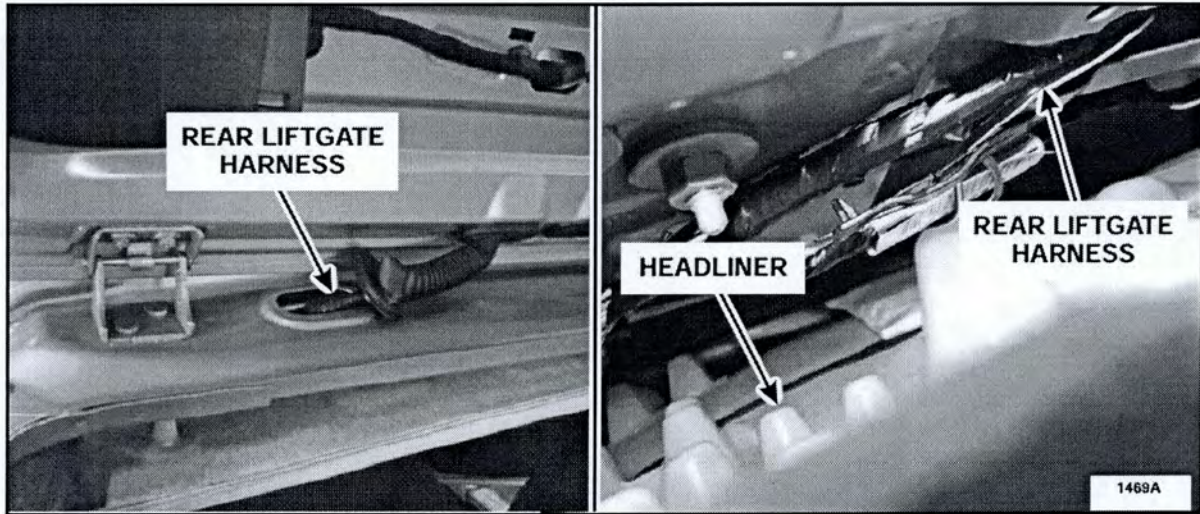
FIGURE 1

1. Inspect for damage or chafing to wiring harnesses in the areas noted below. See Figures 1 through 3 for locations, and Figure 4 for examples of damage and chafing.
 - Rear Liftgate Harness: in the opening between the body and the rear liftgate, and under the headliner near the sheet metal opening where the harness passes through.
 - On the vehicle body wiring harness near C339 and C340.
2. Is damage or chafing present?

Yes - Repair circuits as required. Refer to Wiring Diagram (WD) Section 5-1. Proceed to Step 3.
No - Proceed to Step 3.
3. Wrap 3M™ Temflex™ Cotton Friction Tape or equivalent to the wiring harnesses in following areas:
 - Rear Liftgate Harness: in the opening between the body and the rear liftgate, and under the headliner near the sheet metal opening where the harness passes through.
 - On the vehicle body wiring harness near C339 and C340. Wrap tape on harnesses near connectors to protect against damage or chafing.
4. Repair is complete.
