Technical Service Bulletin

01 MIL on (DTC P310B, P129F, P008B, P129E, P008A, P2540, P0087)

01 15 17 2027417/4 March 12, 2015. Supersedes Technical Service Bulletin Group 01 number 12-45 dated March 16, 2012 for reasons listed below.

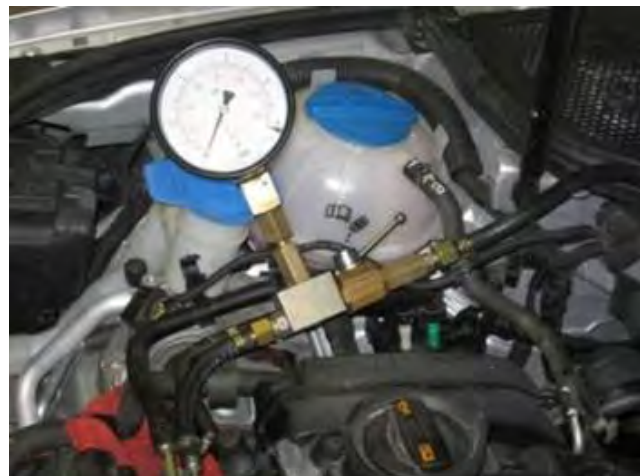
A false signal may be sent to the controller due to fuel intrusion into the low-pressure system fuel pressure sensor, G410. The result is a reading that is out of tolerance.

G410 must be accurately diagnosed with a mechanical gauge, and the results must be compared with the low-side fuel pressure actual value in Measured Value Block (MVB) 103. Comparing MVB 103 with MVB 106 does not accurately diagnose G410.

Figure 1. VAG 1318 gauge installed on an A3 2.0L TFSI.

1. Verify that *24T4 UPDATE - Fuel Pressure Sender (Warr_Ext)* was performed (if applicable).
2. Verify the customer did not run out of fuel at the time the DTCs were stored.
3. Follow indication of GFF for applicable DTCs.
4. To check the low-side fuel pressure sensor G410, measure the fuel pressure with a mechanical gauge using the following method:
 - a. Start engine and allow it to idle for at least one minute.
 - b. Stop the engine.
 - c. Keep the ignition on.
 - d. Measure actual low-side fuel pressure via mechanical gauge (VAG 1318) on the low pressure supply line in the engine compartment (Figure 1).

5. Add 1 bar to the value obtained from the mechanical gauge to calculate the adjusted gauge measurement value.
6. Compare the adjusted gauge measurement value to the actual value stored in MVB 103 field 1.
7. If the MVB 103 field 1 value deviates more than ± 1.0 bar from the adjusted gauge measurement value, then the DTC was likely triggered by a faulty G410 low-side fuel pressure sensor. In this case, document the adjusted gauge measurement value and MVB value on the repair order and perform the *Sensor replacement procedure* below.

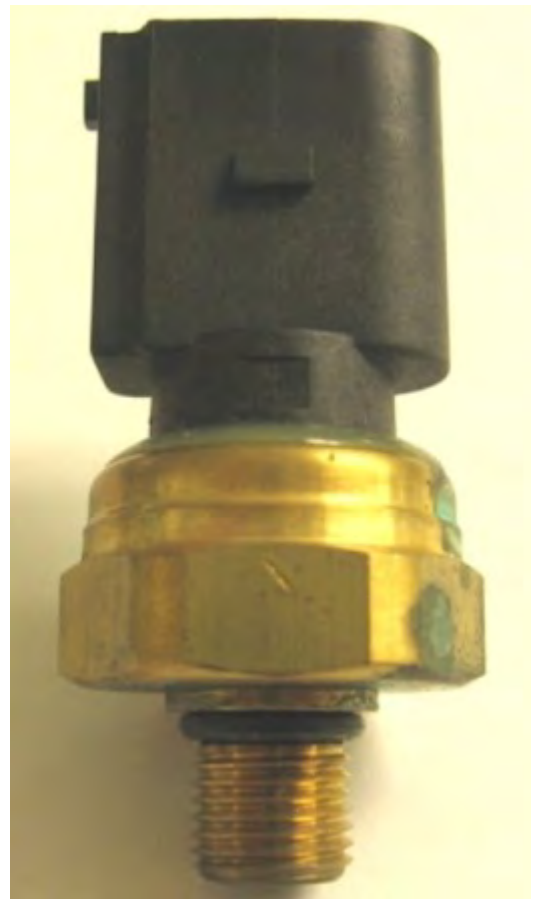
Figure 2. G410 sensor.

1. Replace the low-pressure system fuel pressure sensor, G410 (Figure 2).

2. Clear DTCs and verify that the problem was eliminated.
3. Run Basic Settings 103 to adapt system.
4. Do not replace the high pressure fuel pump, electrical fuel pump, fuel pump control module, or fuel filter unless problem persists and further diagnosis indicates a malfunction of any of these components.
