SB-10058136-4434

HYUNDAI NEW THINKING. NEW POSSIBILITIES. Technical Service Bulletin	GROUP CAMPAIGN	NUMBER 15-01-022-1
	DATE APRIL 2015	MODEL(S) SONATA (LF) 2.0T/2.4L

SUBJECT: E-CVVT SEAL SEATING (SERVICE CAMPAIGN TX3)

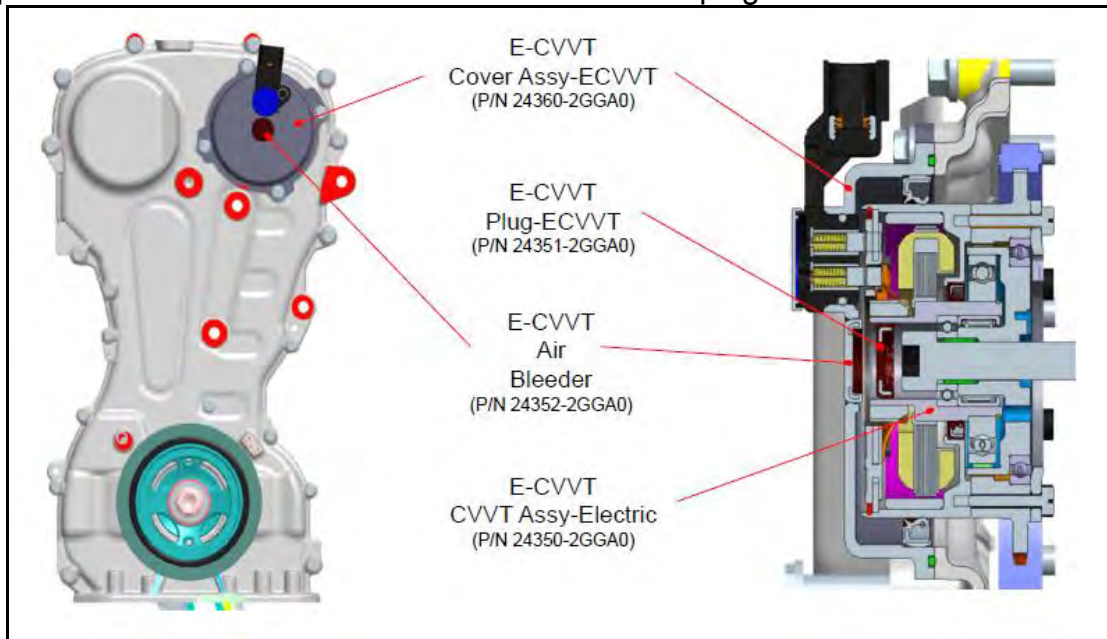
Description: On certain 2015 SONATA (LF) vehicles equipped with 2.0T and 2.4L GDI engines, the "Check Engine Light" may illuminate with DTC P0010 (Intake Camshaft Position Actuator Circuit) stored in the ECM. This condition may be due to incomplete seating of the internal oil seal plug at the intake camshaft E-CVVT (Electronic-Continuously Variable Valve Timing) actuator.

Follow the procedure outlined in this bulletin to seat the seal plug of the intake camshaft E-CVVT.
