Inside door handle jams

Topic number	LI72.00-P-061210
Version	1
Design group	72.00 General
Date	04-10-2015
Validity	MODEL 463 as of code XZ2 (YoM2012/MY2013)
Reason for change	
Reason for block

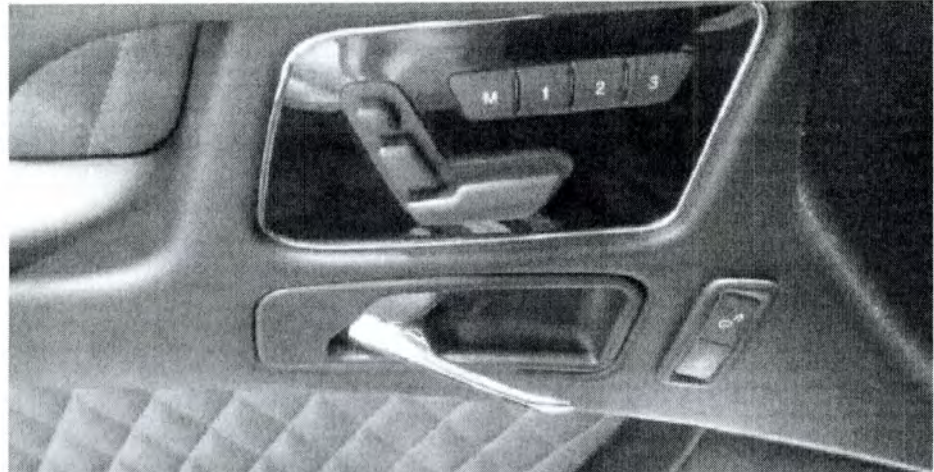
Türgriff innen.JPG:

The inside door handle jams and no longer returns automatically to its design position.

Tolerance error in door lock. The door lock may jam or the components cause interference against each other. In rare cases the return spring in the door lock is broken.

1. Check the door lock for ease of movement. If possible, establish the necessary clearances and grease the components.
2. Install new theft protection trim panel with greater clearance (see below for part number).
3. Replace the door lock if the issue persists.
