Michael A. Berardi
 Director
 Service Engineering Operations
 Ford Customer Service Division

July 8, 2015

SUBJECT: **DELIVERY HOLD - Customer Satisfaction Program 15B21 – Supplement #1**
 Certain 2015 Model Year Edge Vehicles
 A-Pillar Water Leak Inspection and Repair

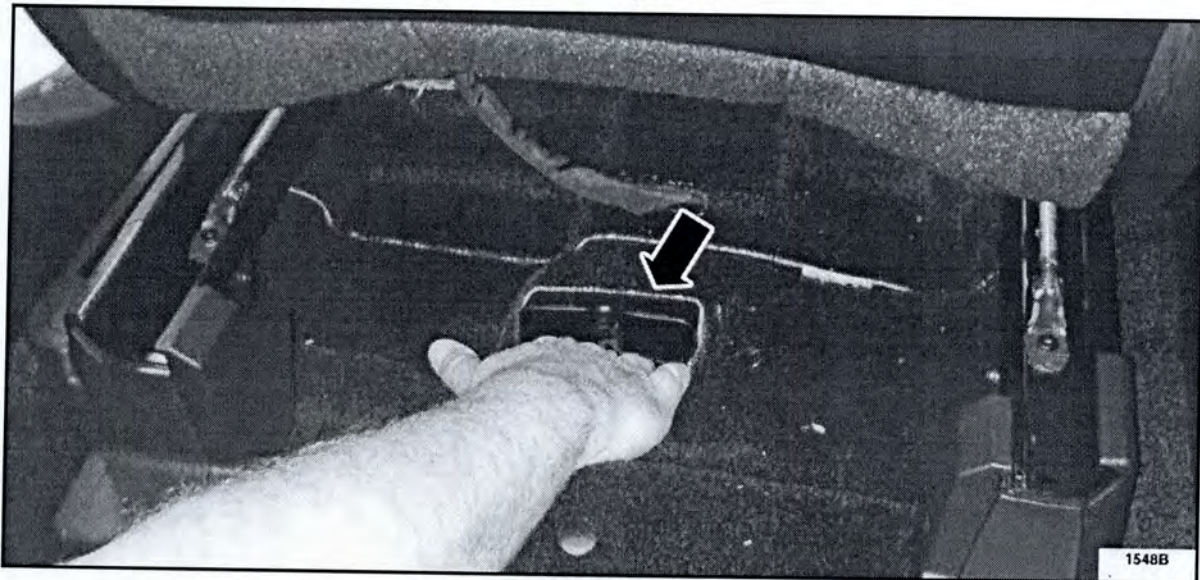
FIGURE 1

- c. Move both front seats to full forward position. From rear seat area, reach in through the holes in the carpet below the rear seat climate control ducts on the floor and feel for water or evidence of moisture on the floor pan sheet metal. See Figure 1.

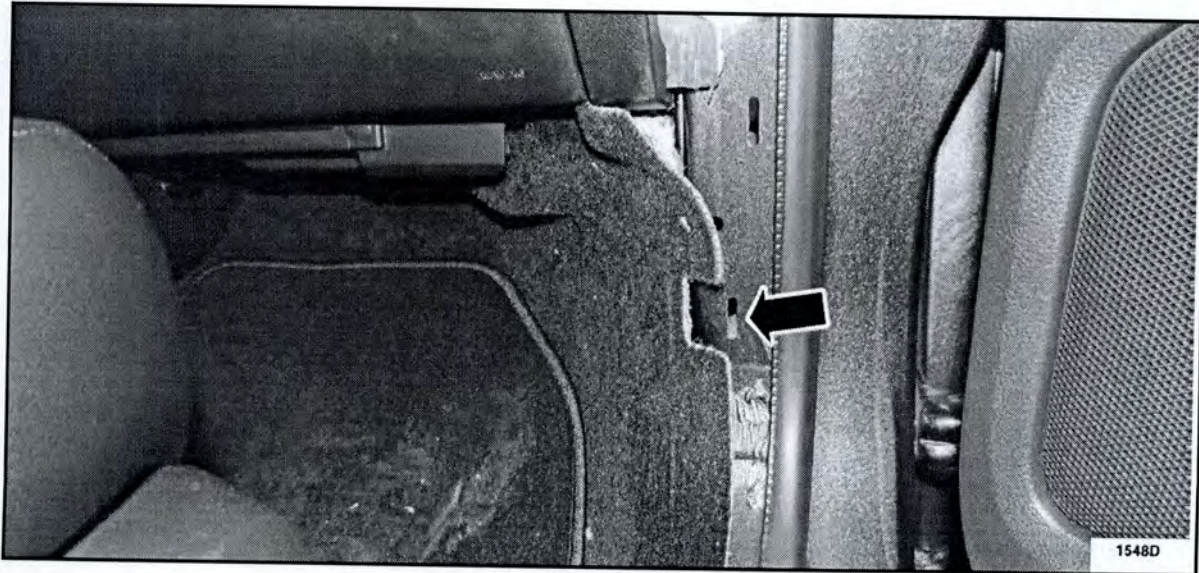
FIGURE 6

7. Using a cotton swab or a piece of paper/cardboard, check for the presence of standing water and visually check for the evidence of water/dampness in the lower A-pillar on both the LH and RH sides of the vehicle through the interior cowl trim panel lower attaching clip retainer opening. See Figure 6.
8. Pull back the carpet and padding on the floor next to the LH and RH A-pillar areas and check for water/dampness.

- **Is standing water, moisture or a mildew/musty odor present?**

YES – Proceed to Wet Vehicle Repair Procedure (Attachment V).

NO – The vehicle did not experience a water leak. Continue to Upper A-pillar Sheet Metal Seam Sealing Procedure to complete repairs.

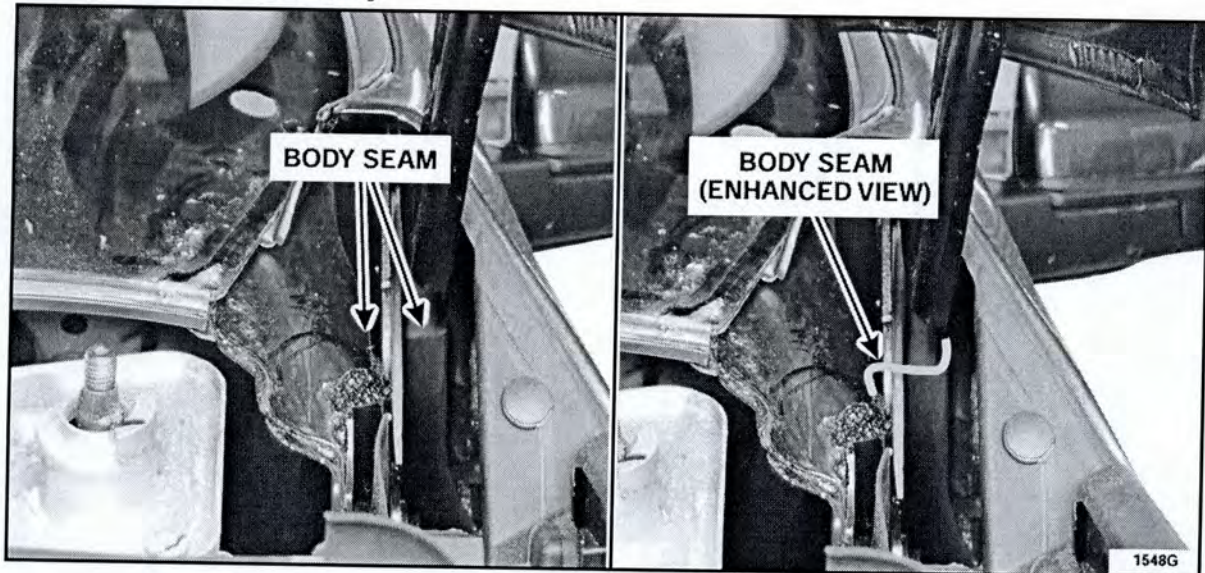
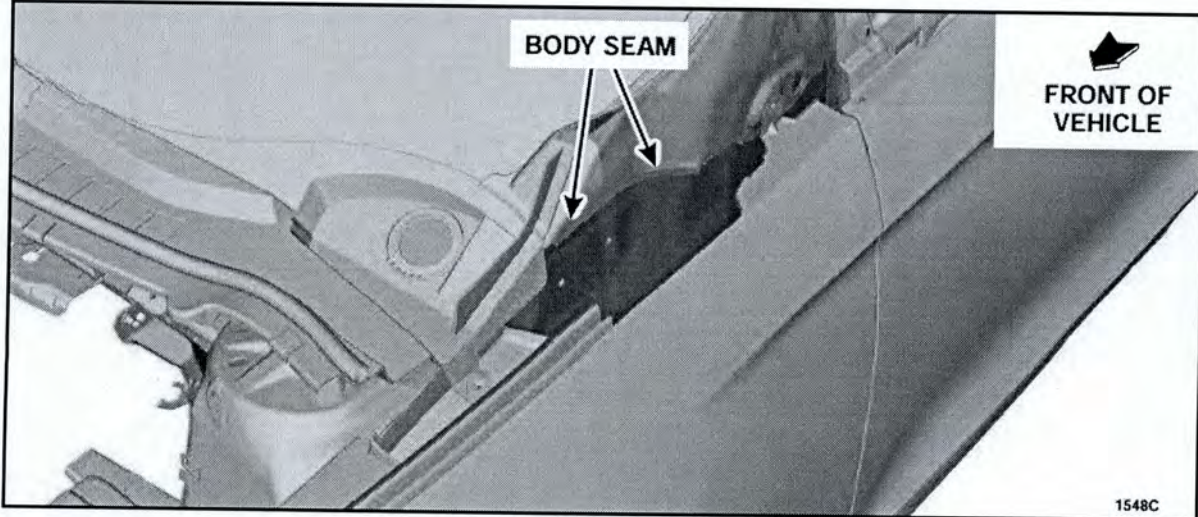
FIGURE 9

In some of the affected vehicles, water may leak into the cabin through the sheet metal joint in the A-pillar area directly behind the hood hinge on both sides of the vehicle. The water enters the cabin at the lower A-pillar areas behind the lower dash panel trim panels.

3. Open the hood and locate the body seam that runs behind the hood hinge at the base of the exterior A-pillar on both the RH and LH sides of the vehicle. See Figures 9 and 10.

4. Use a flashlight to locate the body seam that runs behind and along the side of the LH and RH hood hinges. Apply a bead of sealer to the body seam. See Figures 9, 10 and 11.
