August 20, 2015

SUBJECT: **DELIVERY HOLD - Customer Satisfaction Program 15B21 – Supplement #2**
 Certain 2015 Model Year Edge Vehicles
 A-Pillar Water Leak Inspection and Repair

CERTAIN 2015 MODEL YEAR EDGE VEHICLES — A-PILLAR WATER LEAK INSPECTION AND REPAIR PROCEDURE

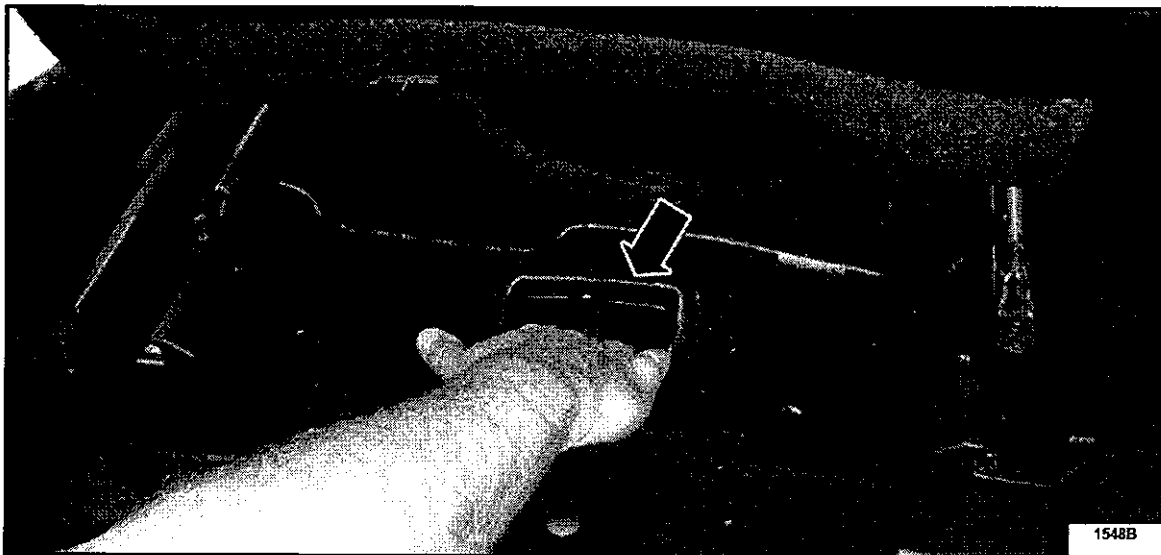
FIGURE 1

- c. Move both front seats to full forward position. From rear seat area, reach in through the holes in the carpet below the rear seat climate control ducts on the floor and feel for water or evidence of moisture on the floor pan sheet metal. See Figure 1.

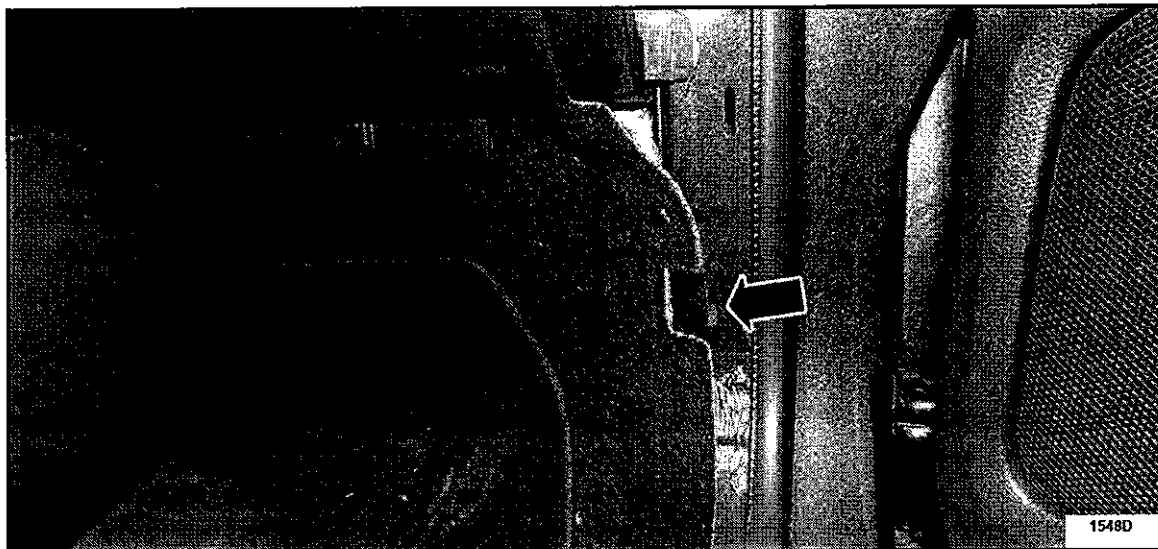
FIGURE 6

7. Using a cotton swab or a piece of paper/cardboard, check for the presence of standing water and visually check for the evidence of water/dampness in the lower A-pillar on both the LH and RH sides of the vehicle through the interior cowl trim panel lower attaching clip retainer opening. See Figure 6.
8. Pull back the carpet and padding on the floor next to the LH and RH A-pillar areas and check for water/dampness.
- **Is standing water, moisture or a mildew/musty odor present?**
 - YES** – Proceed to Wet Vehicle Repair Procedure (Attachment V).
 - NO** – The vehicle did not experience a water leak. Continue to Upper A-pillar Sheet Metal Seam Sealing Procedure to complete repairs.

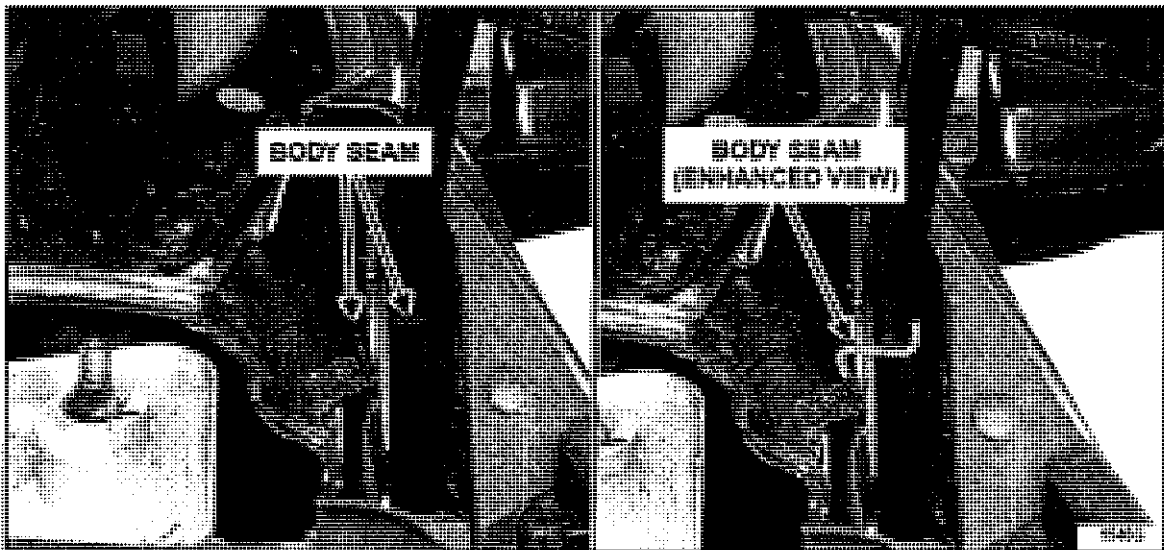
FIGURE 9

3. Open the hood and locate the body seam that runs behind the hood hinge at the base of the exterior A-pillar on both the RH and LH sides of the vehicle. See Figures 9 and 10.

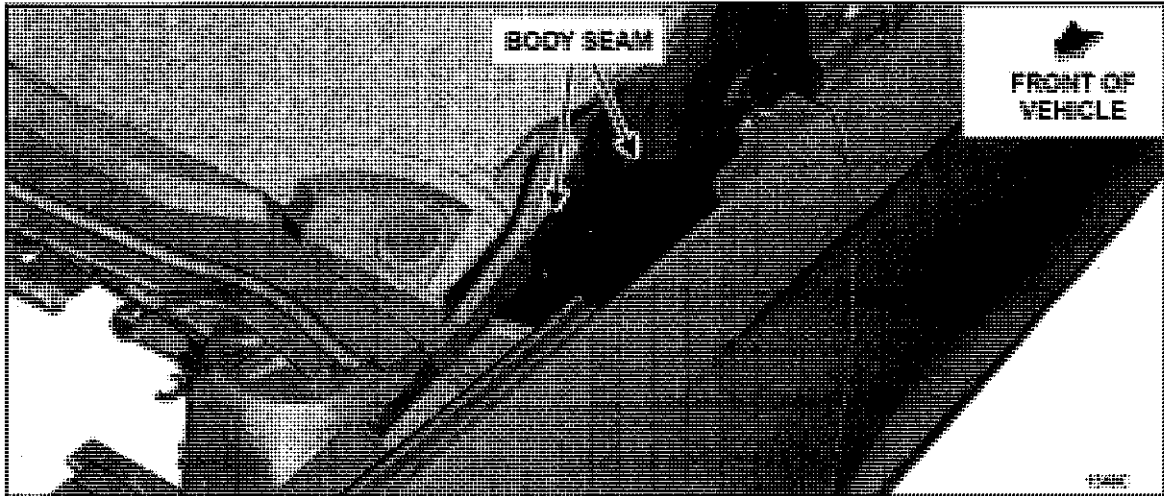
FIGURE 10

4. Use a flashlight to locate the body seam that runs behind and along the side of the LH and RH hood hinges. Apply a bead of sealer to the body seam. See Figures 9, 10 and 11.

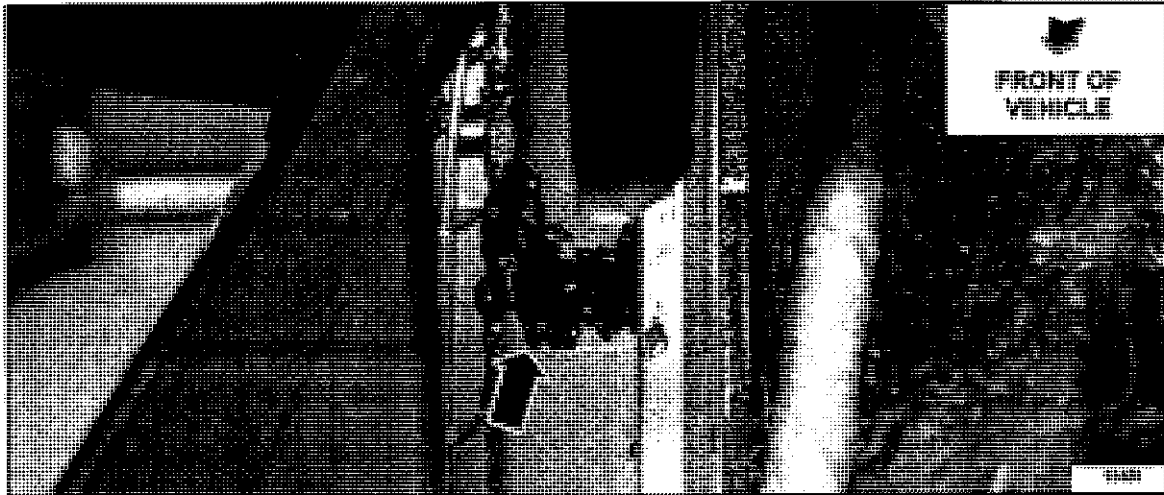
FIGURE 12

5. Carefully inspect the bead of seam sealer to ensure it completely fills the gap in the sheet metal panels. Apply additional seam sealer if required to ensure a leak free joint is attained. See Figure 12.

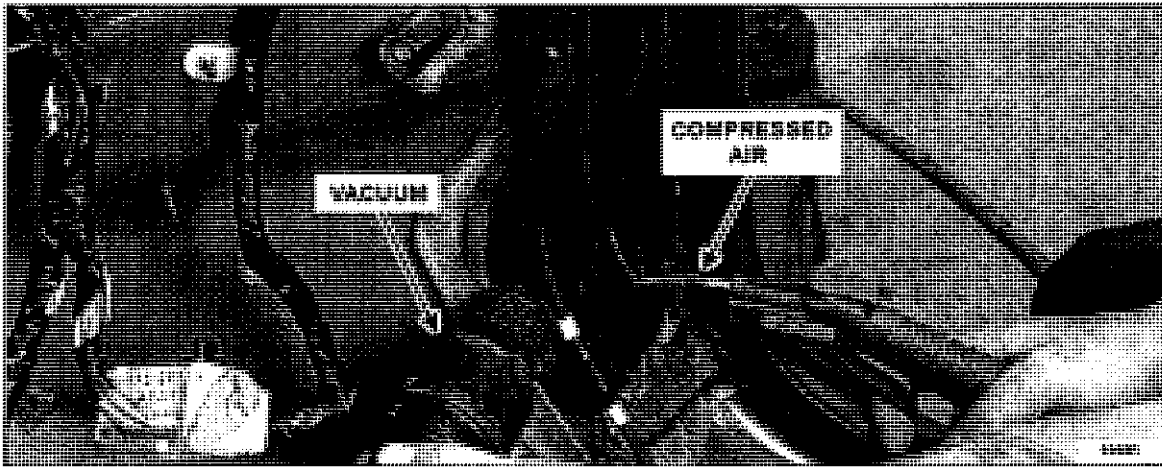
FIGURE 6

8. Using an air hose nozzle and shop vacuum, remove any residual water from the lower A-pillars as shown. See Figure 6.

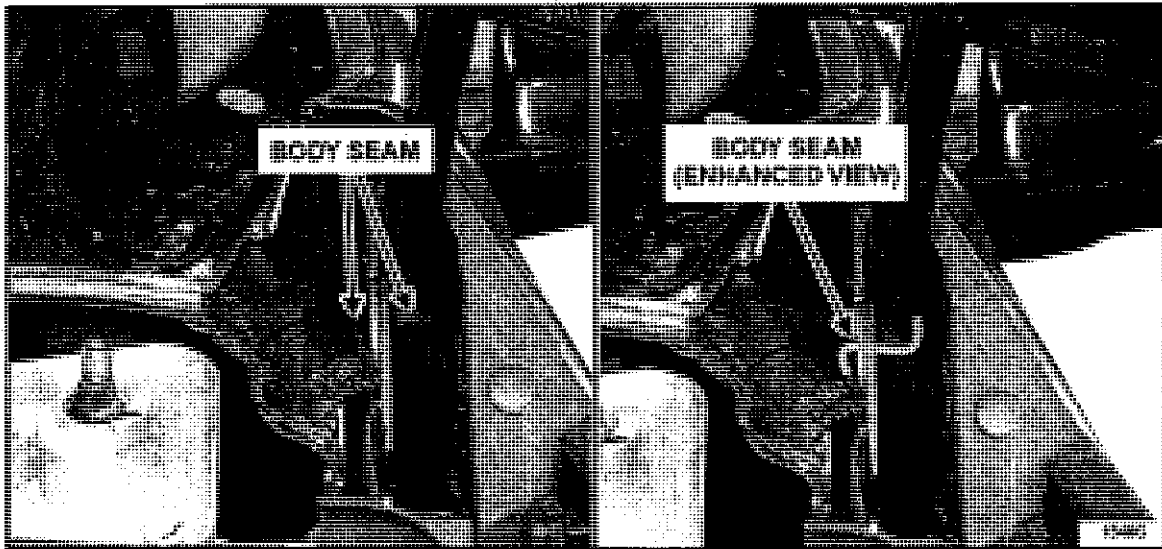
FIGURE 9

11. Open the hood and locate the body seam that runs behind the hood hinge at the base of the exterior A-pillar on both the LH and RH sides of the vehicle. See Figures 9 and 10.

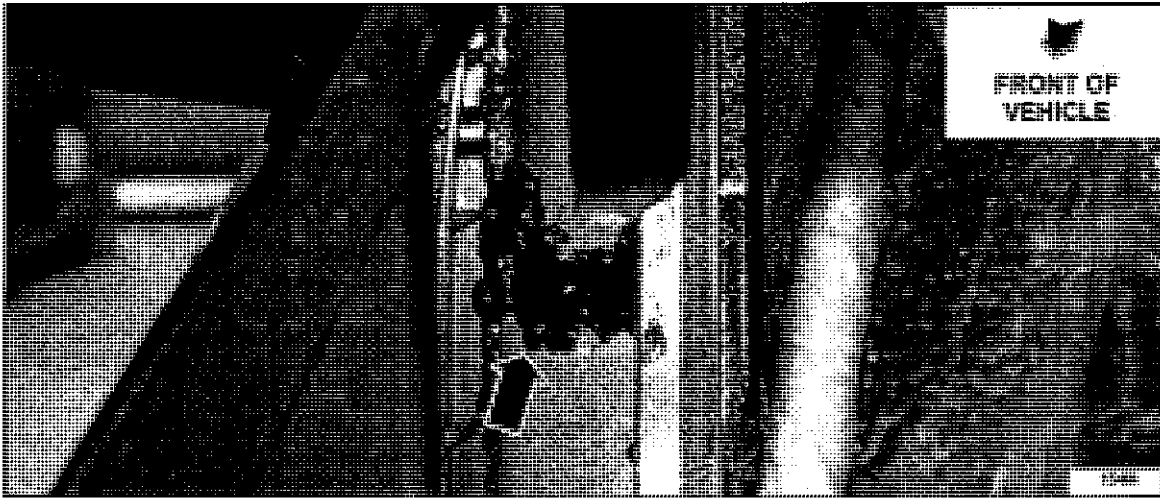
FIGURE 12

13. Carefully inspect the bead of seam sealer to ensure it completely fills the gap in the sheet metal panels. Apply additional seam sealer if required to ensure a leak free joint is attained. See Figure 12.

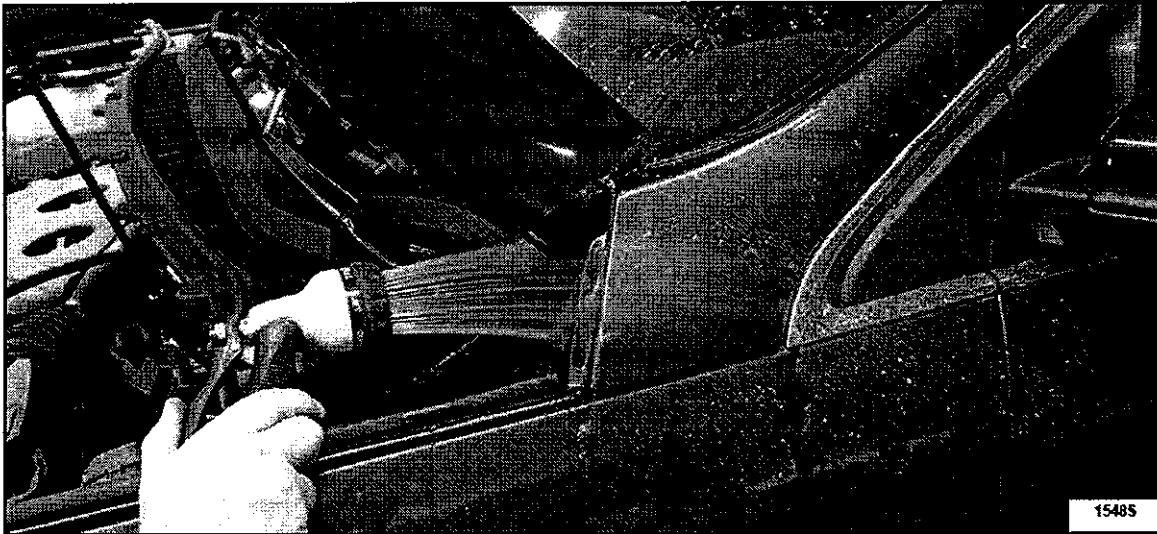
FIGURE 13

Water test the LH and RH A-pillars (See Figure 13) with gently flowing water for 5 minutes per side. **Do not** use pressurized water.

- If water is leaking into the A-pillar(s) dry with compressed air and apply additional seam sealer to repair area. Repeat step to verify repair as needed.

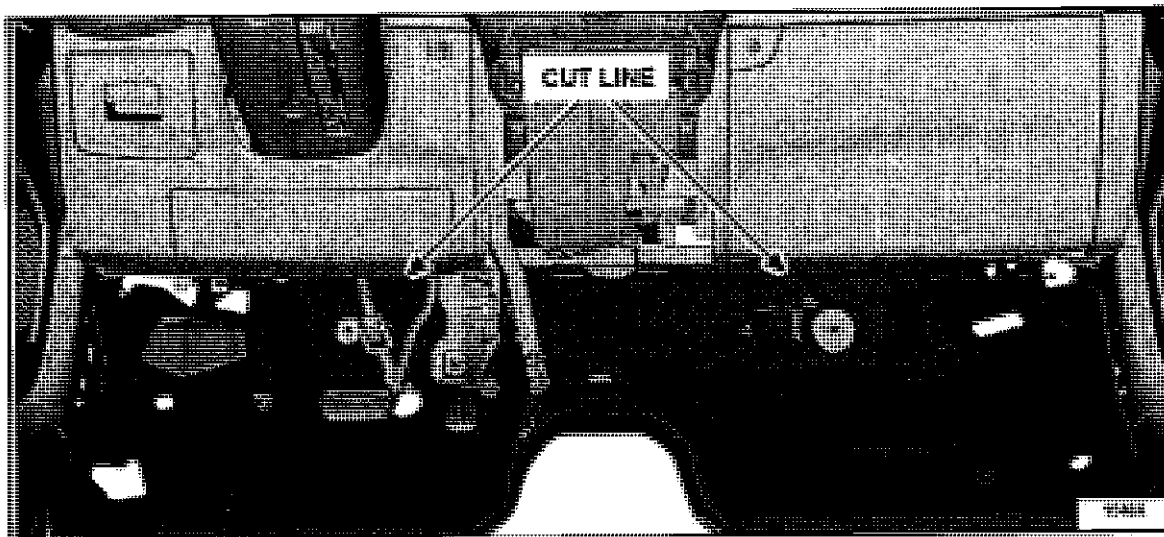
FIGURE 15

22. If possible, the affected wet portion of the instrument panel insulator pad should be cut out of the vehicle without removing the instrument panel at this time, so that the vehicle can be moved within the dealership until final repairs can be performed. Discard the removed portion of the instrument panel insulator pad. See Figure 15.

- If all affected (wet) areas of the insulator pad cannot be removed, follow WSM Section 501-12 to remove the instrument panel and completely remove and discard the instrument panel insulator pad.
