SB-10058251-1199

SUBJECT: **Regional Program 15R01 – Supplement #1**
Certain 2013-2015 Model Year Fusion and MKZ and 2015 Model Year Edge Vehicles
Not Covered Under Safety Recall 15S14
Steering Gear Motor Bolt Corrosion

REF: **Safety Recall 15S14 – Supplement #3**
Dated July 10, 2015

**CERTAIN 2013 THROUGH 2015 MODEL YEAR FUSION AND MKZ AND 2015
MODEL YEAR EDGE VEHICLES NOT COVERED UNDER SAFETY RECALL 15S14
— STEERING GEAR MOTOR BOLT CORROSION**

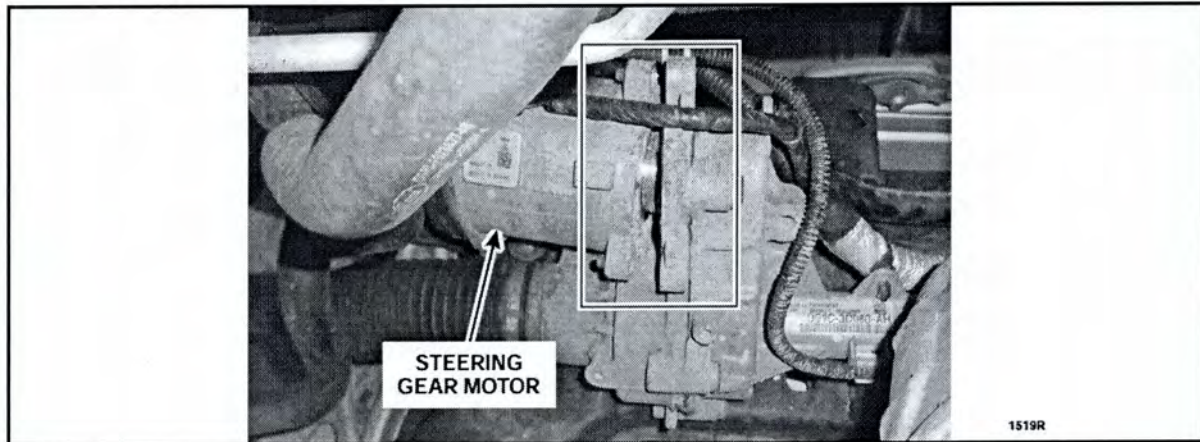
FIGURE 8

1. Inspect the steering gear motor for signs of separation, broken or missing bolts. See Figure 8.
2. Are any of the bolts broken or missing, or is a gap is present between the motor and motor housing?

Yes – replace the steering gear. Please follow the WSM procedures in Section 211-02.

No – proceed to "Replace Steering Gear Motor Bolts".
