ADAPTIVE DRIVE MALFUNCTION MESSAGE IN THE INSTRUMENT CLUSTER WITH POSSIBLE DTCS C110D AND/OR C110C - BUILT ON OR BEFORE 5/4/2015

TSB 15-0075

2013-2015 MKS, MKT

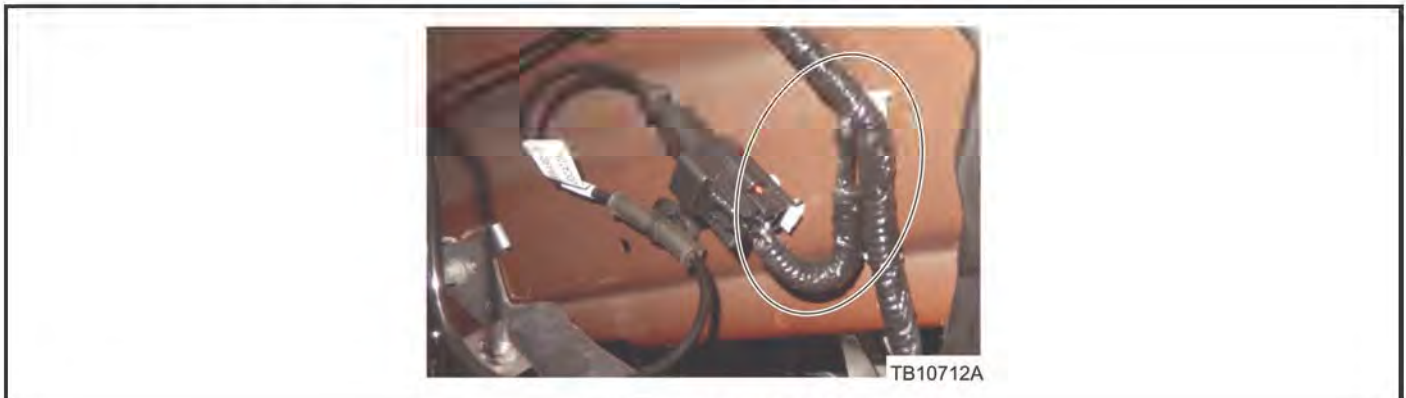
Figure 1 - Article 15-0075

1. Raise vehicle on a hoist, refer to Workshop Manual (WSM), Section 100-02.
2. Remove the front right and front left side wheel and tire per the WSM, Section 204-04.
3. Disconnect connector C1668 on the left front strut assembly and C1669 on the right front strut assembly.
4. Remove the tape and plastic convolute around the take out to connector C1668 and C1669 and the main wire harness, approximately 5.0 cm (2.0") in each direction from the take out. (Figures 1 and 2)

5. Inspect for wire damage to the main harness for any broken or exposed copper under the wire insulation.

6. Isolate any chafed/corroded wiring and replace connector (main harness 14290 side only) C1668 and C1669 with a new pigtail connector. Refer to the wiring repair kit instructions included in the pigtail kit. (Figure 1 and 2)
7. Wrap the main harness wiring 5.0 cm (2") in both directions from the take out and wrap the entire wiring of the new pigtail connectors with Coroplast™ electrical wire harness tape or equivalent. (Figure 1 and 2)
 - a. Normal electrical tape does not have the anti-abrasion properties required to protect the wiring.
8. Replace the original convolute and cover with standard electrical tape.
9. Reconnect connectors C1668 and C1669.
 - a. For MKT make sure the connector take out is routed behind the main wiring harness. (Figure 1)
10. Reinstall the right and left wheel and tire per WSM, Section 204-04.
11. Lower the vehicle.
12. Retrieve and clear any DTCs.
