Service Campaign Bulletin

SB-10058275-3454

Campaign No. 2015040005, May 2015

SUBJECT: **Model 205, Model Year 2015**
Install Spacer Ring at Coolant Line

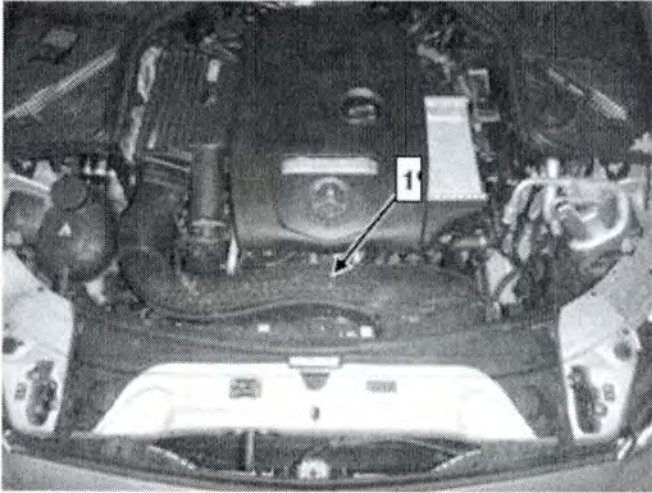
**Figure 1**

Daimler AG (DAG), the manufacturer of Mercedes-Benz vehicles, has determined that the coolant line may not correspond to the current series production configuration. The coolant line may chafe at the air intake pipe which may lead to leaks at the cooling system. To correct this condition an authorized Mercedes-Benz dealer will install a spacer ring on the coolant line at the next dealer visit.

Remove engine air intake duct (1, Figure 1) upstream of air filter.
