# Service Campaign Bulletin

Mercedes-Benz

Campaign No. 2015050003, May 2015

SUBJECT: **Model X204 (GLK), Model Year 2014**  
**Check Door Seam Seals**

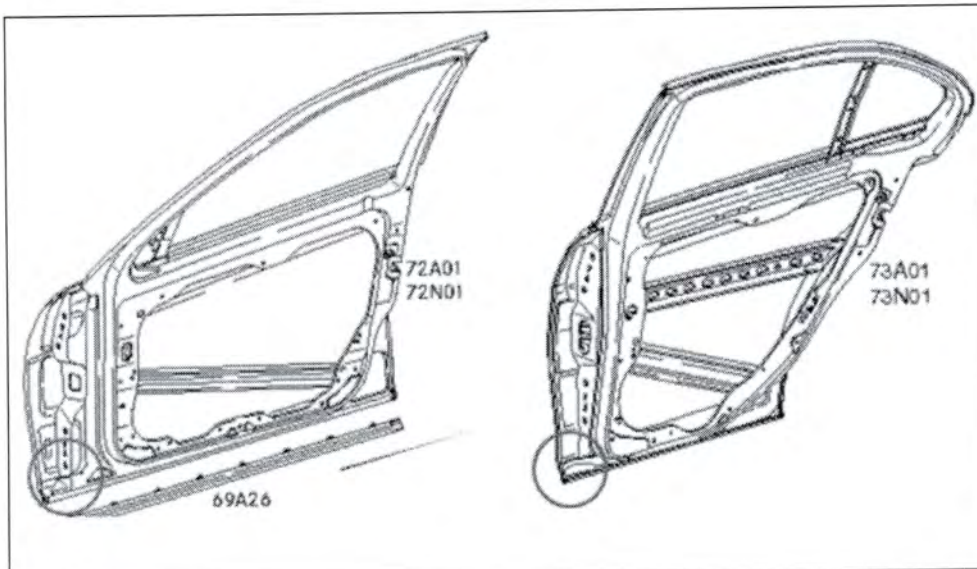
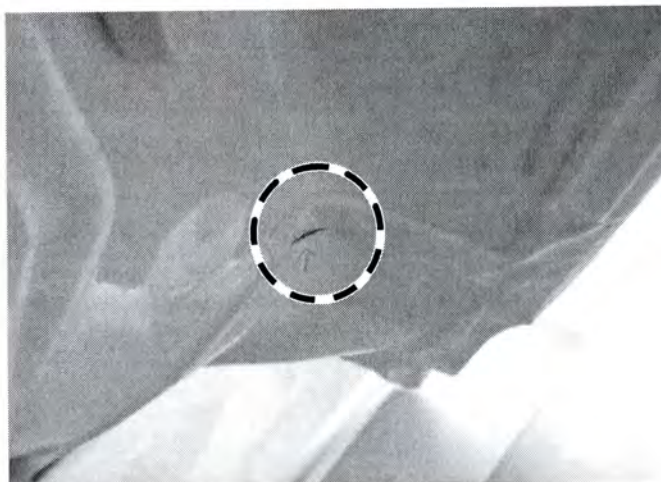
1. Check seam seal at driver, front passenger and rear doors at left and right in area of hinge reinforcement to the inner door panel (S-shape deformation) (Figures 1 and 2).
  - If seam seal is **OK**: **Procedure is complete.**
  - If seam seal is **NOT OK**: Proceed to step 2.
2. Apply transparent seam sealant in faulty area.

Be sure to clean affected area prior to applying seam sealant.
