NUMBER: 08-055-15 REV. A

SB-10058299-4218

RE2 RE3 RE6 RB4 RB5 RB6 Radio Enhancements

2011-2012	(LD)	Dodge Charger
2011-2012	(LX)	Chrysler 300
2011-2012	(JC)	Dodge Journey

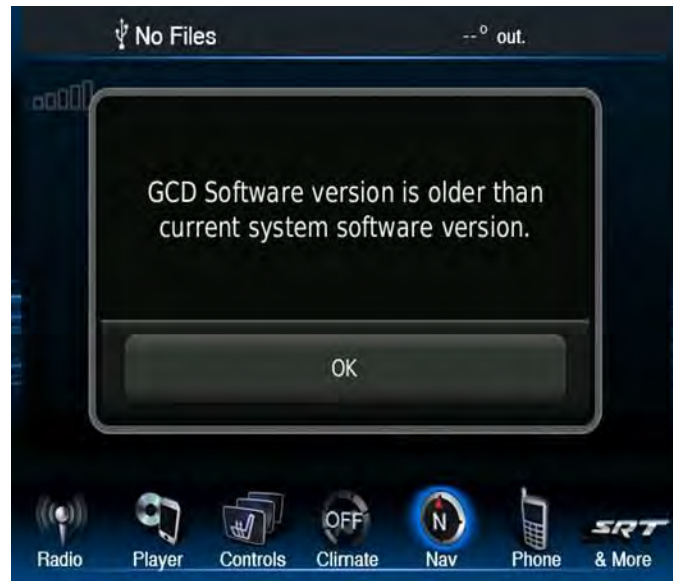
Fig. 1 Radio already has the latest software

16. Which screen does the radio display?
 - a. (Fig. 1) >>> The radio has the latest Garmin software in it, press OK and proceed to [Step #20](#).
 - b. (Fig. 2) >>> Press Yes to update the Garmin software.
17. The first step in the update is "system recover". There will be a pop up that indicates this step. This will only take a few minutes.
18. This screen will be displayed when the update is being downloaded, see (Fig. 3).

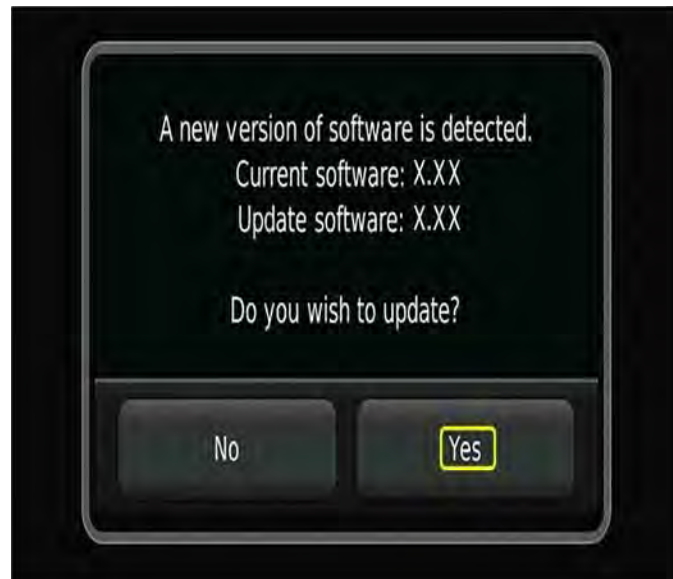
Fig. 2 Garmin software needs to be updated

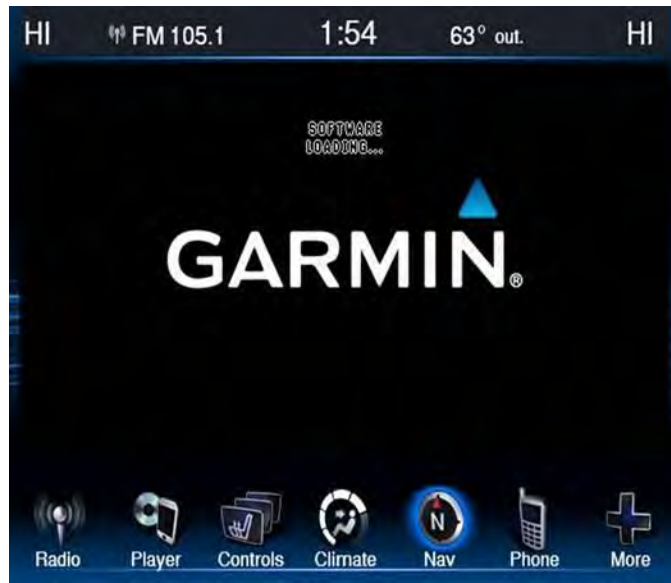
Fig. 3 This screen will be displayed next

1 - Loading software

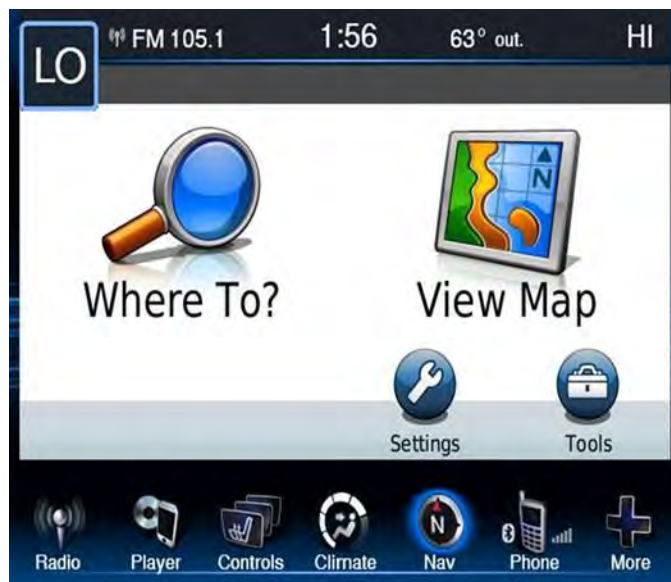
Fig. 4 Update is completed

1 - Navigation has been updated
