**Countries:** CANADA, TAIWAN, UNITED STATES, MEXICO, GUAM, KOREA, SOUTH KOREA  
**Document ID:** IK1201195  
**Availability:** ISIS, FleetISIS  
**Revision:** 6  
**Major System:** ENGINES  
**Created:** 8/21/2014  
**Current Language:** English  
**Last Modified:** 3/30/2015  
**Other Languages:** NONE  
**Author:** Erik Wass  
**Viewed:** 1315

**Title:** SPN 3216 FMI 4 NOxIN signal Out of Range LOW

**Applies To:** EPA 2014 N9 and N10 SCR Engines ESN 3540000+

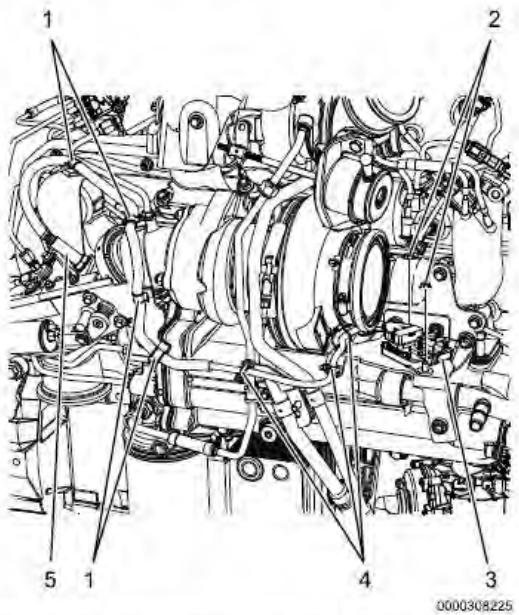
**Figure 53 NOxIn Concentration Sensor and Module**

1. Harness clipping (4)
2. M6 nut (2)
3. NOxIn Concentration Module
4. Tie straps (3)
5. NOxIn Concentration Sensor

1. Remove two NOxIn Concentration Sensor Module M8 nuts from NOxIn Concentration Sensor bracket.
2. Cut three NOxIn Concentration sensor harness tie straps.
3. Undo NOxIn Concentration sensor harness from four routing and clipping points.
4. Remove NOxIN Sensor and Module from exhaust brake under rail housing.

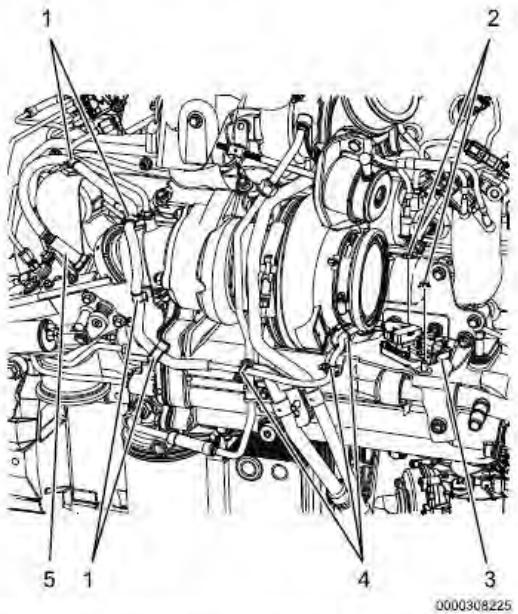
**Figure 53 NOxIN Concentration Sensor and Module**

1. Harness clipping (4)
2. M6 nut (2)
3. NOxIN Concentration Module
4. Tie straps (3)
5. NOxIN Concentration Sensor

1. Install NOxIN Concentration sensor into exhaust brake under rail housing.
2. Torque NOxIN Concentration sensor to 50 N·m (37 lb·ft).
3. Route NOxIN Concentration module harness through four routing and clipping points.
4. Install three new tie straps onto NOxIN Concentration module harness.
5. Install NOxIN Concentration module onto NOxIN Concentration module support.
6. Install two NOxIN Concentration module M6 nuts onto NOxIN Concentration module support and torque nuts to 10 N·m (7 lb·ft).
