SB-10058325-1132

FORD:

2013-2014 C-MAX

Technical Service Bulletin Title: 2013-2014 C-MAX – Discharged 12 Volt Battery

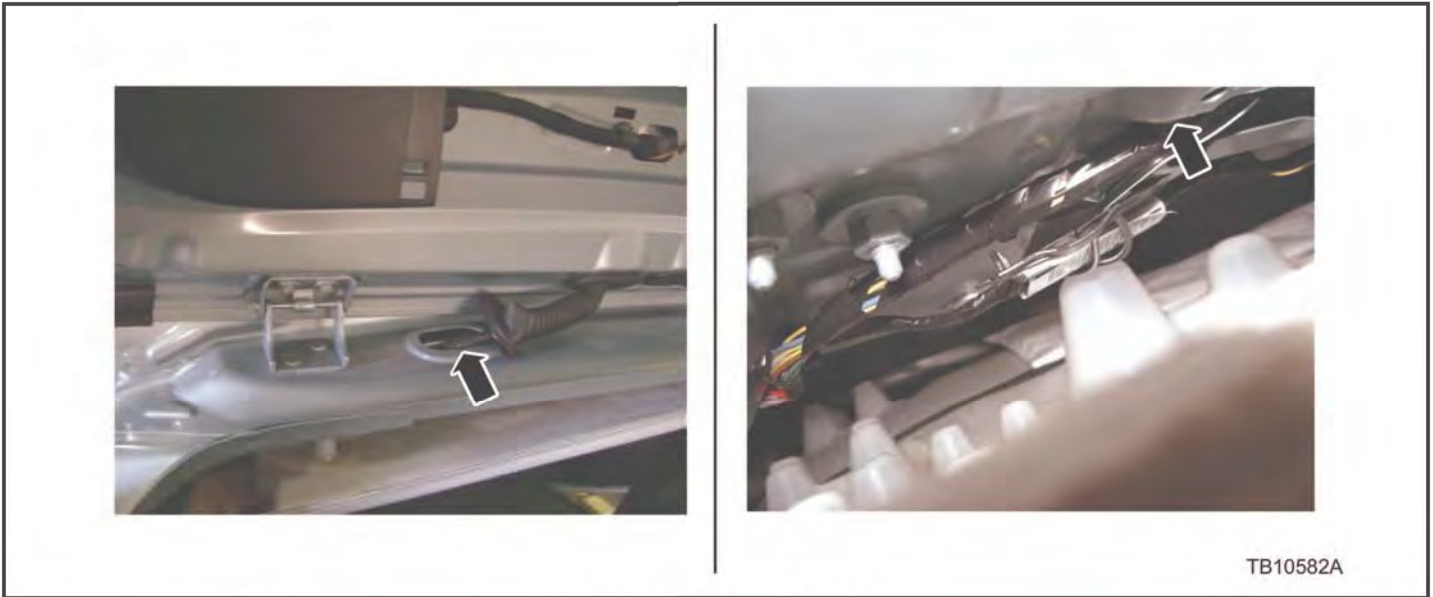
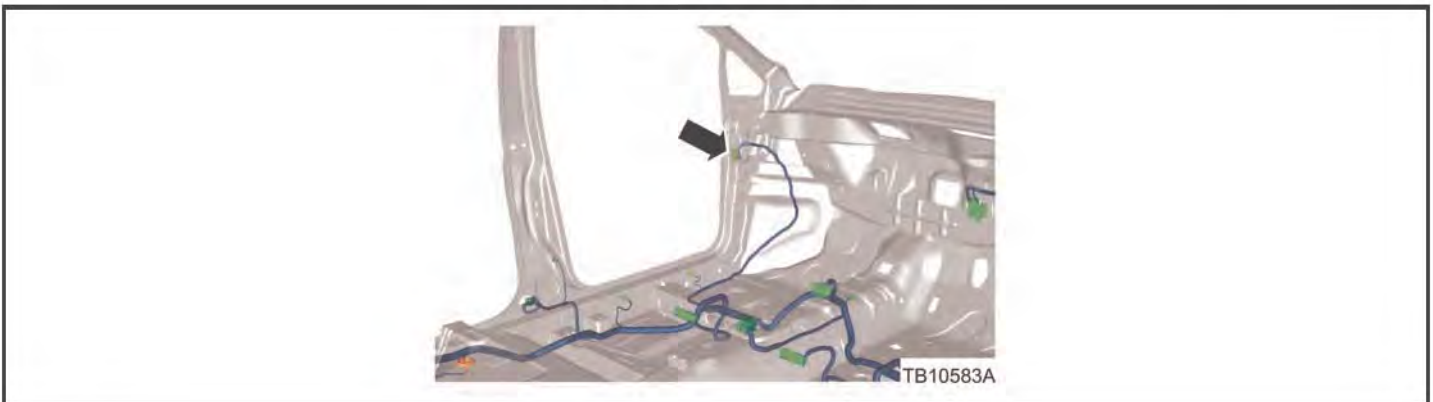
5. Was the vehicle built on or before 9/12/2013?
 - a. Yes - replace the telematics control unit (TCU) module. Refer to WSM, Section 415-00. Proceed to Step 6.
 - b. No - proceed to Step 6.
6. Was the vehicle built on or before 6/3/2013?
 - a. Yes - proceed to Step 7.
 - b. No - proceed to Step 8.
7. Inspect the wiring for damage or chafing in the rear liftgate area, driver door connector wire harness C339, and front passenger door connector wire harness C340 (Figures 1, 2, 3 and 4). Is damage or chafing present?

- a. Yes - repair the circuits as needed. Refer to Wiring Diagram (WD), Section 5-1. After repair, wrap the affected area with 3M™ Temflex™ Cotton Friction Tape or equivalent to prevent future concerns. Proceed to Step 8.
 - b. No - wrap affected area with 3M™ Temflex™ Cotton Friction Tape or equivalent to prevent future concerns. Proceed to Step 8.
8. Print the information sheet and provide to the customer. Communicate to the customer that Ford recommends disconnecting any devices attached to the auxiliary power port, USB port and OBDII port when the vehicle is turned off (such as cell phone chargers, USB devices, insurance company snapshot devices). (Figure 5)
