# 2013 OBD/GHG14, 6-Gallon DEF Header Suction Line Connection Broken by Ice Pressure

# 49-16

Western Star  
Service Bulletin

## SB-10058360-5473

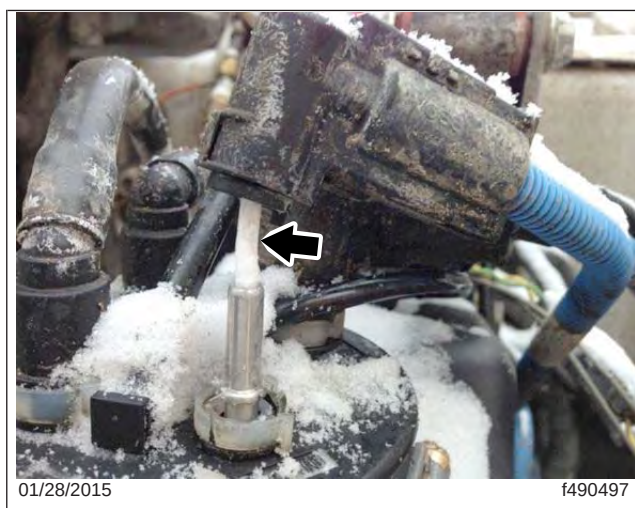
Under certain extreme cold ambient conditions, with the vehicle parked and shut off for an extended period, as the DEF freezes, ice expansion can break the DEF line fitting connected to the suction port of a 2013 OBD / GHG14 6-gallon DEF header. See [Fig. 1](#). For vehicles that are typically exposed to these kinds of conditions and have had the occurrence, a different suction stand pipe and DEF line design can be retrofitted using kit part number Z04-32079-000.

Fig. 1, Ice Expansion at the DEF Line Fitting

Replacing the suction stand pipe involves removing the header from the tank, disassembling the header and reassembling it with the new suction stand pipe that has smaller diameter and a larger fitting. With the larger fitting on the stand pipe, a different DEF line is required to connect to it.

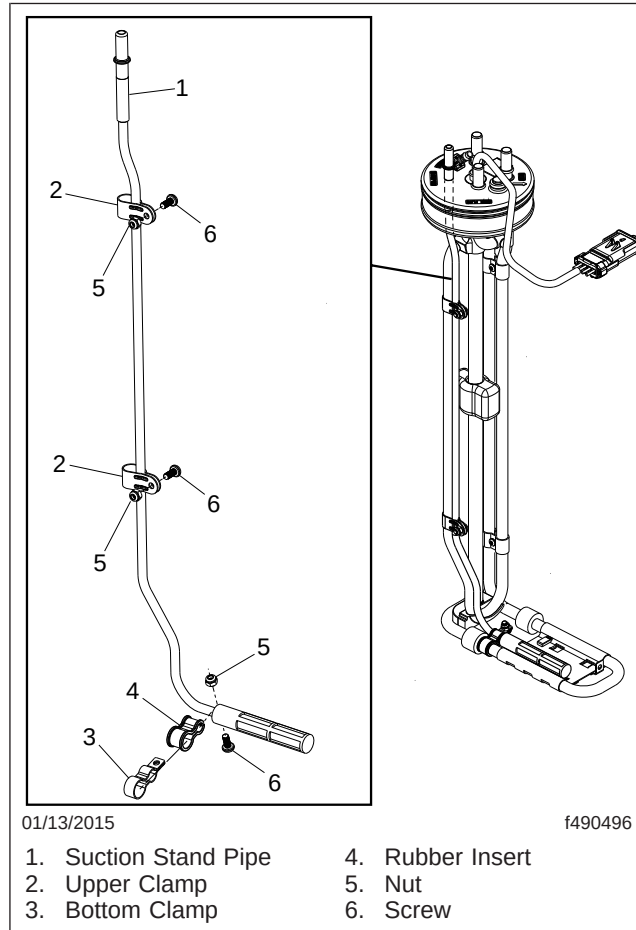
Fig. 2, WEMA Six Gallon DEF Tank Header Assembly

1. Park the vehicle on a level surface, shut down the engine, and set the parking brakes. Chock the tires.
2. Disconnect the batteries.
3. Using line clamp pliers, clamp the DEF tank coolant hoses.
4. Place a collection container under the DEF tank.
5. Disconnect the coolant hoses and plug them.
6. Disconnect the DEF lines.
7. Disconnect the harness connectors from the DEF level sensor.
8. If necessary, remove the DEF tank from the vehicle.
  - 8.1 Cut the zip ties holding chassis electrical harness to blue DEF lines on side of tank.
  - 8.2 Disconnect the DEF lines from the DEF tank header.
  - 8.3 Disconnect coolant supply lines from the DEF tank header.
  - 8.4 Remove two DEF tank mounting bolts, then remove DEF tank from truck.

- 11.4 Install the new suction stand pipe into the rubber head from the bottom. Make sure it is properly positioned.
- 11.5 Install the new bottom clamp with the rubber insert directly behind the filter.
- 11.6 Install the new clamps at the two upper locations as shown in [Fig. 2](#).
- 11.7 Tighten the clamp fasteners 25 to 29 lbf·in (280 to 360 N·cm).
- 11.8 Verify that the stand pipe sticks out of the top of the head enough to connect the DEF line fitting.
- 11.9 Verify that the DEF level float can travel freely for the entire length of the sensor tube.
