# MIL "ON" DTC P0A0F, P3190, P3191, P0171 Due to Purge VSV Vacuum Line Separation

## SB-10058403-8857

YEAR(S)	MODEL(S)	ADDITIONAL INFORMATION
2011 – 2013	CT200H

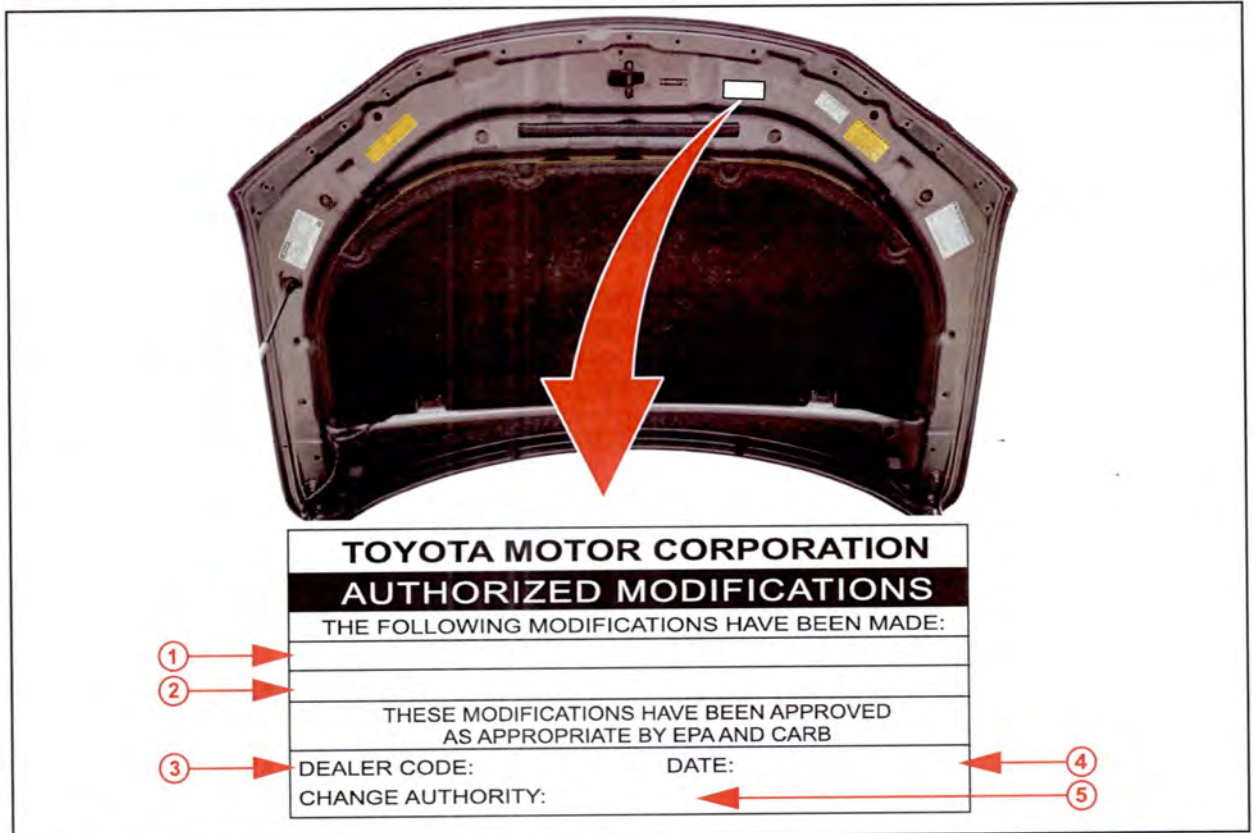
Figure 1. Location of Authorized Modifications Label on 2011 – 2013 CT 200h

2. Check for the Authorized Modifications Label affixed to the vehicle in the location shown in Figure 1. Confirm if the ECM (PCM) calibration has been updated. If the calibration ID listed is NOT the latest ECM (PCM) calibration — go to step 3.

4. Install the Authorized Modifications Label.
  - A. Using a permanent marker, enter the following information on the label:
    - ECM part number [*Refer to the **Parts Information** section for the **NEW PART NUMBER***]
    - Calibration ID(s) [*Refer to the **Calibration Information** section for the **NEW CALIBRATION ID***]
    - Dealer Code
    - Repair Date
    - Change Authority [***This bulletin number***]
  - B. Affix the Authorized Modifications Label to the vehicle at the location shown in Figure 1. The Authorized Modifications Label is available through the MDC, P/N 00451-00001-LBL.
5. Test drive the vehicle to confirm proper vehicle operation.
