SI B61 10 15
General Electrical Systems

SB-10058426-3128

i8: Retrofitting High-Voltage Battery Ground Cables

I12 (i8)

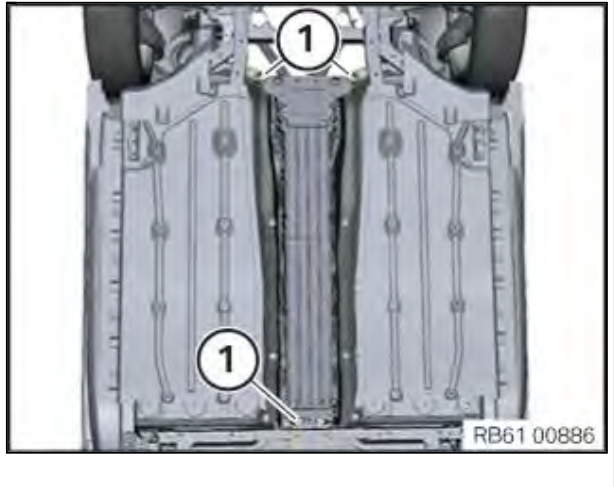
After HV battery (or front axle support) removal and reassembly, HV battery grounding points contact resistance (on both axles) may increase. As a result, the HV battery housing grounding path (resistance value) will be incorrect.

<p>If work was performed on the vehicle which made it necessary to loosen the M10 x 40 mm screw connections between the HV battery and front/rear axle carries (1), follow the procedure steps below.</p>
--	---

1. Inspect whether the additional ground cables are already fitted between the HV battery housing and the front/rear axle carries. If the cables are not found, retrofit both ground cables using the repair instructions below:

2. If the additional ground cables were already installed, clean the corresponding contact surfaces on the HV battery and front/rear axles, following appropriate precautions:

On all contact surfaces, sand the oxidized coating using a fine sandpaper (P500 or finer) with a planar sanding block.

Do not touch the contact surfaces after they have been sanded, and do not use any cleaning agents. Using cleaning agents (e.g., brake cleaner) may promote the formation of oxide coating.

To prevent oxidation of the surfaces, the M10 x 40mm screw connection for the grounding cables must be established within 10 minutes after sanding.
