FIELD SERVICE CAMPAIGN – 15108

15 July 2015

WorkStar® Radiator Inlet Hose

WorkStar®

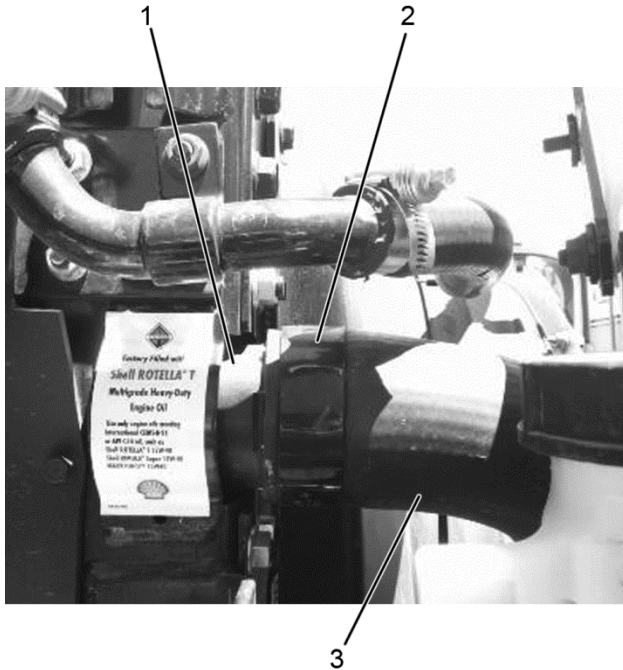
Figure 1. Radiator Inlet Hose.

The radiator inlet hose may separate from the radiator inlet resulting in coolant loss and illuminating amber or red engine diagnostic lamps.

1. Radiator inlet
 2. Hose clamp
 3. Radiator inlet hose
-
6. Use tool ZTSE4479 to remove hose clamp (Figure 1, Item 2) from radiator inlet hose (Figure 1, Item 3) at radiator inlet (Figure 1, Item 1).
 7. Tighten radiator surge tank cap.
 8. Install new clamp in place of previously removed clamp. Tighten clamp to 64 lb-in (7.3 N.m).
 9. Close and latch hood.
 10. Remove wheel chocks.
