**SB-10058488-4298**

SI B65 02 15  
Audio, Navigation, Monitors, Alarms, SRSJune 2015  
Technical Service

**SUBJECT****iDrive Controller Trim Peeling****MODEL****NEW** E70 (X5)**NEW** E71 (X6)**NEW** E72 (ActiveHybrid X6)

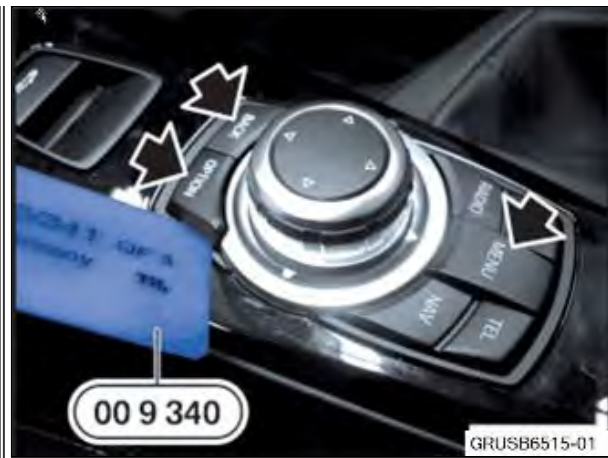
The chrome ring on the iDrive controller is peeling.

Poor chrome material adhesion

1. Carefully pry up the "OPTION," "BACK," and "MENU" buttons with special tool 00 9 340.
