This Service Information bulletin supersedes SI B12 18 14 **dated October 2014**.

Engine Misfire Due to Failed Ignition Coil

With the N51, N52, N52K, and N52T engines

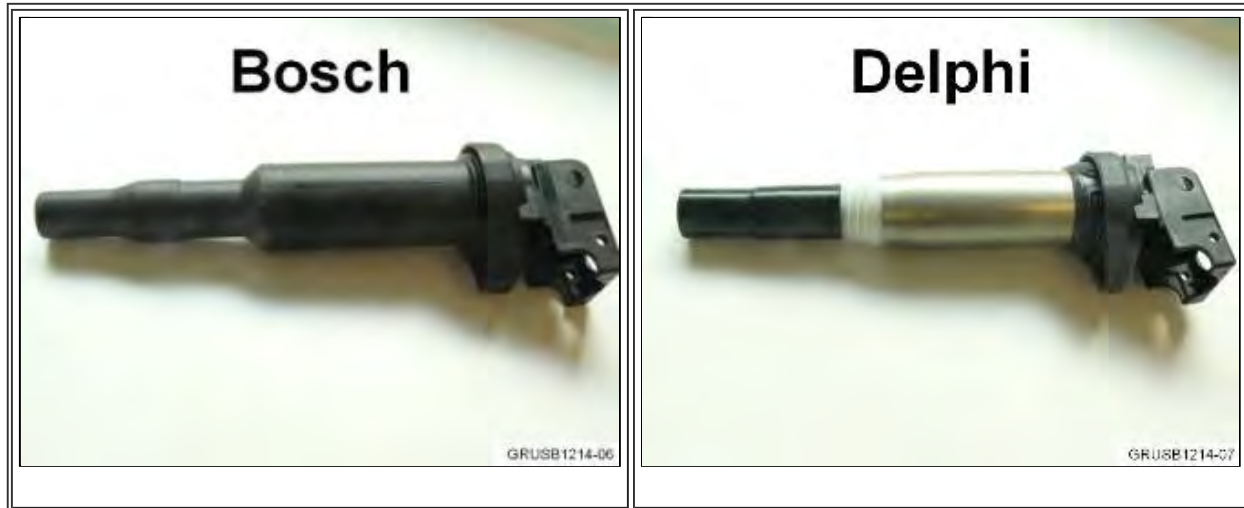
Ignition Coil Identification

During operation with high temperature fluctuations, the different materials used in the Bosch ignition coil construction can deteriorate over time, leading to a failure.

1. **NEW** For vehicles with the **N51, N52, and N52K** engines which have been in service for over 24 months or 10,000 miles: during the first service visit due to an ignition coil failure, replace **all Bosch** ignition coils with **Delphi** coils as indicated in ETK (March 2015).

NEW If any ignition coil(s) was replaced previously with a **Delphi** part, it does **NOT** need to be replaced.

2. For the F10 and F25 with the **N52T** engine, replace **all Bosch** ignition coils with the replacement **Delphi** coils under these situations:
