SI B26 01 14  
Driveshaft

March 2015  
Technical Service

**Service Action: Inspect Front Driveshaft**

E70 (X5)

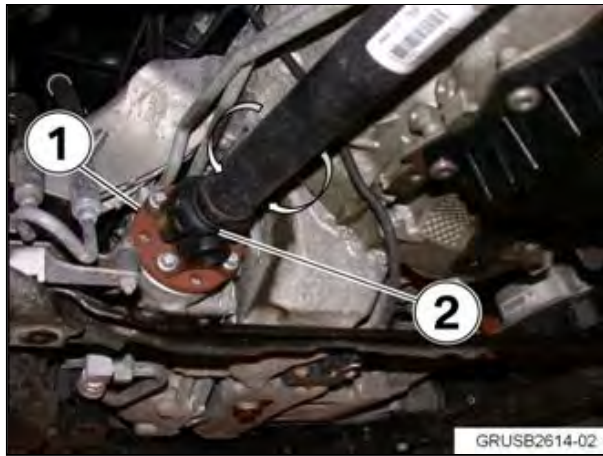
<p>Check the universal joints in the front driveshaft for radial play (1). Note: The E72 will need to have the reinforcement plate removed to check the driveshaft U-joints. Refer to Repair Instruction 31 10 010, "Removing and installing/replacing reinforcement plate."</p>
	<p>1. Checking the front U-joint:</p>

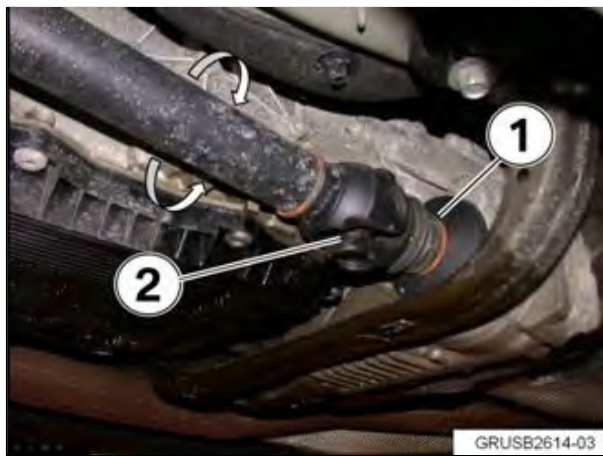
Hold the input flange (1) on the front differential and check for radial play in the U-joint (2).  
**NEW** There should be no play.

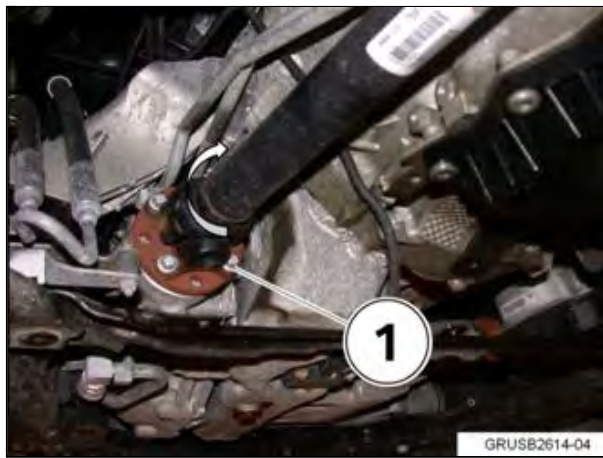
Hold the output flange (1) on the transfer case and check for radial play in the U-joint (2). **NEW**  
 There should be no play.

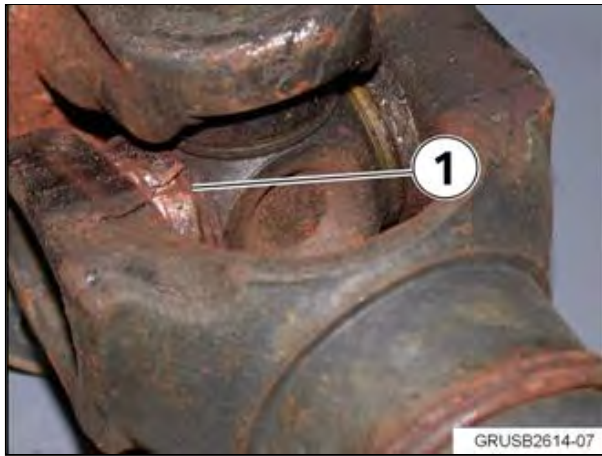
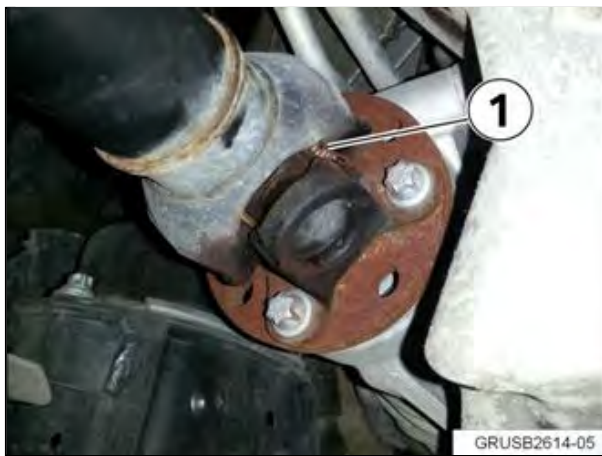
1. There should be no cracking or damage at the bearing seals (1).

If any of the above conditions are present, replace the driveshaft. Refer to Repair Instruction 26 20 000, "Removing and installing front propeller shaft as of 4/2010."

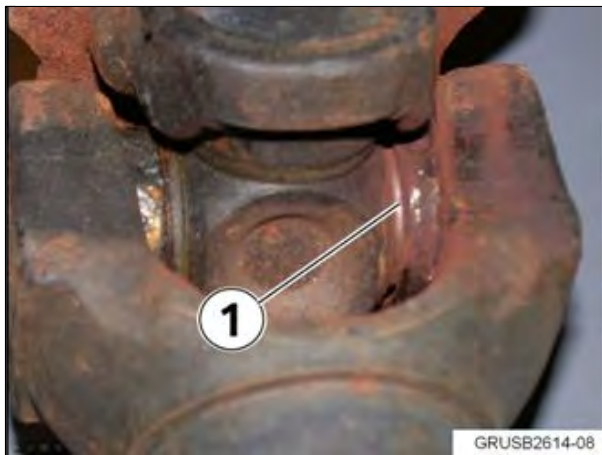
- 
2. There should be no exposed needle bearings (1).

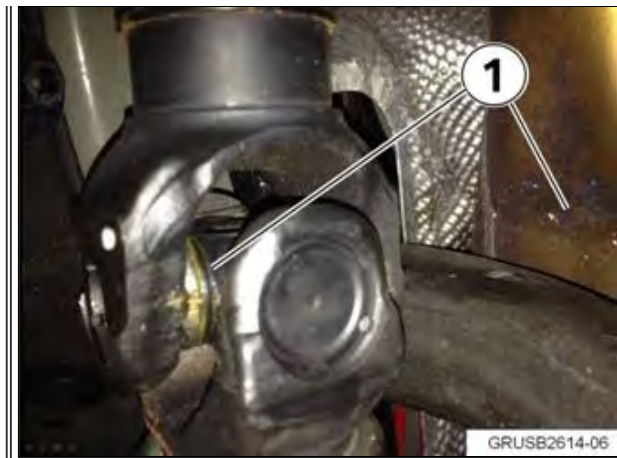
- 
- 
- 
4. Also check for excessive grease marks on the surfaces of surrounding components around the U-joints and for excessive grease released out of the bearing seals (1).
