**SUBJECT****Various Check Control Messages Caused by Shorted K-CAN****MODEL**

F22 (2 Series Coupe)

F32 (4 Series Coupe)

F34 (3 Series Gran Turismo)

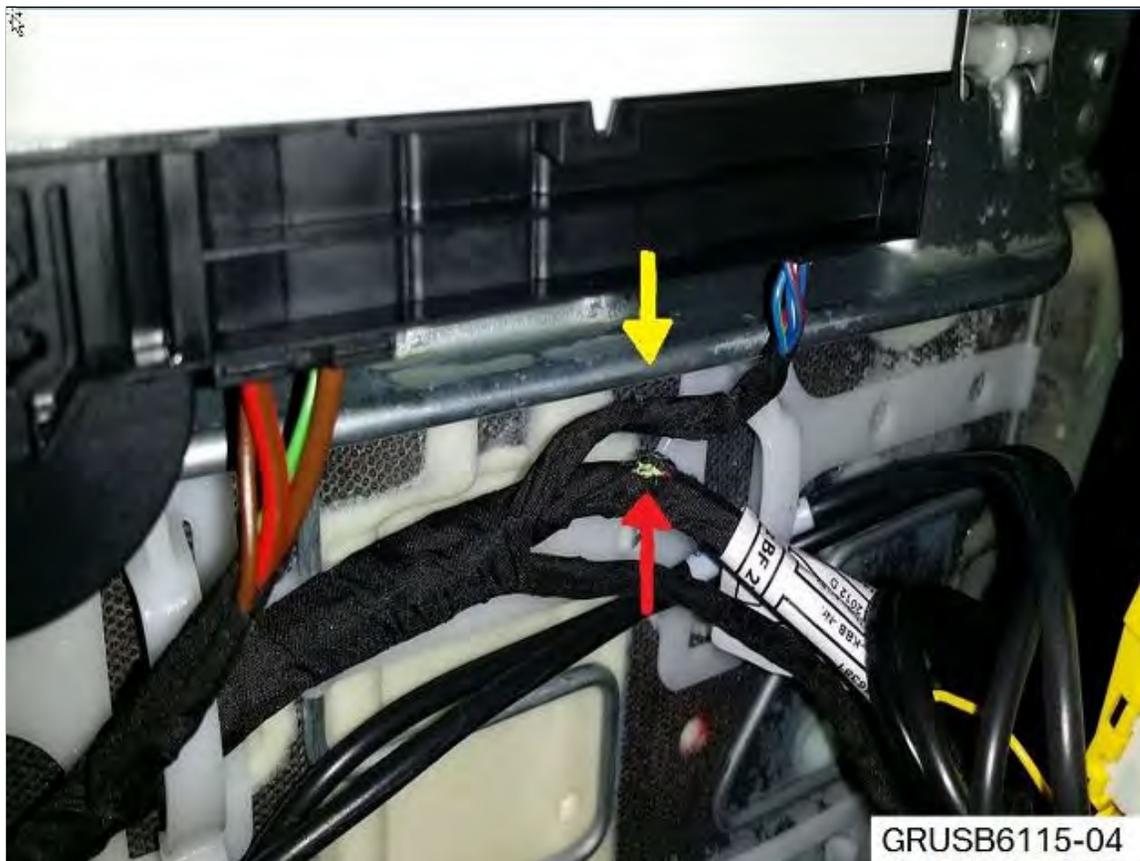
Shorted KCAN wiring under driver or passenger seat

1. Perform a vehicle test with ISTA. Identify if any CAN-related faults are shown, as listed above.
2. First look at the wiring harness under the seat bottom for areas where it rubs against the seat frame, as seen below.

3. Repair the wiring harness as needed.
4. Secure the harness away from the seat frame.
