# Technical BULLETIN

5-9-15

## CERTAIN 2015 FJ09F MODELS

### Excessive Clearance Between Side Case Stays and Rear Frame

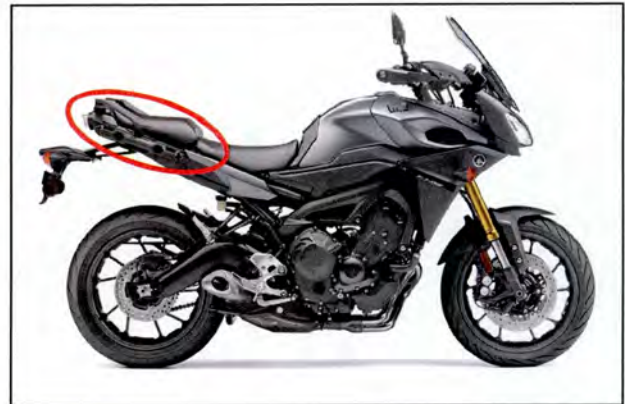
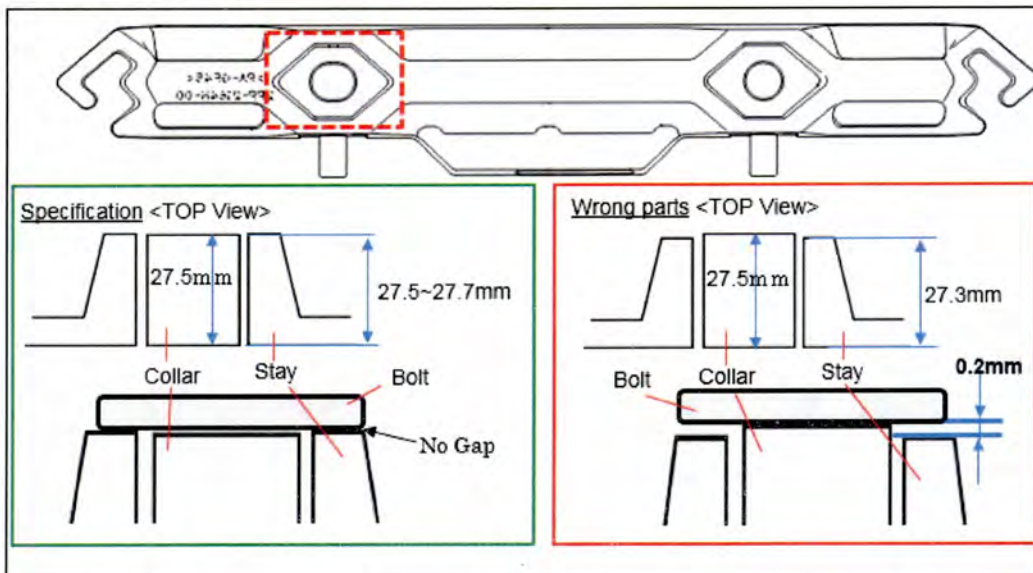
**Problem:** On a small number of units, a rattling noise may be heard from the area where the stays and rear frame are bolted together.

**Cause:** There is excessive clearance between the left and right side case stays and the rear frame due to the mounting boss on the side case stay being molded approximately 0.2mm thinner than specification. On these units, when the collar is inserted and the bolt tightened to specification, the collar will bottom before contacting the side case stay.

**Remedy:** On units that fall within the affected range, replace the left and right side case stays (Stay 3 / Stay 4) with new parts (see the Parts Information section for more details).
