# Technical BULLETIN

5-9-15

## ALL 2015 YZF-R1MF(C) MODELS CCU Reprogramming/Battery Discharge

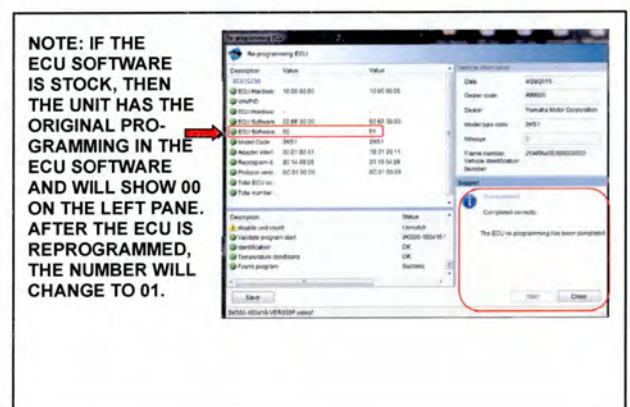
6. Wait for the ECU reprogramming process to complete. Do not disconnect the cables or start any other applications on the computer. Reprogramming may take several minutes. It is normal to see errors or codes displayed on the meter during the reprogramming process.
7. When reprogramming is complete, YDT will display a message showing that reprogramming has been completed correctly. Click "Close" and exit the reprogramming section of YDT.

8. Enter the malfunction feature of YDT and clear any codes that may have been stored as a result of reprogramming. Now, exit the application and disconnect YDT from the unit.
