**NUMBER:** 18-021-15 REV. A**GROUP:** Vehicle Performance**DATE:** May 27, 2015

Flash: 3.0L Powertrain Diagnostic And System Enhancements

2014 (DS) RAM 1500 Pickup

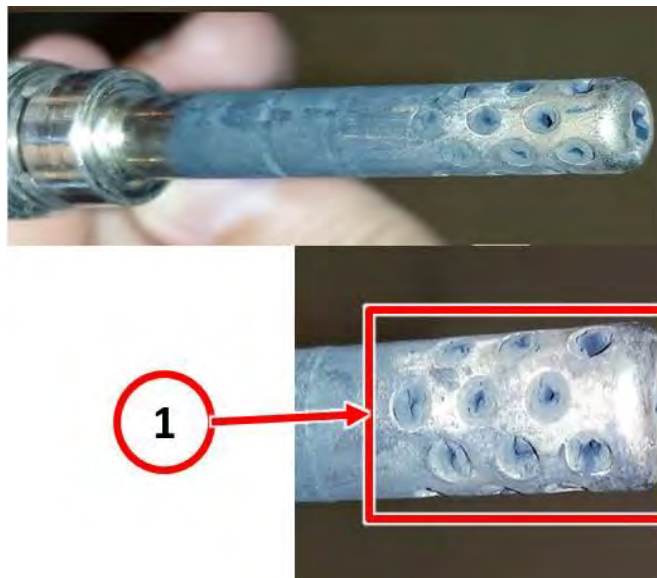
Fig. 1 EGT Sensor Bank 1 Sensor 1

1 - Excessive soot blocking sensor ports

-
12. Was excessive soot found on the sensor?
 - a. Yes>>> Proceed to [Step #13](#).
 - b. No>>> Proceed to [Step #14](#).
 13. Using shop air set to a maximum of 80 psi, clean all excessive soot from the sensor probe.
