# SB-10058534-6970

GROUP Engine	MODEL All Models w/3.3L GDI Engine
	NUMBER PS417	DATE July 2015

SUBJECT: DTC P0315 - CRANKSHAFT POSITION (CKP) SENSOR VARIATION NOT LEARNED

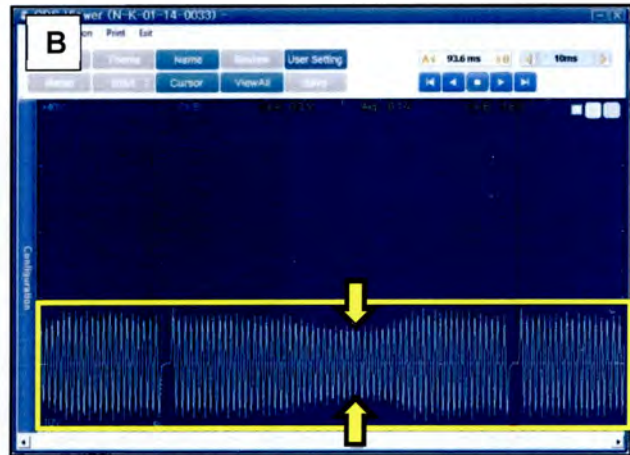
When encountering a customer complaint of engine misfire with a Malfunction Indicator Light (MIL) on in the dash, check for the presence of DTC P0315 – Crankshaft Position Sensor (CKP) Variation Not Learned. Use the VMI to view the scope pattern of the crankshaft position sensor signal. Verify a good equal crankshaft sensor pattern is present with no dips or variation, as shown in Figure A, in the sign wave pattern. If the pattern is identical to Figure A, Use GDS/KDS to perform a crank sensor relearn procedure. If the pattern shows a dip or variation, as shown in Figure B, replace the flex plate to resolve the concern.

Crankshaft Sensor deviation
