## SB-10058537-3091

TO: Mercedes-Benz Dealer Principals, General Managers, Sales Managers, Service Managers, Parts Managers	FROM: Thomas Brunner, Department Manager, Vehicle Compliance and Analysis, Engineering Services
RE: Service Campaign 2015050004 - <b>Check Radiator Fan. Replace if Necessary Model 222 (S-Class). Model Year 2014 - 2015</b>	DATE: June 26, 2015

Campaign No. 2015050004, June 2015

SUBJECT: **Model 222 (S-Class), Model Year 2014 - 2015**  
**Check Radiator Fan, Replace If Necessary**

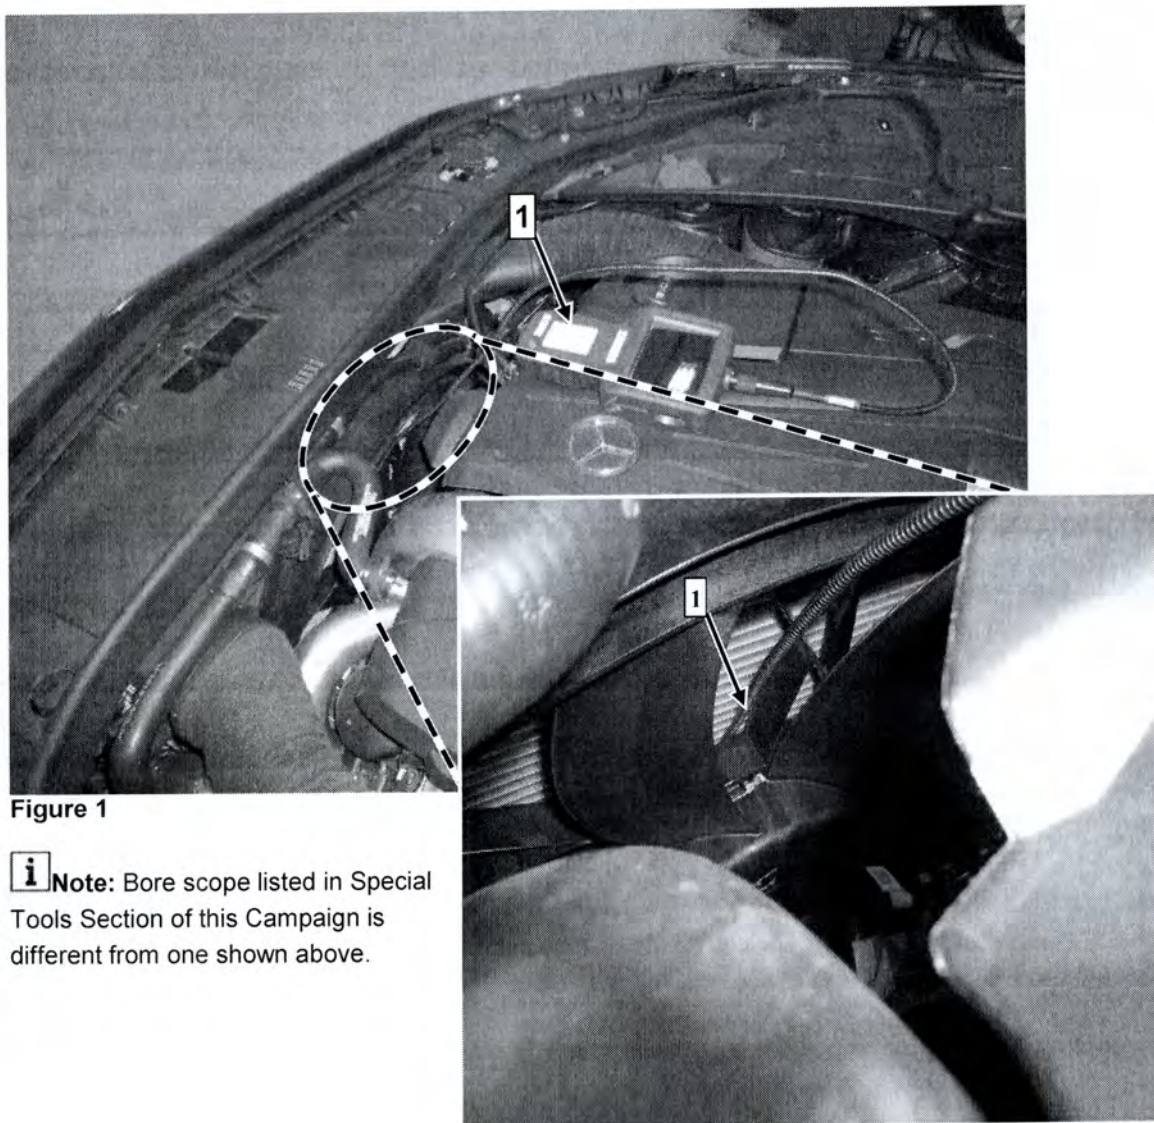
Figure 1

Check production date on radiator fan using bore scope (1, Figure 1):  
Insert bore scope (1) with 5.5 mm viewer from above, between radiator and radiator fan.

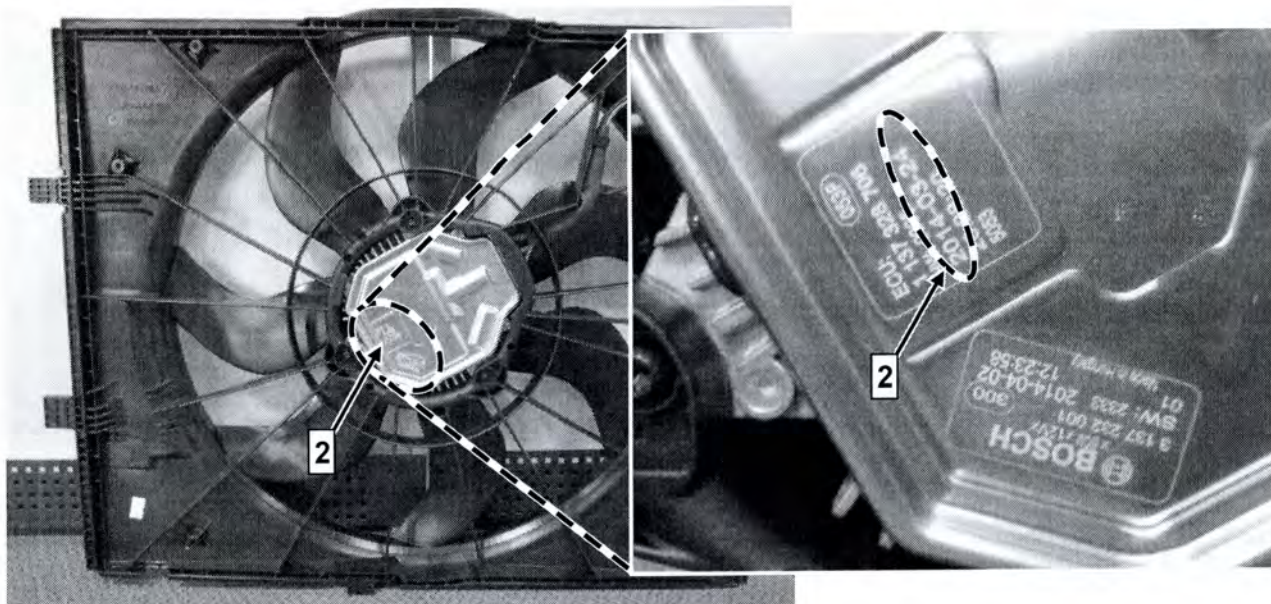
Figure 2

- Use only specified bore scope (refer to equipment table in this bulletin)
- The production date (2, Figure 2) is located in the lower section of the radiator fan motor (Figure 2).
- If **no** production date (2) can be found in the lower section of the radiator fan motor (**OK**):  
Procedure is complete.

Radiator fans with a production date between: **2013-04-22 – 2013-05-08** (April 22 – May 8, 2013) or **2013-10-11 – 2013-10-15** (October 11 – October 15, 2013) **must be replaced (NOT OK)**.

If **no** production date (2, Figure 2) can be found in the lower section of the radiator fan motor (OK): Procedure is complete.

- If production date **is not** between 2013-04-22 – 2013-05-08 or 2013-10-11 – 2013-10-15 (OK): Procedure is complete
- If production date **is** between 2013-04-22 – 2013-05-08 or 2013-10-11 – 2013-10-15 (NOT OK): Proceed to step 2.
