Technical Service Bulletin

94 Daytime running light (DRL) inoperative (DTC 02895 or 02897)

94 15 68 2032184/5 June 29, 2015. Supersedes Technical Service Bulletin Group 94 number 14-43 dated June 9, 2014 for reasons listed below.

Model(s)	Year	VIN Range	Vehicle-Specific Equipment
Q5	2013 - 2015	All	Not applicable

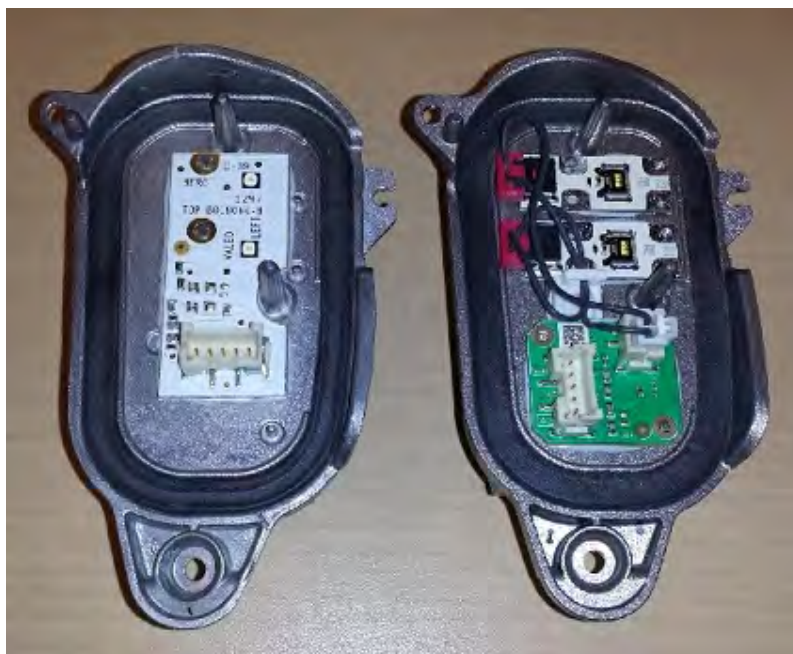
As of March 12th, 2013 production, the LED unit with heat sink has been updated (Figure 3). If a failure occurs, these parts do *not* need to be replaced in pairs.

Figure 3. Current (left) and early (right) style LED DRL units.

6. The appearance of the replacement part for the LED DRL has changed, but functionality is the same. If an LED DRL needs to be replaced, they do not need to be replaced as a pair.

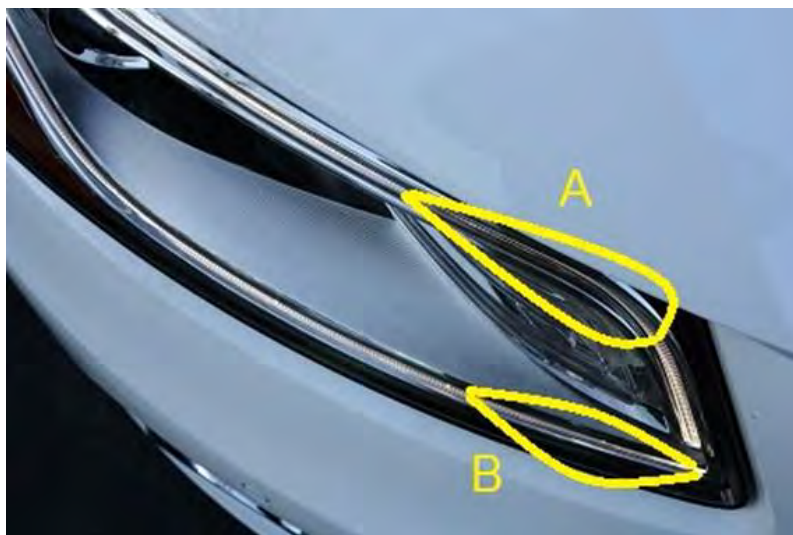
- A defect may be perceived for top-down viewing angle (Figure 4).

Figure 4. Upper light pipe perceived defect (A). Lower light pipe perceived defect (B).

Explain to the customer that the LED illumination appears differently to someone standing in front of the vehicle than it appears to oncoming traffic. The viewing angle of someone standing in front of the vehicle will give a visual effect of an LED DRL inoperative or partially-inoperative condition.

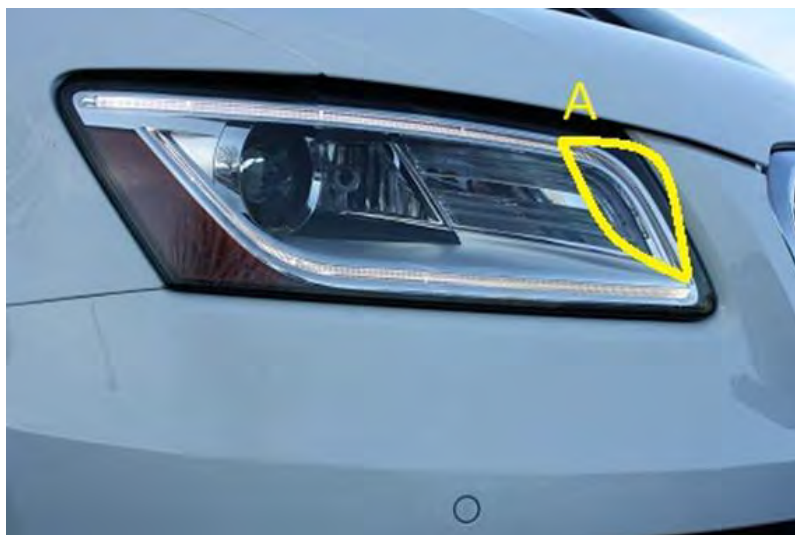
- A defect may be perceived for corner viewing angle (Figure 5).

Figure 5. Upper light pipe perceived defect (A).

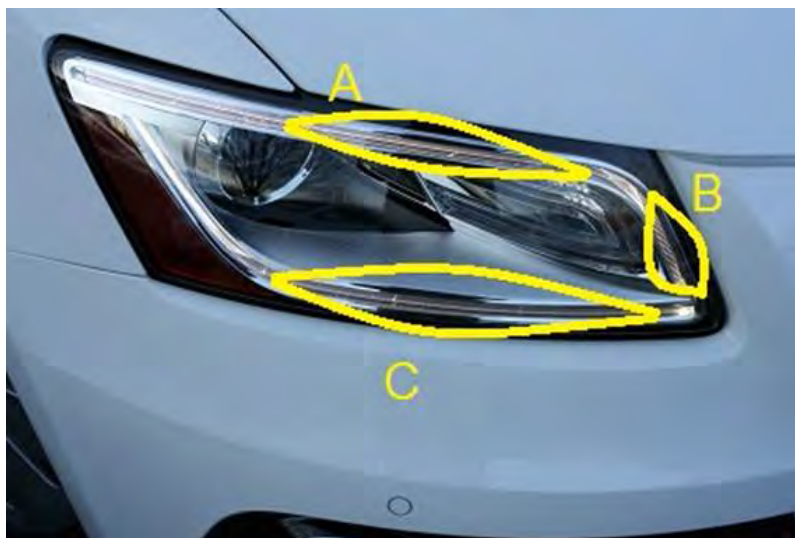
- A defect may be perceived for acute corner viewing angle (Figure 6).

Figure 6. Upper light pipe perceived defect (A, B). Lower light pipe perceived defect (C).

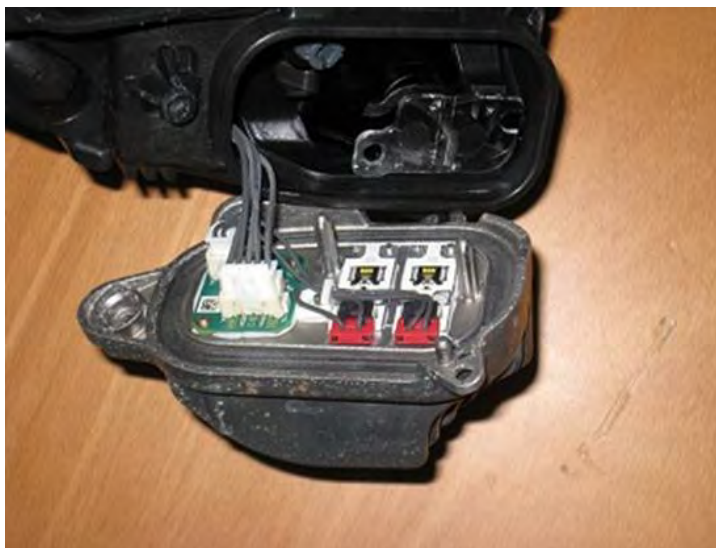
Figure 7: Dual surface mount LED unit exposed.

Be extra careful with red surface mount connectors. In general, a repair kit is not available for any internal headlight connectors.
