Technical BULLETIN

CERTAIN 2015 YZF-R1F and YZF-R1MF MODELS Excessive Rear View Mirror Vibration

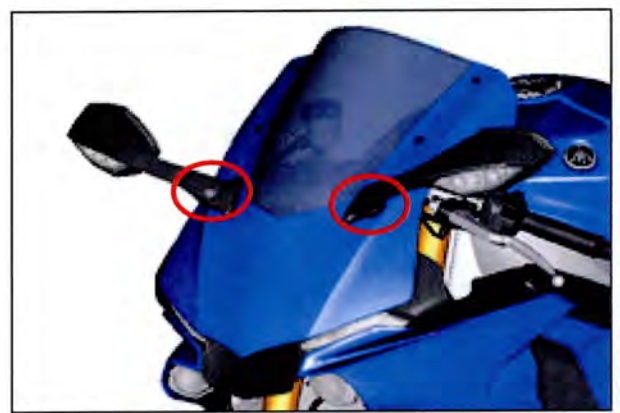
Problem: In certain units, the rider may notice excessive vibration of the rear view mirrors while riding.

Cause: The spring washers that supply tension to the pivot points in the mirrors were installed incorrectly during manufacturing. Since tension is decreased in the pivot point of the mirror, free play occurs which results in vibration.

Remedy: On units within the affected range, replace the left and right side mirrors.
