SB-10058585-9388

Technical Service Bulletin

19 Coolant pipe seepage on turbocharger

19 15 60 2036167/2 June 24, 2015. Supersedes Technical Service Bulletin Group 19 number 14-47 dated January 31, 2014 for reasons listed below.

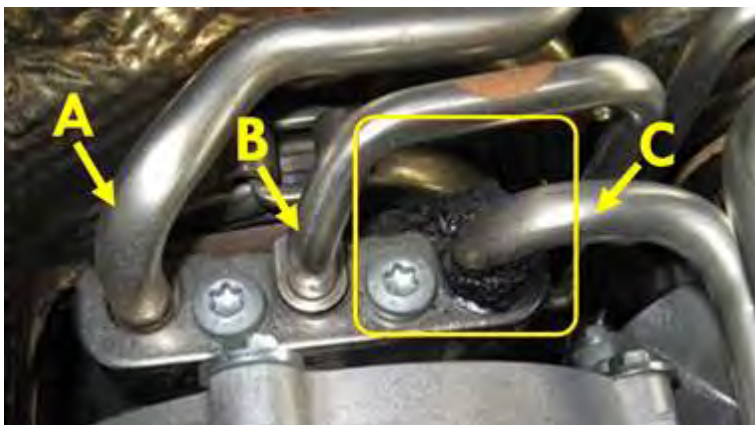
- The low coolant level light is illuminated.
- The coolant level is too low.
- A black crust is visible on the turbocharger coolant lines.

There may be slow coolant loss from the connections of the coolant feed pipe and coolant return pipe. High temperatures cause the coolant to become encrusted on the connection flange of the turbocharger (Figure 1).

Figure 1. Black, encrusted coolant residue (outlined area), coolant feed pipe (A), oil feed pipe (B), and coolant return pipe (C).

1. Drain the cooling system.
2. Replace the coolant feed pipes and coolant return pipes for both cylinder banks.
3. Replace the oil feed pipe o-rings.
4. Tighten the coolant line and oil line hold-down bolts to 9nm.
5. Fill and bleed the cooling system.
