# Technical Service Bulletin

## **SB-10058587-8426**

**91 Rearview camera intermittently inoperative (DTC 2203)**

91 15 04 2041430/1 July 22, 2015.

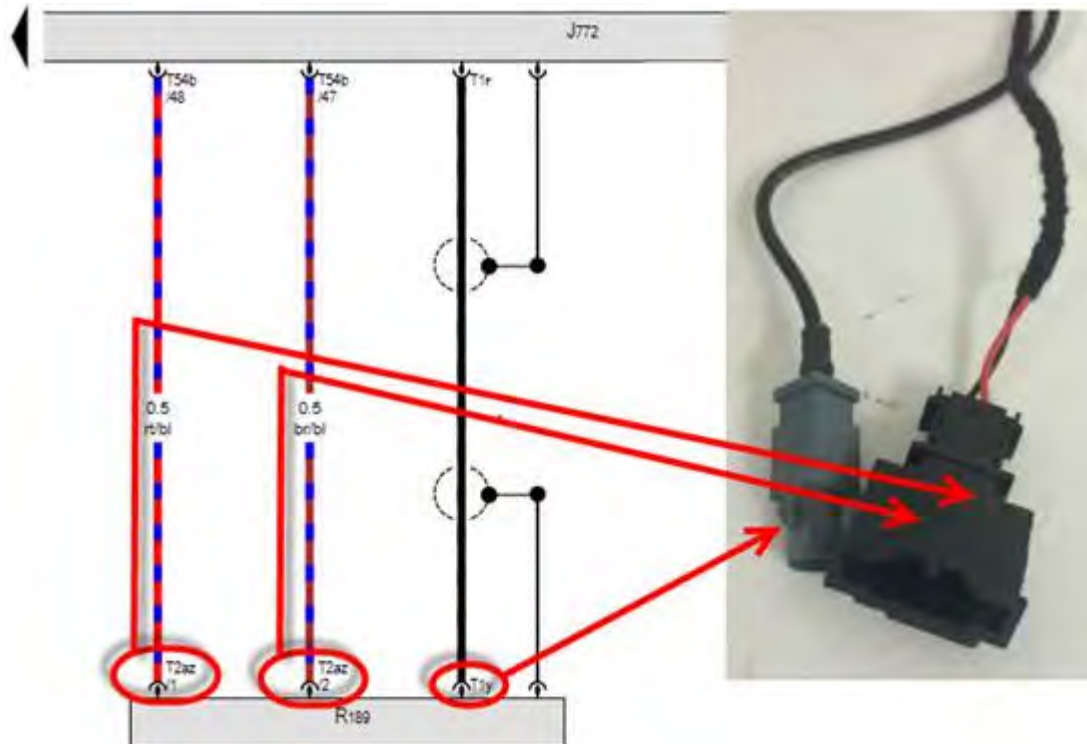
- The customer complains that the rearview camera image is not displayed on the MMI display.
- **DTC 02203** (audio/video input 1) is logged in the rearview camera system control module, J772 (address word 6C) with one of the following fault symptoms:
  - 11 open circuit
  - 8 implausible signal

An issue with the wiring harness may cause the condition.

**Figure 1.** Check the wiring of the R189 reverse camera at connector T2az and T1y.

1. Before proceeding, confirm that the DTC and one of the fault symptoms listed in the *Condition* are logged in the rearview camera system control module, J772 (address word 6C). If the DTC is not listed with one of the fault symptoms, this bulletin does not apply.
2. Check the wiring of the R189 reverse camera at connector T2az and T1y (Figure 1). Repair any loose connectors or pins, corrosion, or any other physical damage.

3. After the wiring has been checked and repaired, try to reproduce the condition:
  - If the rearview camera image still is not displayed on the MMI display, but no cause related to the wiring was found, replace the camera.
  - If the rearview camera image is correctly displayed on the MMI display, do not replace the camera. Clear the DTC and postpone the repair until this TSB is updated with repair instructions.
