SB-10058671-7184

January 2015

Emissions Recall P35 Diesel Particulate Filter Wiring

- 2013 (DJ) RAM Pick Up Truck (2500 series)
(D2) RAM Pick Up Truck (3500 series)

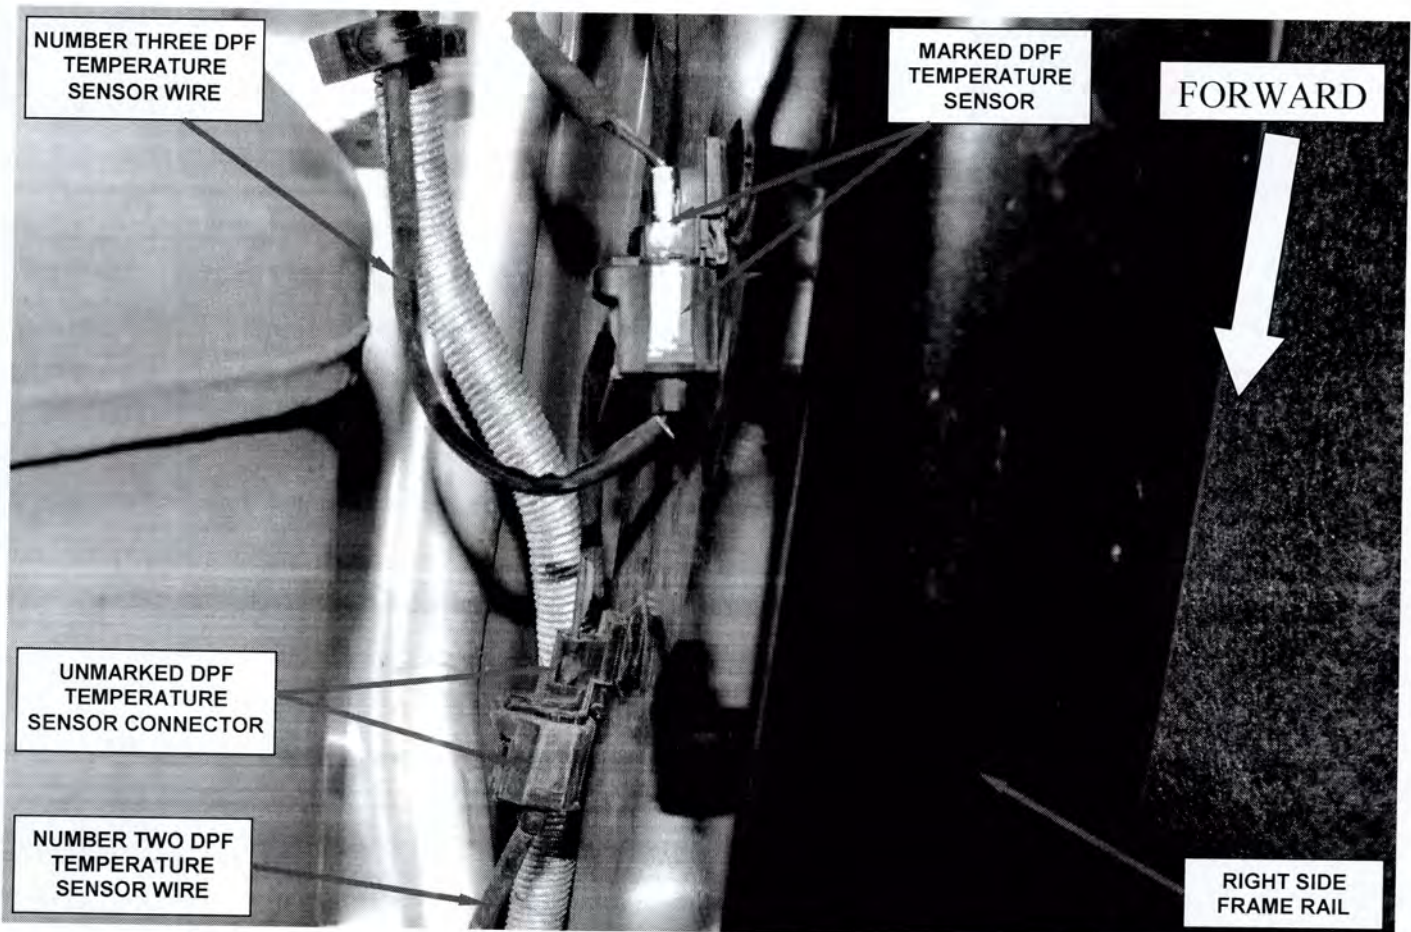
Figure 1 – Mark Number Three DPF Temperature Sensor Connector

1. Lift the vehicle on an appropriate hoist.
2. Using a china marker or equivalent, place an identification mark on both sides of one of the Diesel Particulate Filter (DPF) temperature sensor electrical connectors (Figure 1).

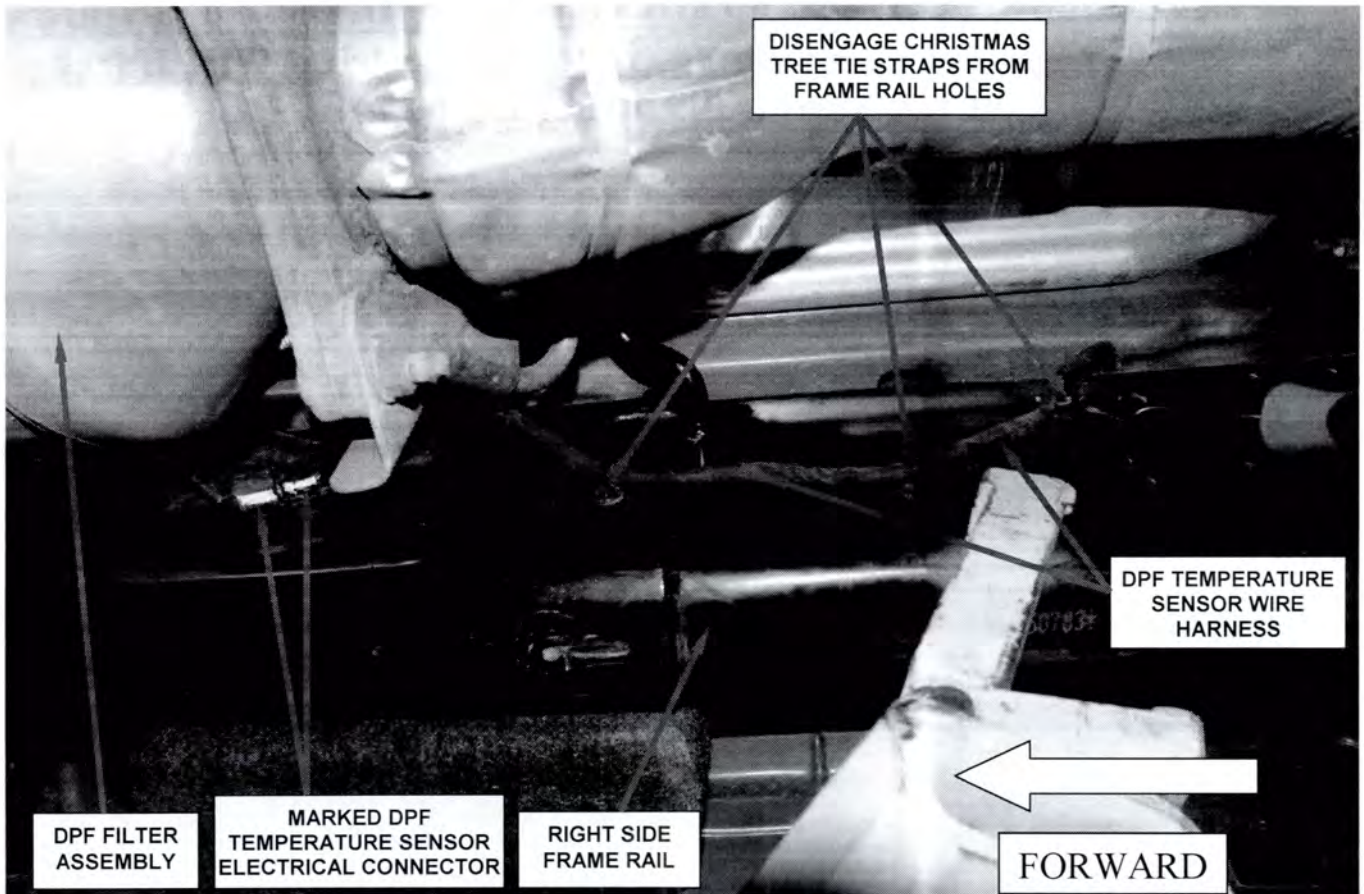
Figure 2 – Detach DPF Temperature Sensor Wire Harness from the Frame Rail

3. Detach the three DPF temperature sensor wire harness Christmas tree tie straps from the frame rail (Figure 2).
4. Cut off and discard the three Christmas tree tie straps from the DPF temperature sensor wire harness (Figure 2).

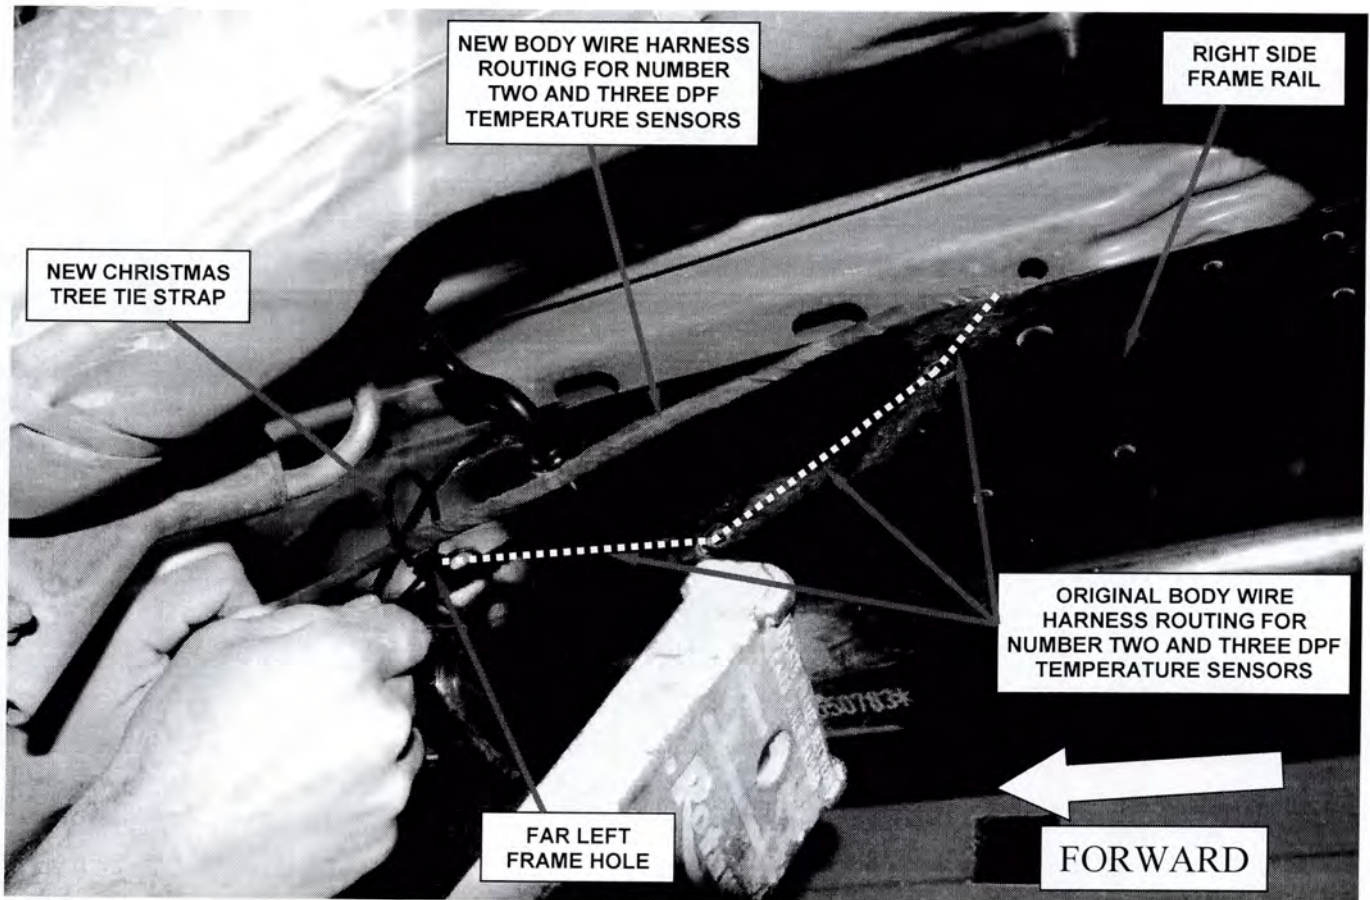
**Figure 3 – New Body Wire Harness Routing**

5. Insert one Christmas tree tie strap barbed peg into the far left frame hole (Figure 3).
6. Loosely install the DPF temperature sensor electrical connector wire harness to the Christmas tree tie strap installed in Step 5.
7. Route the temperature sensor electrical wire harness as shown in Figure 3 and tighten the new Christmas tree tie strap.
8. Trim off the tail from the new Christmas tree tie strap.

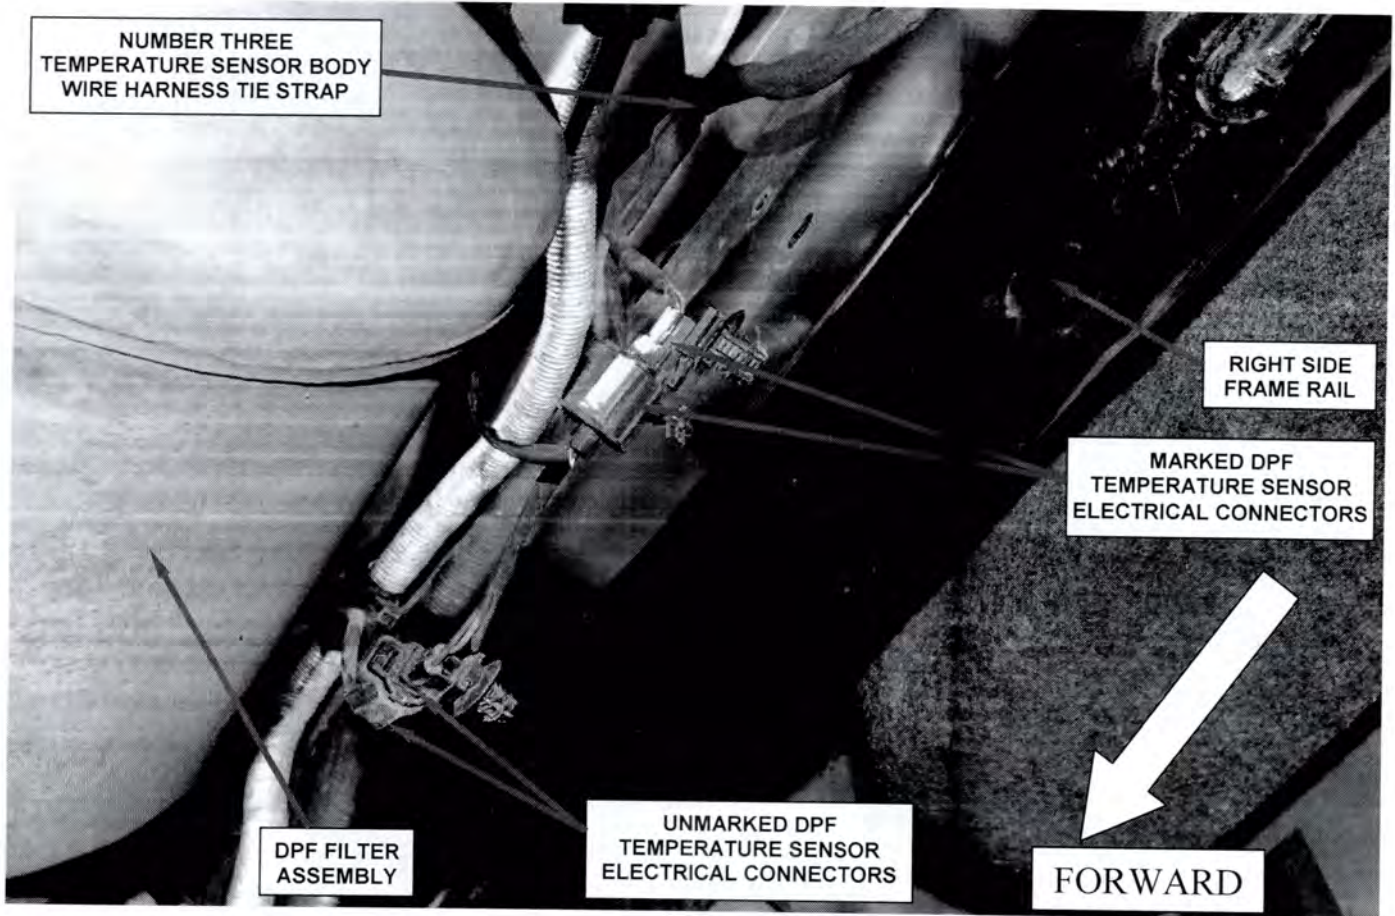
Figure 4 – Detach Both DPF Temperature Sensor Electrical Connectors from the Frame Rail

9. Carefully detach the two DPF temperature sensor electrical connectors from the frame rail (Figure 4).
10. Detach the Christmas tree tie strap from the wire harness for the number three DPF temperature sensor electrical connector wire harness (Figure 4).
11. Disconnect both DPF temperature sensor electrical connectors from the body wire harness connectors.

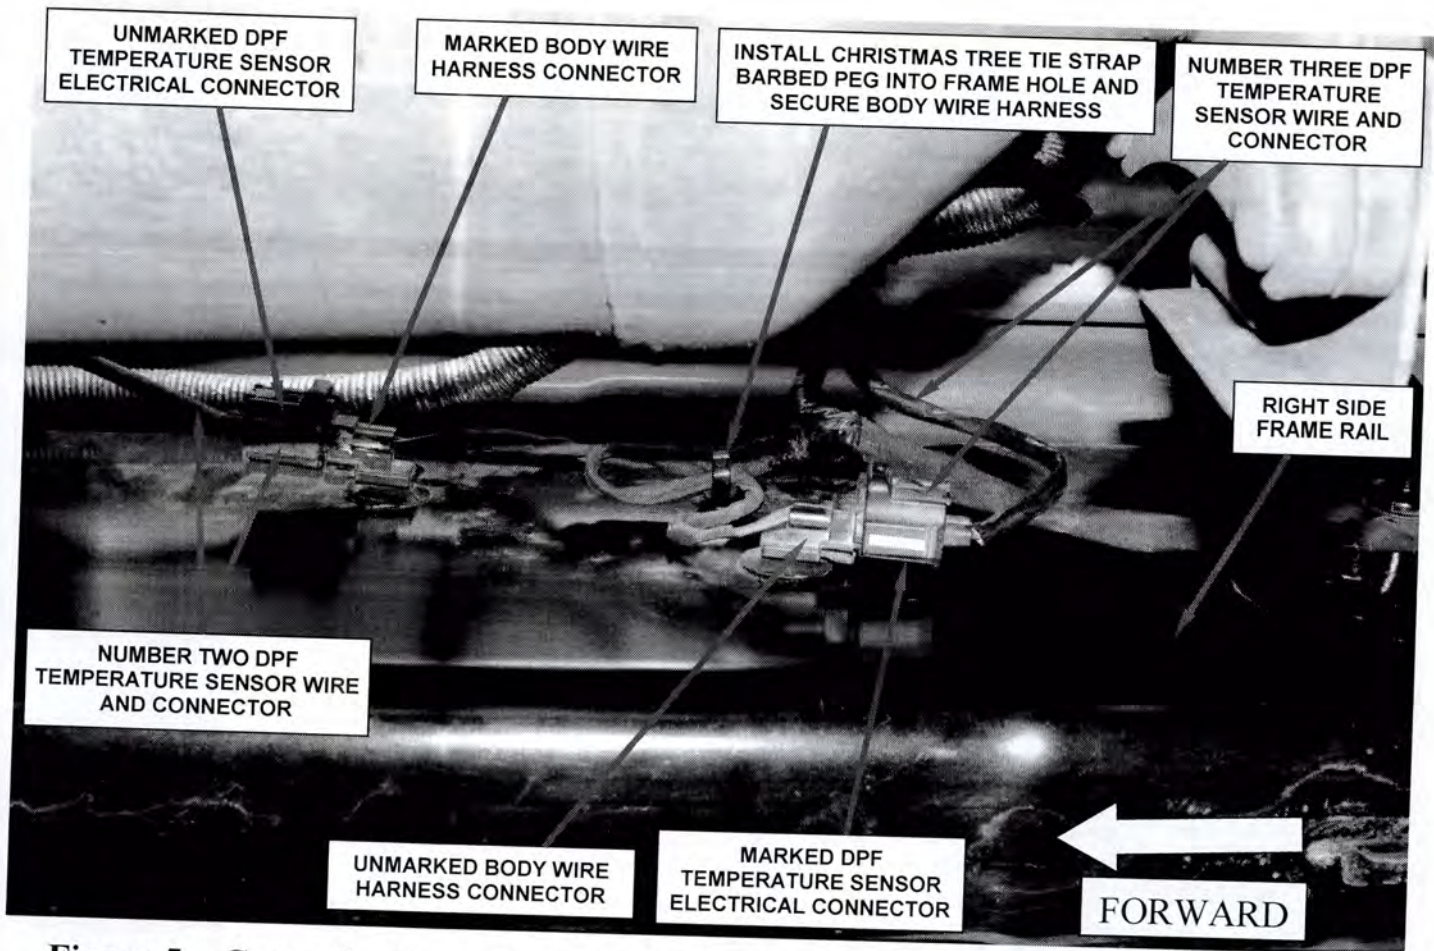
Figure 5 – Correctly Connected and Routed DPF Electrical Connectors and Wire Harness

12. Connect the marked body wire harness connector to the unmarked DPF temperature sensor electrical connector (Figure 5).
13. Connect the unmarked body wire harness connector to the marked DPF temperature sensor electrical connector (Figure 5).
14. Secure the DPF temperature sensor electrical connectors into the frame so that the connectors face away from each other (Figure 5).
15. Install one Christmas tree tie strap in the frame hole (Figure 5).
16. Loop the long body side wire harness and secure it to the frame with the Christmas tree tie strap installed in Step 15 (Figure 5).
17. Continue with **Section C. DPF Orientation Verification Test**

1. Disconnect the number three DPF temperature sensor electrical connector (Figure 5 or 10).
2. Lower the vehicle from the hoist.
3. Connect the wiTECH scan tool to the vehicle and start a wiTECH session.

5. Lift the vehicle on the hoist and reconnect the number three DPF temperature sensor electrical connector to the body wire harness (Figure 5 or 10).
6. Lower the vehicle from the hoist.

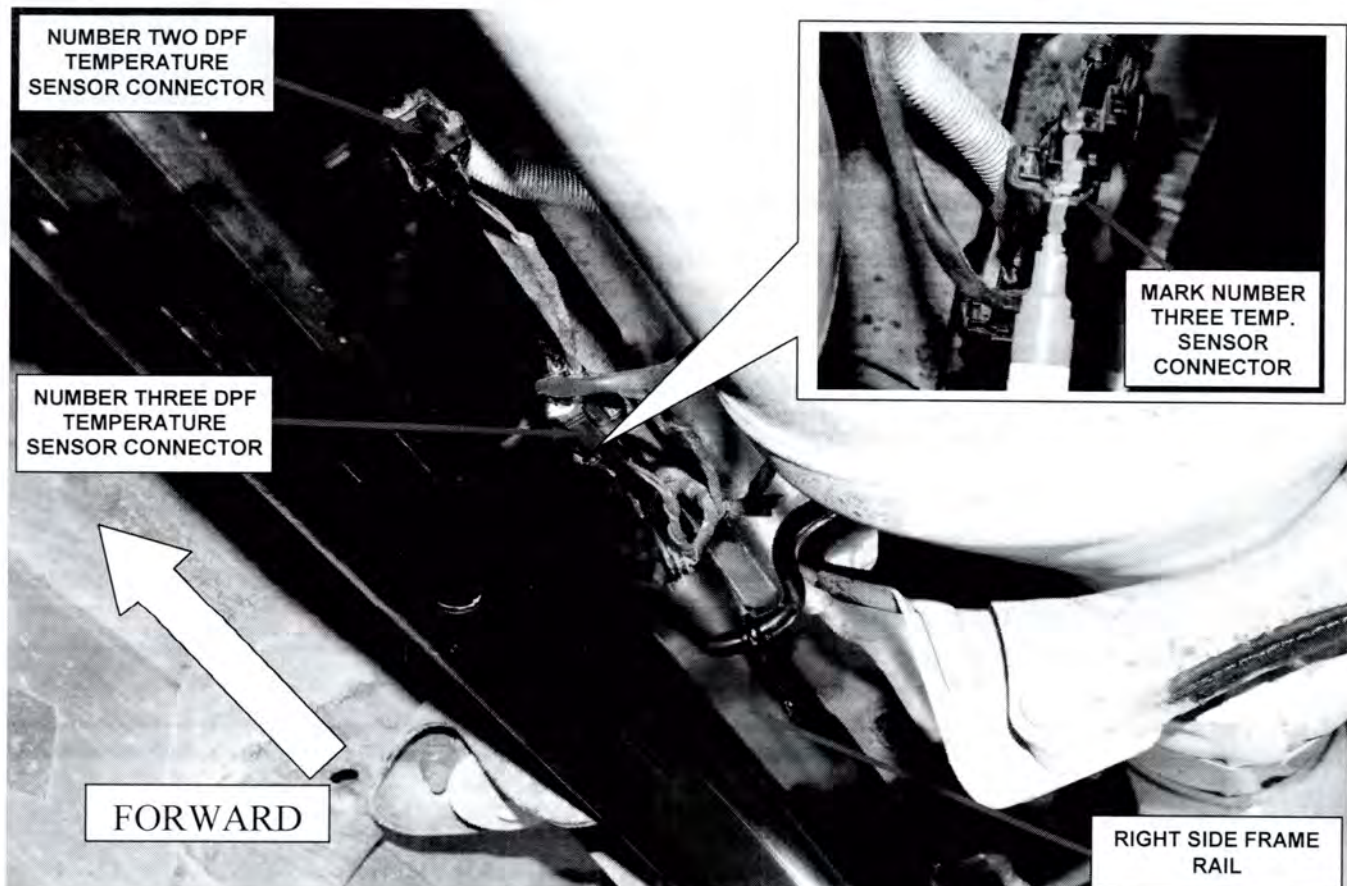
Figure 6 – Mark the Rear Connector

1. Lift the vehicle on an appropriate hoist.
2. Using a china marker or equivalent, place an identification mark on both sides of one of the Diesel Particulate Filter (DPF) temperature sensor electrical connectors (Figure 6).

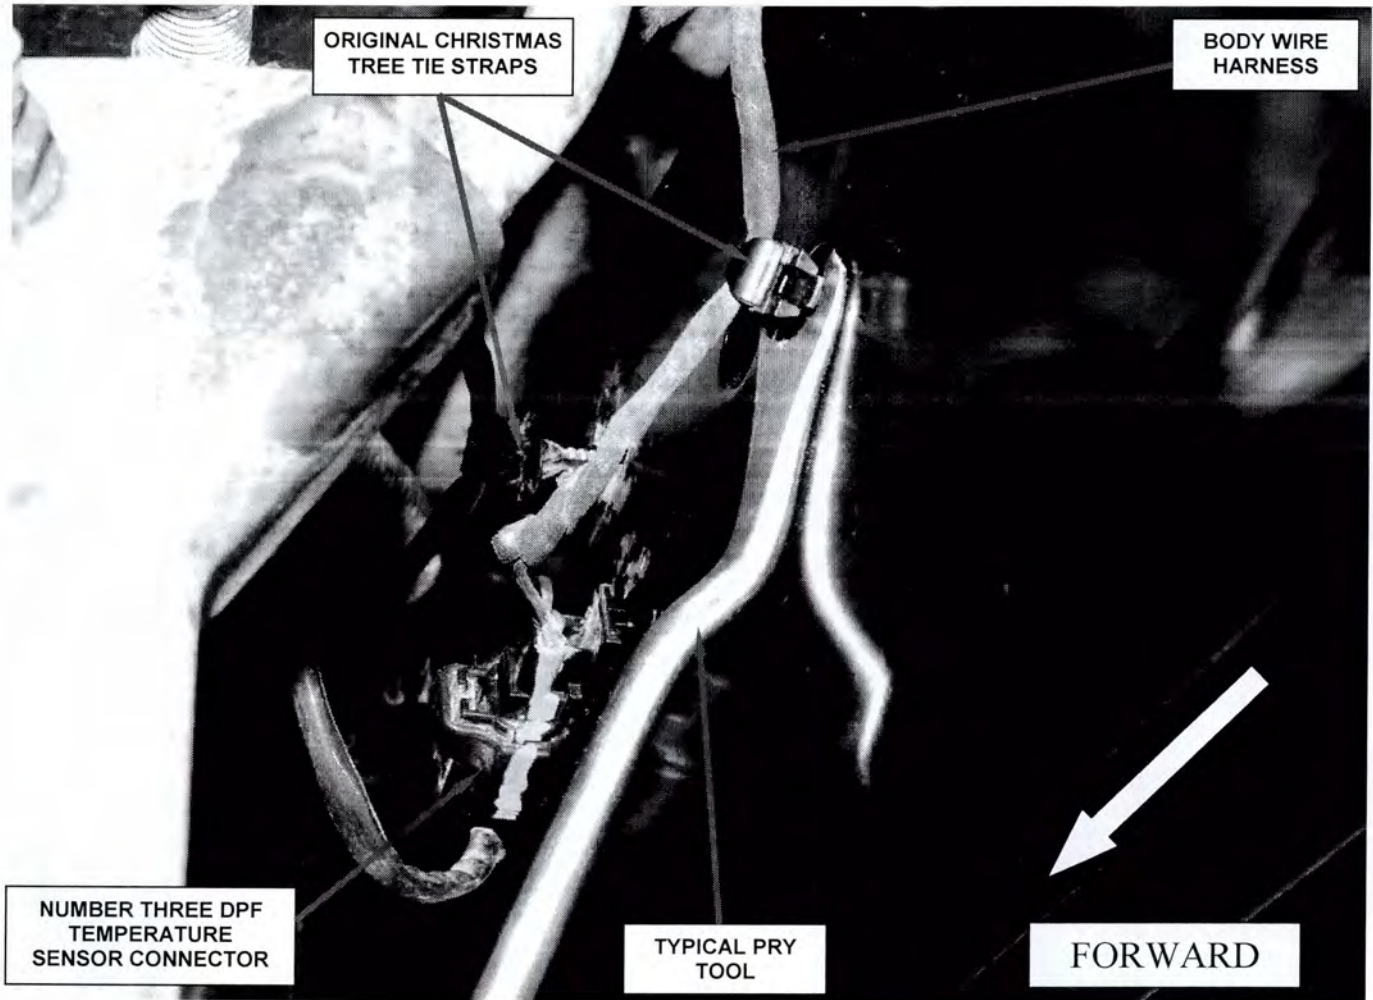
Figure 7 - Detach DPF Temperature Sensor Wire Harness from the Frame Rail

3. Detach the two DPF temperature sensor wire harness Christmas tree tie straps from the frame rail (Figure 7).

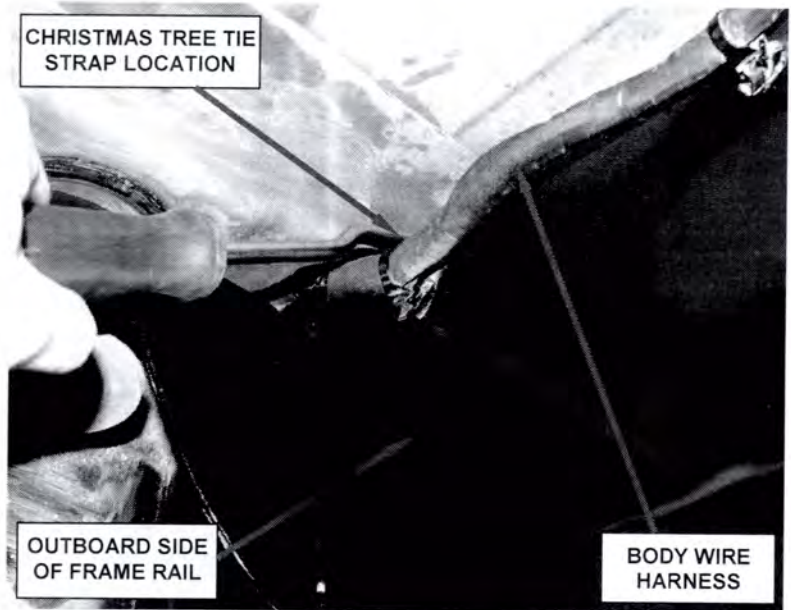
Figure 8 – Detach Christmas Tree Tie Strap From Top of Frame

5. Disconnect the Christmas tree tie strap from the top of the frame rail (Figure 8).
6. Disconnect the marked and unmarked DPF temperature sensor electrical connectors from the body wire harness connectors (Figure 9).

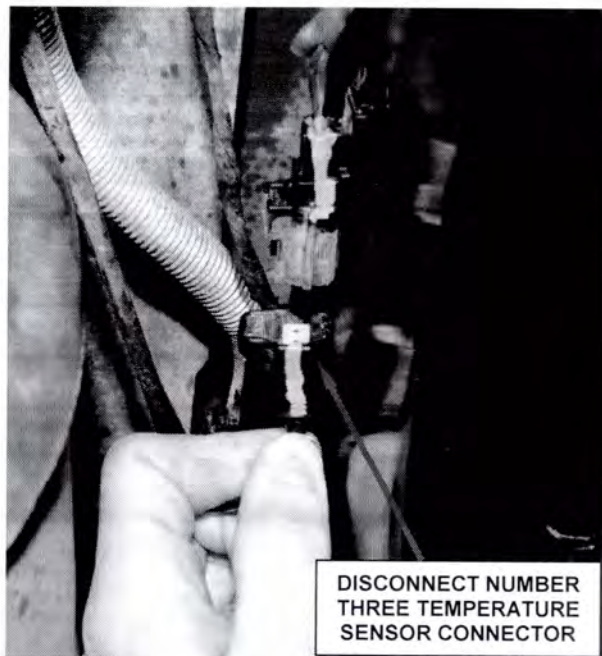
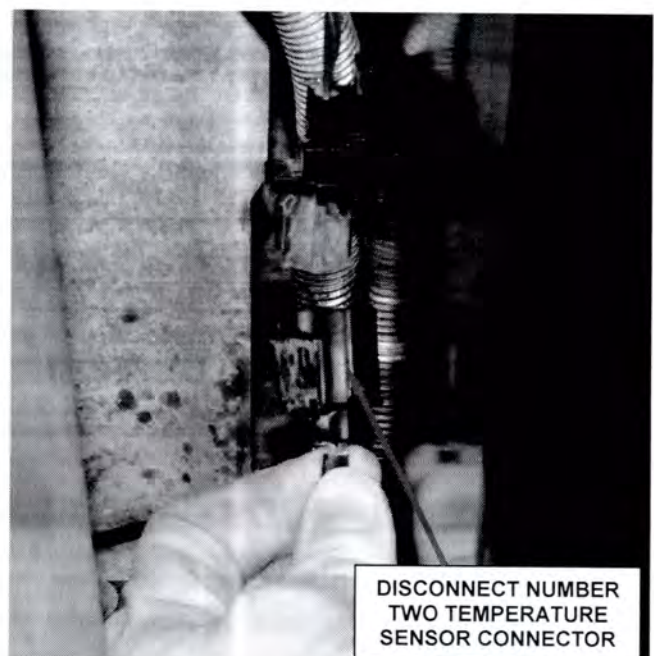
Figure 9 – Disconnect the Marked and Unmarked DPF Electrical Connectors

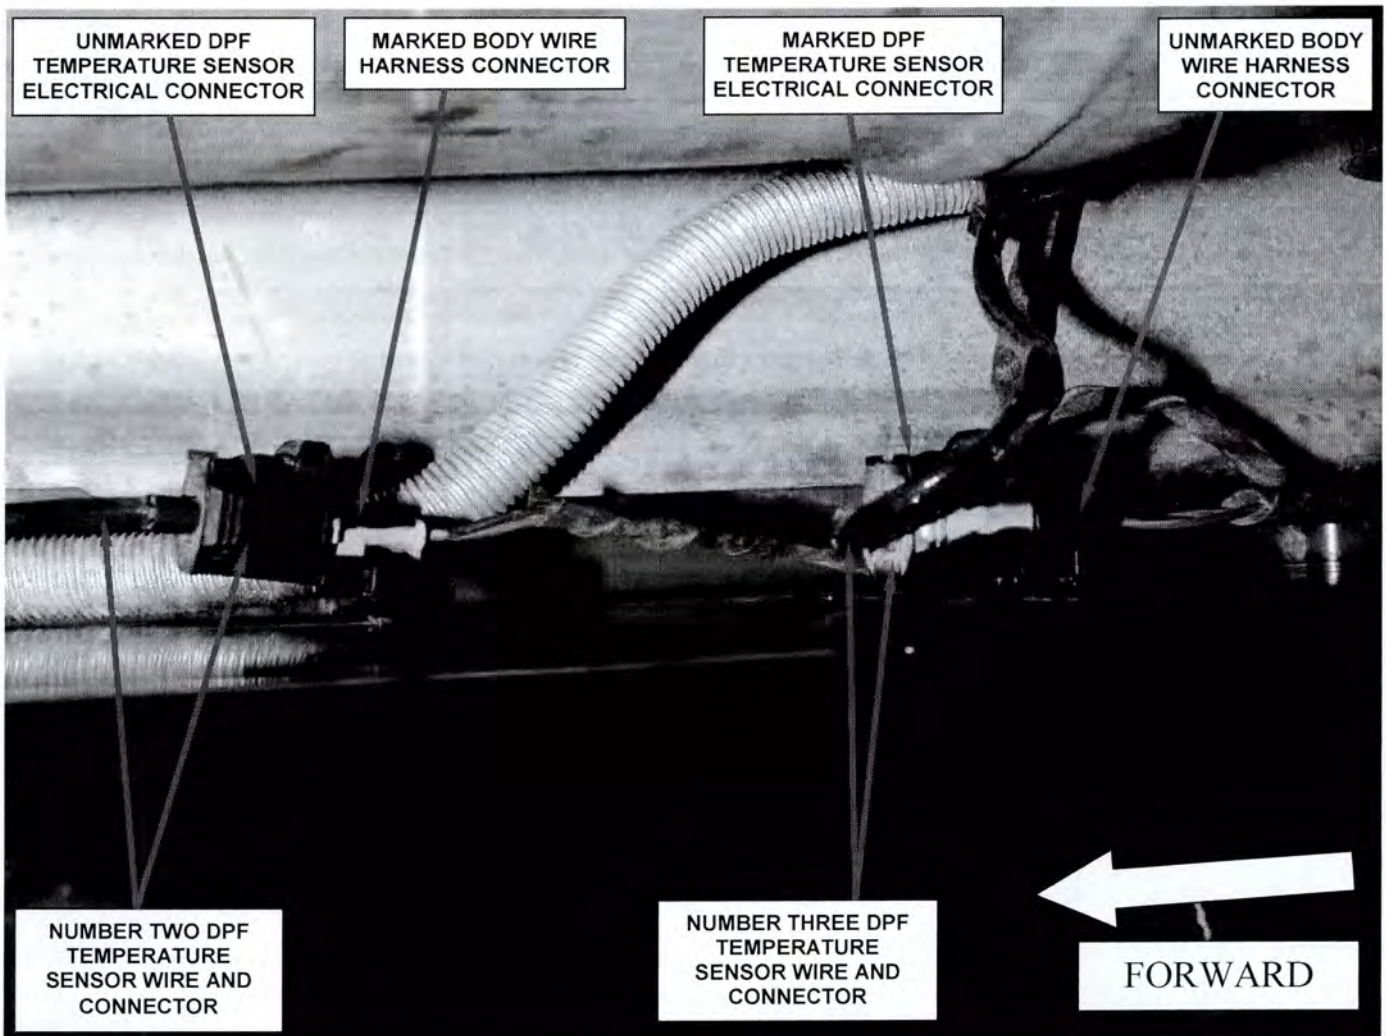
Figure 10 - Correctly Connected DPF Electrical Connectors and Wire Harness

7. Connect the marked body wire harness connector to the unmarked DPF temperature sensor electrical connector (Figure 10).
8. Connect the unmarked body wire harness connector to the marked DPF temperature sensor electrical connector (Figure 10).
9. Secure the DPF temperature sensor electrical connector wires to the frame rail.
10. Continue with **Section C. DPF Orientation Verification Test.**
