Service Bulletin

SB-10058683-6181

SUBJECT: Special Coverage Adjustment - Rear Seat Belt Buckle Damage

MODELS: 2013-2015 Chevrolet Trax
2013-2015 Buick Encore

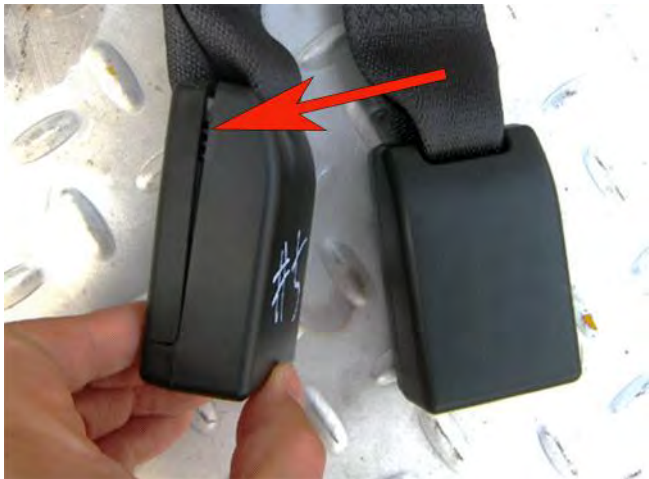
4213814

1. Move the front seats to the forward most position.
2. Pull the release strap and flip the lower seat cushion forward on both rear seats.
3. Verify which buckles are damaged and require replacement. Use the photos below to identify buckles that are no longer serviceable.

1. Replace the buckle assemblies that are no longer serviceable. Refer to *Rear Seat Belt Buckle Replacement* in SI.
