Bulletin No.: 14567  
Date: June 2015

## SB-10058683-6445

**SUBJECT:** Special Coverage Adjustment - Rear Seat Belt Buckle Damage

**MODELS:** 2013-2015 Chevrolet Trax  
2013-2015 Buick Encore

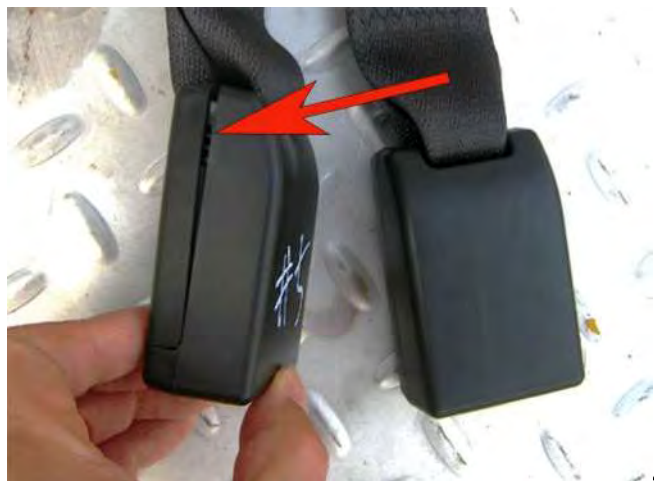
4213814

1. Move the front seats to the forward most position.
2. Pull the release strap and flip the lower seat cushion forward on both rear seats.
3. Verify which buckles are damaged and require replacement. Use the photos below to identify buckles that are no longer serviceable.

1. Replace the buckle assemblies that are no longer serviceable. Refer to *Rear Seat Belt Buckle Replacement* in SI.
